## MARINE INVESTIGATION REPORT

M11W0211

### STRIKING OF BERTH

**ROLL-ON/ROLL-OFF FERRY *COASTAL INSPIRATION***  
**DUKE POINT, BRITISH COLUMBIA**  
**20 DECEMBER 2011**

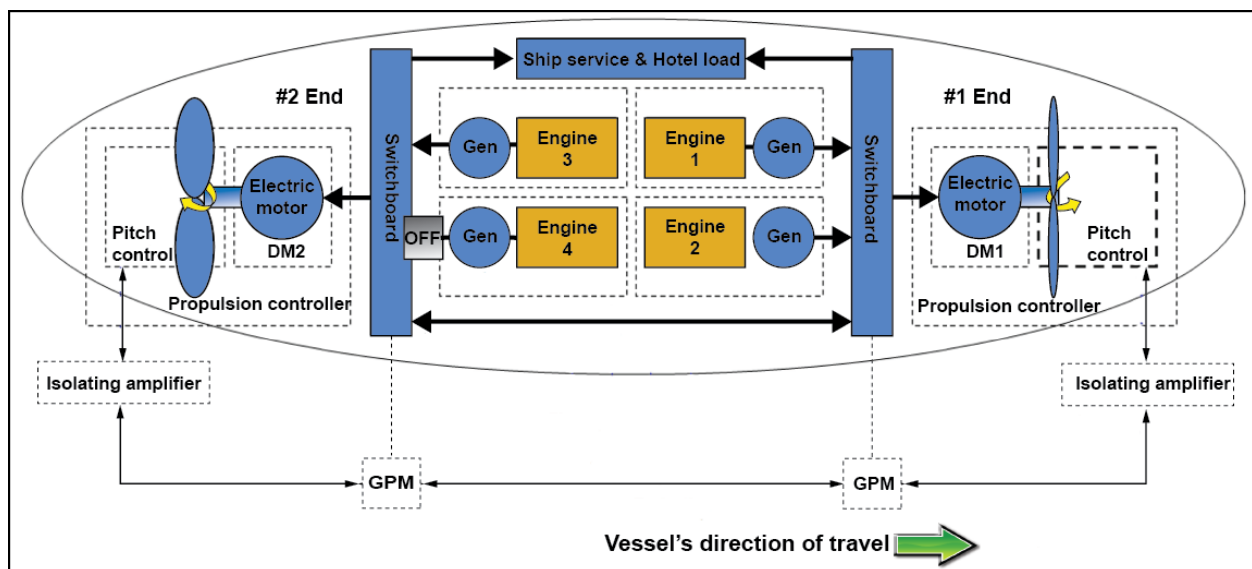
Figure 1. Propulsion system layout (3 engines online)

Figure 1 presents a layout of the propulsion system. The engine room contains 4 engines, each coupled to a synchronous generator (Gen). The generated electrical power is fed to two 6.6 kV propulsion switchboards, 1 at either end of the vessel. Two 600 V main switchboards are then fed from the propulsion switchboards via transformers and supply power to other auxiliaries. The switchboards are arranged in 2 sections with a tie bar that electrically connects both sides of the engine room or isolates one side from the other. The propulsion switchboards drive the electric motors required for propulsion. The vessel is propelled by 2 electric drive motors (DM1 and DM2), 1 at either end of the vessel. Each drive motor has 1 propeller shaft and associated components.

Propeller pitch can be varied while the propeller shafts rotate at a constant speed of 140 rpm. Vessel speed is controlled from either the bridge or the engine control room by altering the propeller pitch via handles; <sup>2</sup> moving a handle transmits data to the pitch control system electronically. The propeller pitch is normally controlled from the bridge and has several back-up features (see the Controllable-pitch Propeller section on page 4).

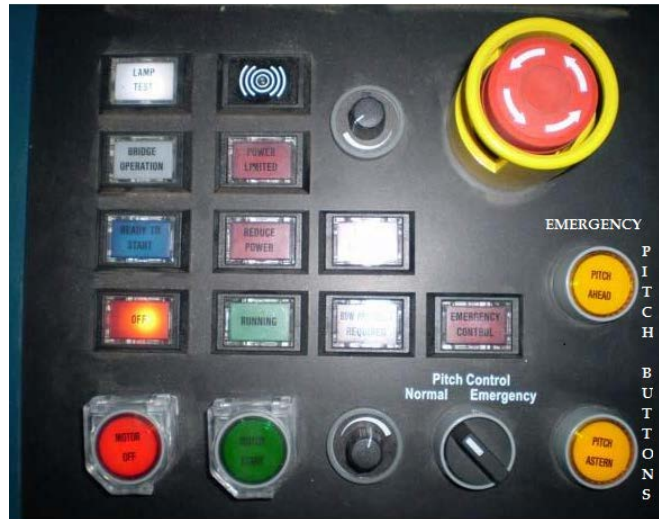
Photo 2. Pitch control panel

The pitch can be operated under emergency conditions via a selector switch at each propulsion control panel, located at each bridge and engine control room. Operation of the pitch is carried out by changing the switch from Normal to Emergency. In emergency mode, the bow propeller pitch is controlled by the push buttons labelled PITCH AHEAD and PITCH ASTERN. These push buttons bypass the power load automation and operate the pitch control hydraulic valves directly. They are round, yellow, and raised push buttons situated one above the other. The Normal/Emergency selector switch is black and is situated in proximity to the emergency propeller pitch controls (Photo 2).

Emergency procedures in the VSM cover the use of the emergency pitch control. In the event of a pitch control system failure that does not allow the pitch to be controlled by the bridge or engine control room's normal or emergency modes, the pitch can be operated in the propulsion room for each propeller by using the handles at the hydraulic valve block itself. Ahead and astern directions can be read out from the mechanical dial located on the oil distribution unit.
