**MARINE INVESTIGATION REPORT
M13L0123**

COLLISION

**BULK CARRIER *HELOISE* AND TUG *OCEAN GEORGIE BAIN*
PORT OF MONTRÉAL, QUEBEC
03 AUGUST 2013**

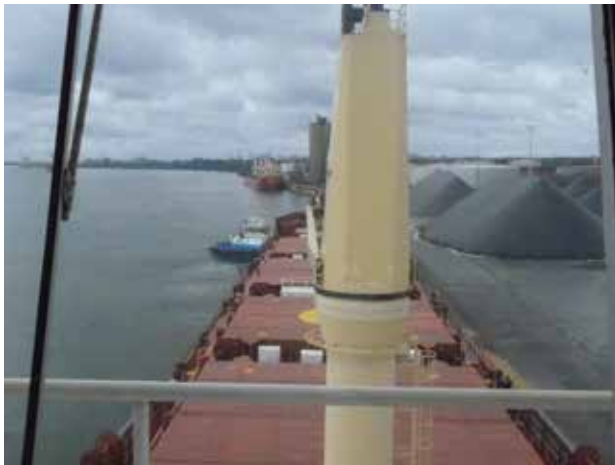
Photo 2. View through bridge windows to slightly left of centreline (Appendix A)

The *Heloise* is a dry bulk cargo vessel of steel construction, with machinery space and accommodation located aft (Photo 1). The vessel has 7 cargo holds and hatches that are serviced by three 36-tonne electric-hydraulic cranes mounted on the centreline of the vessel. The bridge is fitted with a navigation console that is offset from the vessel's centreline (Appendix A). Depending on the position of an observer on the bridge, the view out of the bridge windows can be obstructed by the cranes (Photos 2 and 3).

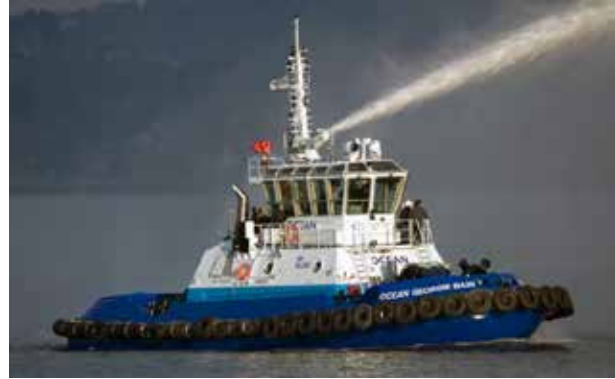
Photo 4. The *Ocean Georgie Bain* (Photo: Groupe Ocean)

A post-occurrence inspection determined that the damage sustained by the *Ocean Georgie Bain* consisted primarily of the following: the pilot house was crushed inward at the starboard aft corner, 10 windows on the bridge were broken, 7 window frames were bent and distorted, the starboard main engine exhaust pipe was disconnected from the deck, and the starboard auxiliary engine exhaust pipe was bent and broken above the deck connection. The vessel was subsequently dry-docked and was out of service for almost 7 weeks.

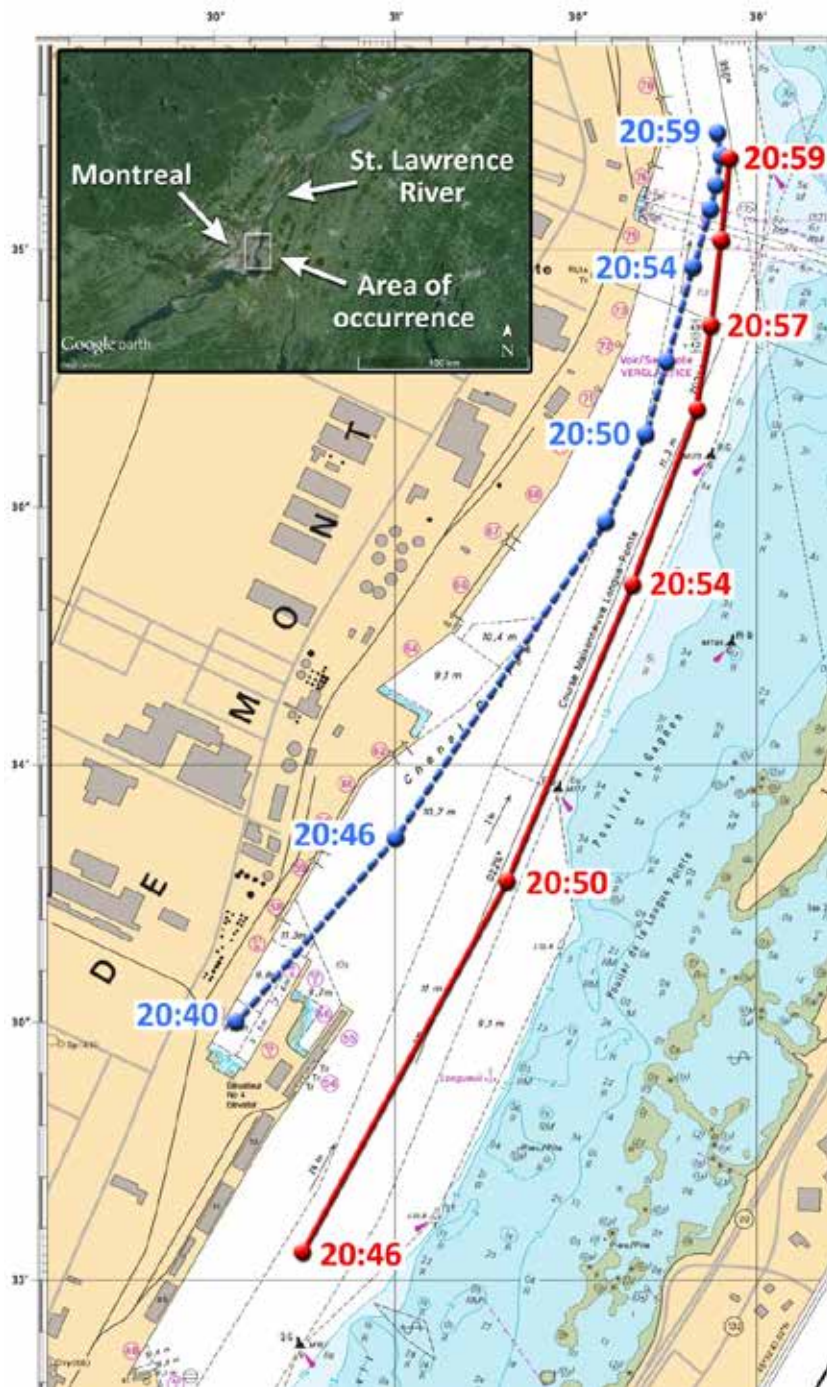
Appendix B – Area of the occurrence

At about the same time, the tug *Ocean Georgie Bain* requested authorization from MCTS to depart section 57 to assist another vessel, the *Acadian*, with berthing. MCTS granted the authorization and reported updated vessel traffic. Six minutes later, at 2046, the tug *Ocean Pierre-Julien* called MCTS asking for the same authorization; permission was granted to proceed, and MCTS also relayed the same message concerning the upbound traffic. At that time, the *Heloise* was passing abeam of section 51 at a speed of 11.7 knots, and the *Ocean Georgie Bain* was visible at a distance of approximately 0.9 nautical miles (nm)⁸ (Appendix B).
