**MARINE INVESTIGATION REPORT**  
**M14P0014**

**GROUNDING**

**CONTAINER VESSEL *CAP BLANCHE***  
**FRASER RIVER, BRITISH COLUMBIA**  
**25 JANUARY 2014**

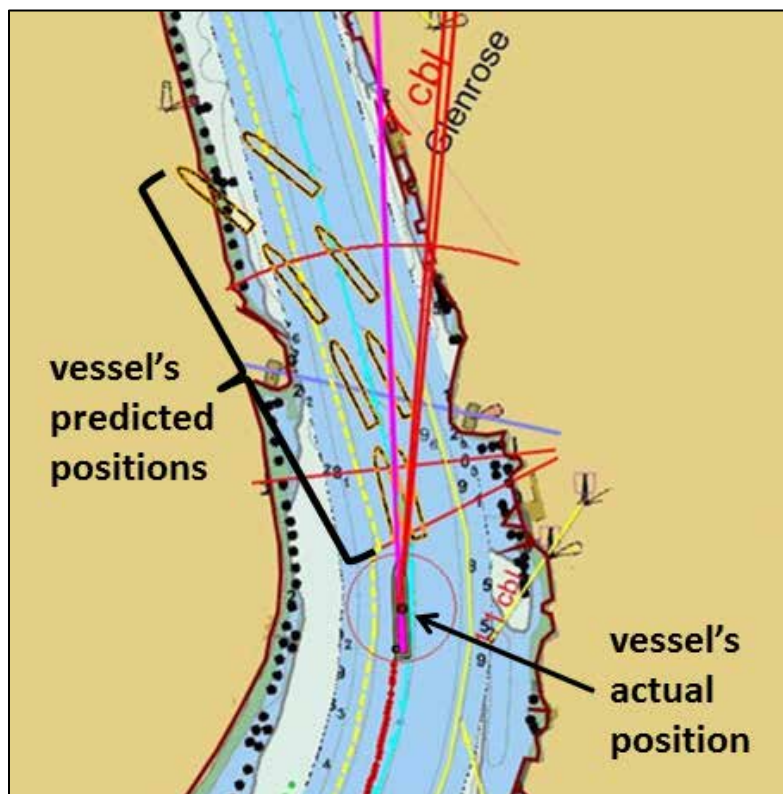
On 22 March 2014, a TSB investigator, accompanied by 2 Fraser River pilots, boarded the *Cap Blanche* to observe the vessel transiting the Fraser River to the same berth as that of the occurrence voyage. During the voyage, a comparison was made between the vessel-positioning data provided by the vessel's AIS versus that provided by the pilot's WAAS-based DGPS antenna, both of which were set to their pre-determined GPS smoothing intervals. The comparison found that the WAAS-based DGPS and AIS provided data that resulted in a discrepancy between the projected vessel positions (Figure 1). The projected vessel positions were less accurate when the PPU was connected to the AIS.

Figure 1. Discrepancy between projected vessel positions, based on input from the vessel's automatic identification system (AIS) and a wide area augmentation system (WAAS)-based DGPS antenna as the *Cap Blanche* transits through City Reach near km 29.

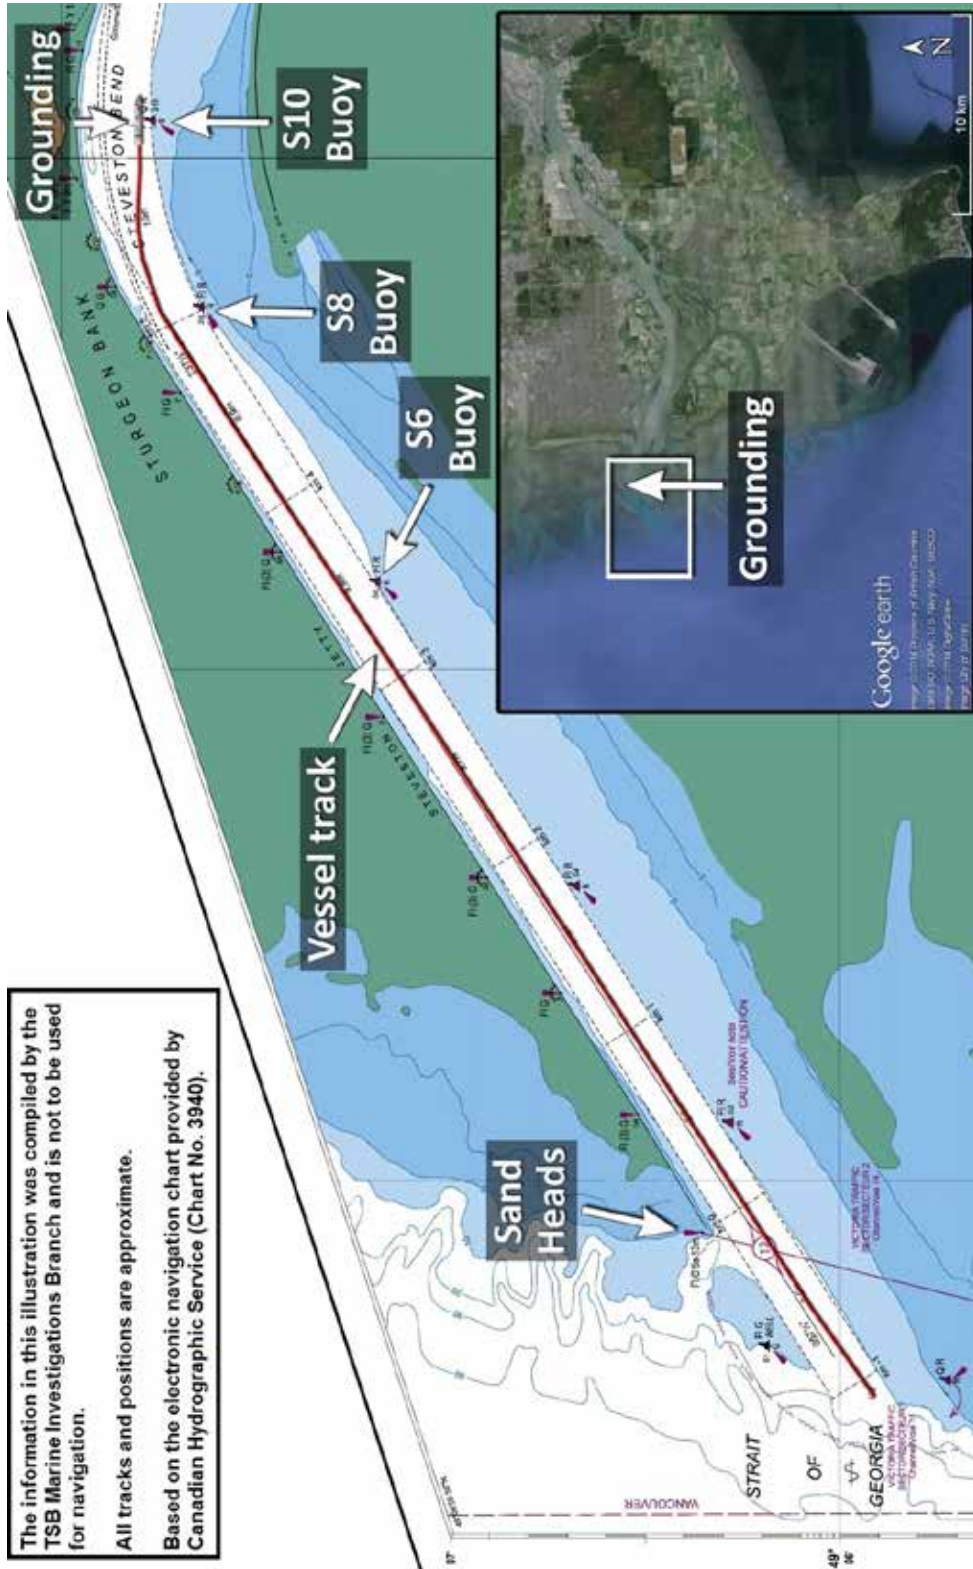
## Appendix A – Area of the occurrence

At 2153:20, when buoy S8 was about midships, the vessel's heading was 065° gyro (G), and the rate of turn was 24.8° per minute<sup>12</sup> to starboard at a speed of 14.3 knots. At 2154:30, the heading was 089°G, the speed was 13 knots, and the vessel had started to turn toward the south side of the channel. The pilot ordered counter rudder to port and full ahead on the engine to stop the turn to starboard and correct the vessel's position in the channel, but the vessel did not respond sufficiently, and it grounded just north of buoy S10 at 2156 within the navigable channel.

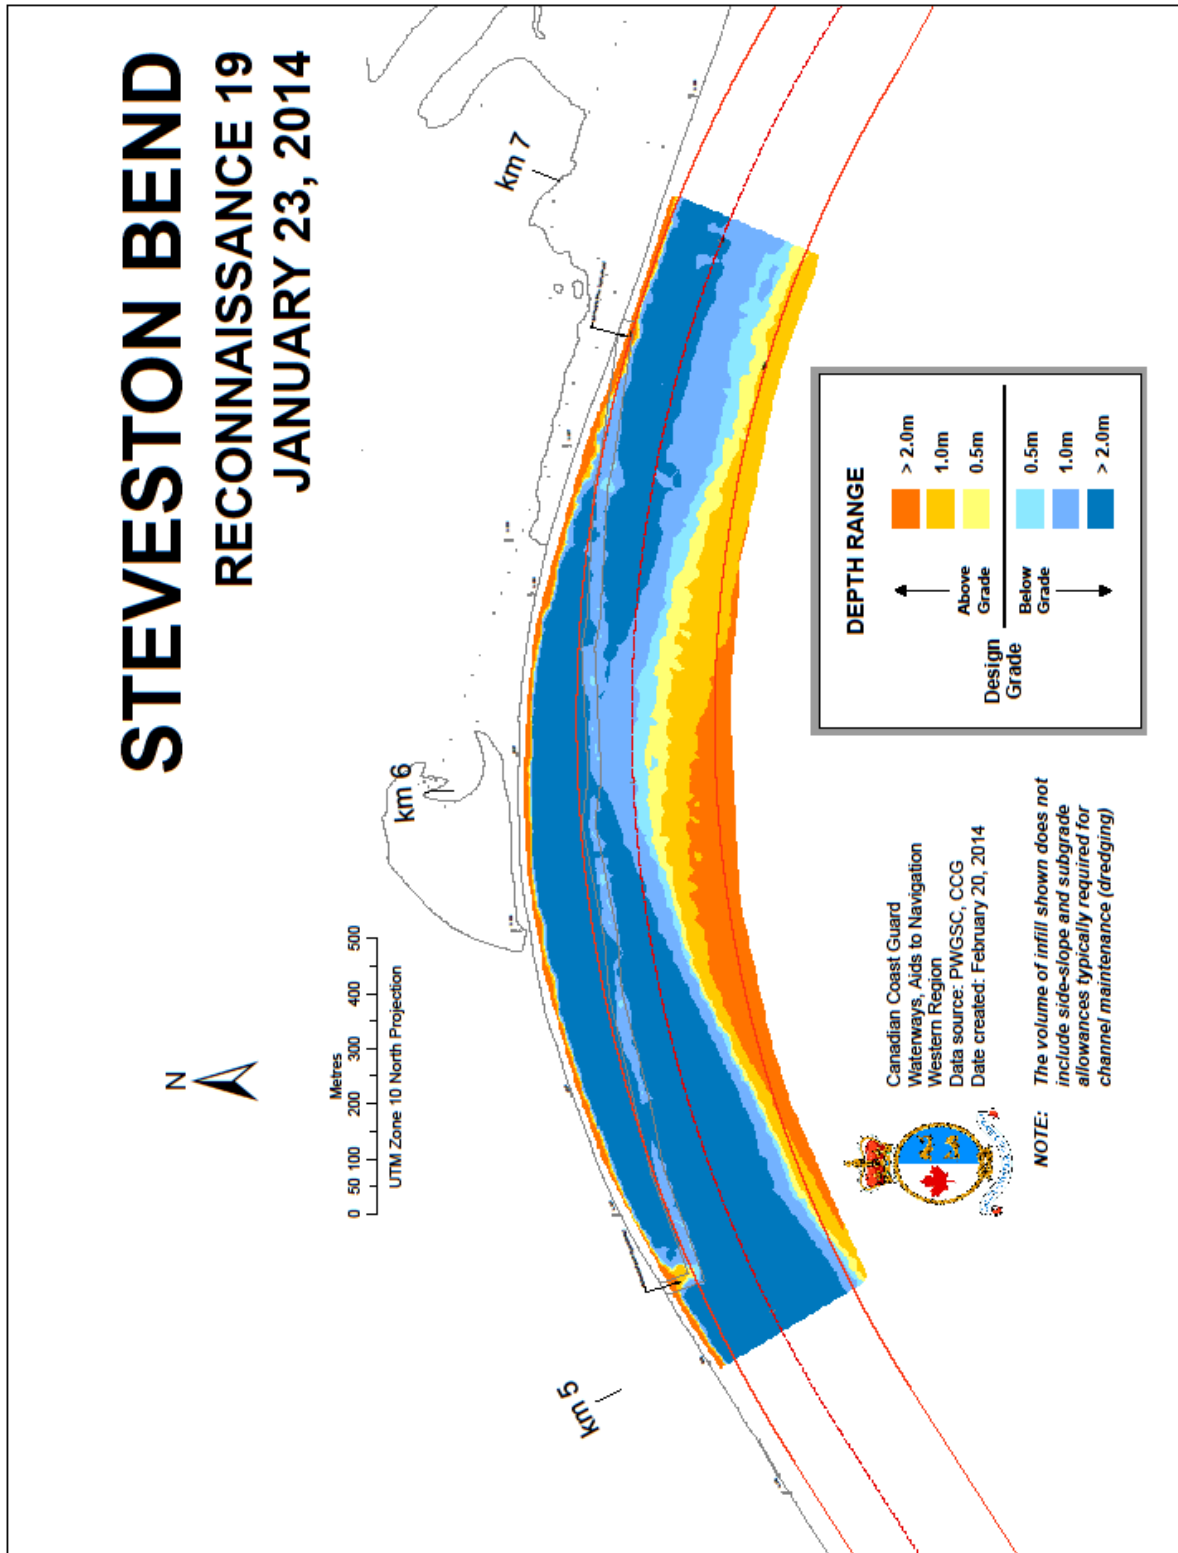
# Appendix B – Silting at Steveston Bend

At the time of the occurrence, the Steveston Bend had silting on the south side that extended into the navigable channel, thereby reducing the design depths of 10 m between kms 5 and 6 and 10.1 m between kms 6 and 7 (Appendix B). Buoy S10, which is approximately where the vessel grounded, is located on the south side of the channel and is slightly east of km 6.
