**MARINE INVESTIGATION REPORT**  
**M15C0006**

**GROUNDING**

**SELF-DISCHARGING BULK CARRIER *ATLANTIC ERIE***  
**CHENAL DU HAVRE DE LA GRANDE ENTRÉE**  
**ÎLES DE LA MADELEINE, QUEBEC**  
**11 JANUARY 2015**

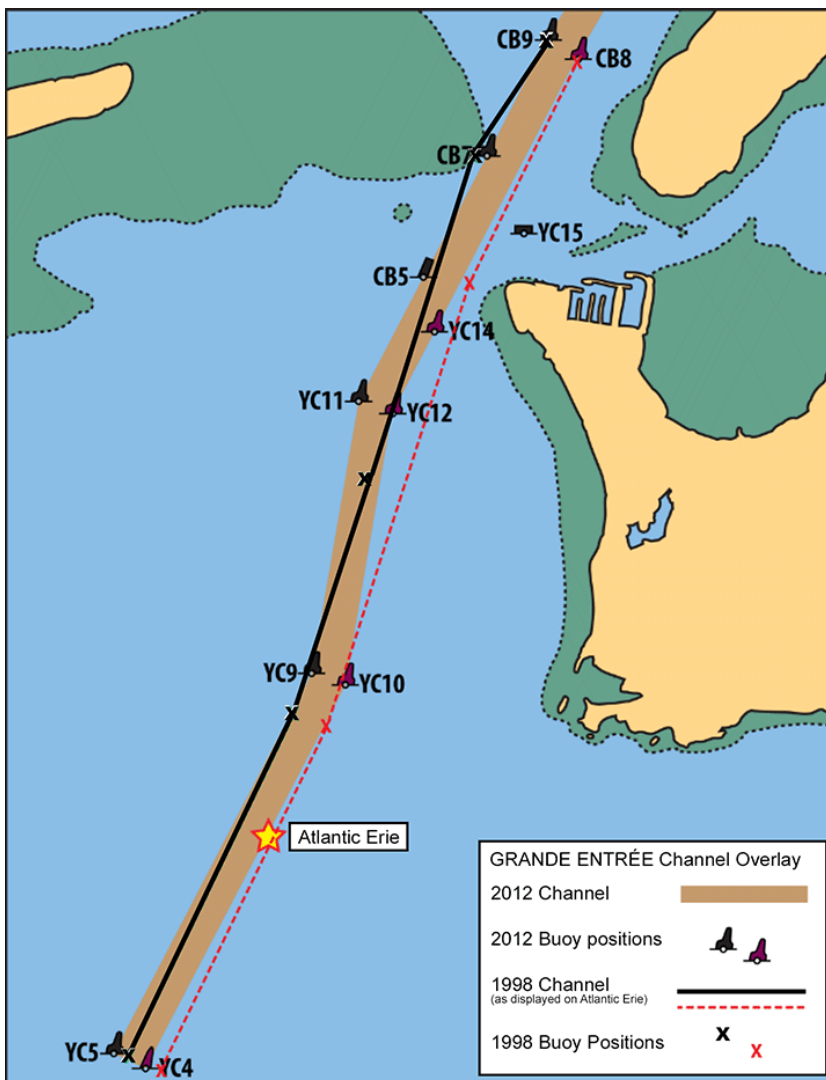
Figure 1. Canadian Hydrographic Service chart with NTX format chart overlaid using dotted lines to show differences

The location of the channel depicted on CHS chart CA579084 and NTX chart C4954NT differed, as did the depictions of the buoy locations (Figure 1). Specifically, on the NTX chart, buoys YC9 and YC10 were shown as being 125 m further south-southwest in the channel than they were at the time of the occurrence.

The NTX chart had been loaded manually the night before the occurrence; it was displayed on the ECPINS during the inbound voyage, but was not used for navigation. On the day of the occurrence, the NTX chart was displayed on the ECPINS from the time of departure until the time of the grounding. Chart CA579084 was also loaded on the ECPINS, but was not being displayed.

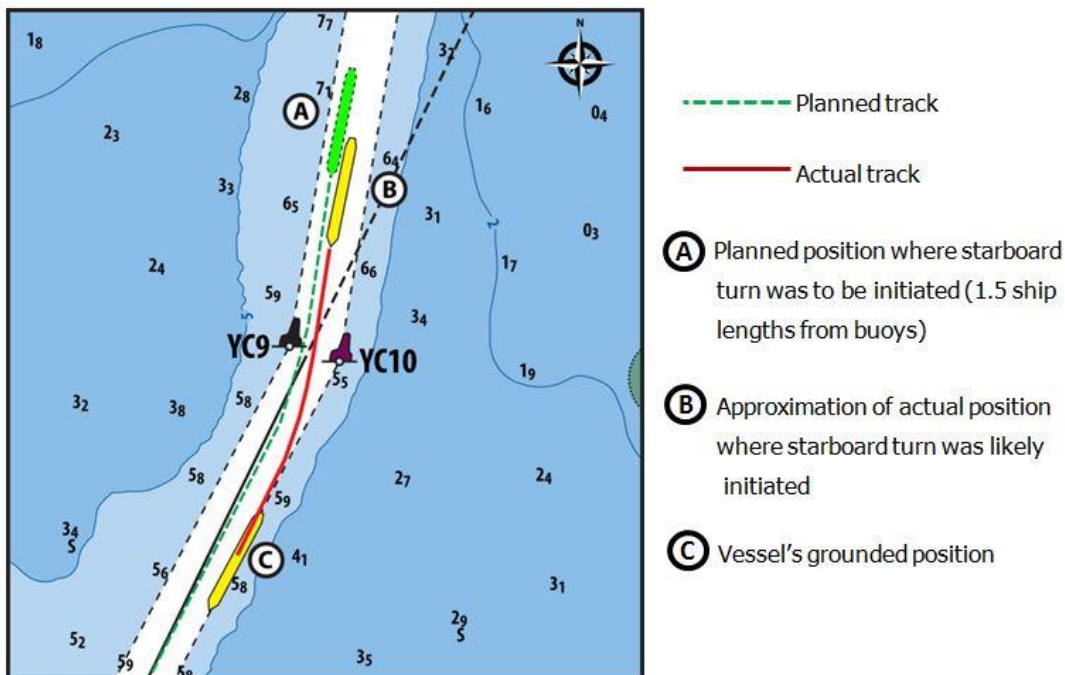
Figure 2. Vessel's planned position at time of turn compared to approximation of actual position

The outdated ECPINS chart was also displaying buoys YC9 and YC10 as being 125 m further south-southwest along the course line than their actual location in the channel. By using the buoy positions indicated on the ECPINS to verify the wheel-over position, the master likely initiated the turn when the vessel was only 213 m, or 0.9 ship length, from the actual buoy positions, later than intended (Figure 2).

The bridge team was not using all available bridge resources to monitor the vessel's position in the channel and lost situational awareness. Because the turn was initiated when the vessel was in the centre of the channel and further south than intended, there was not enough sea room to overcome the environmental conditions and complete the manoeuvre with the helm applied. However, the bridge team perceived the turn to be proceeding as intended while the *Atlantic Erie* crossed over to the port side of the channel and ran aground.

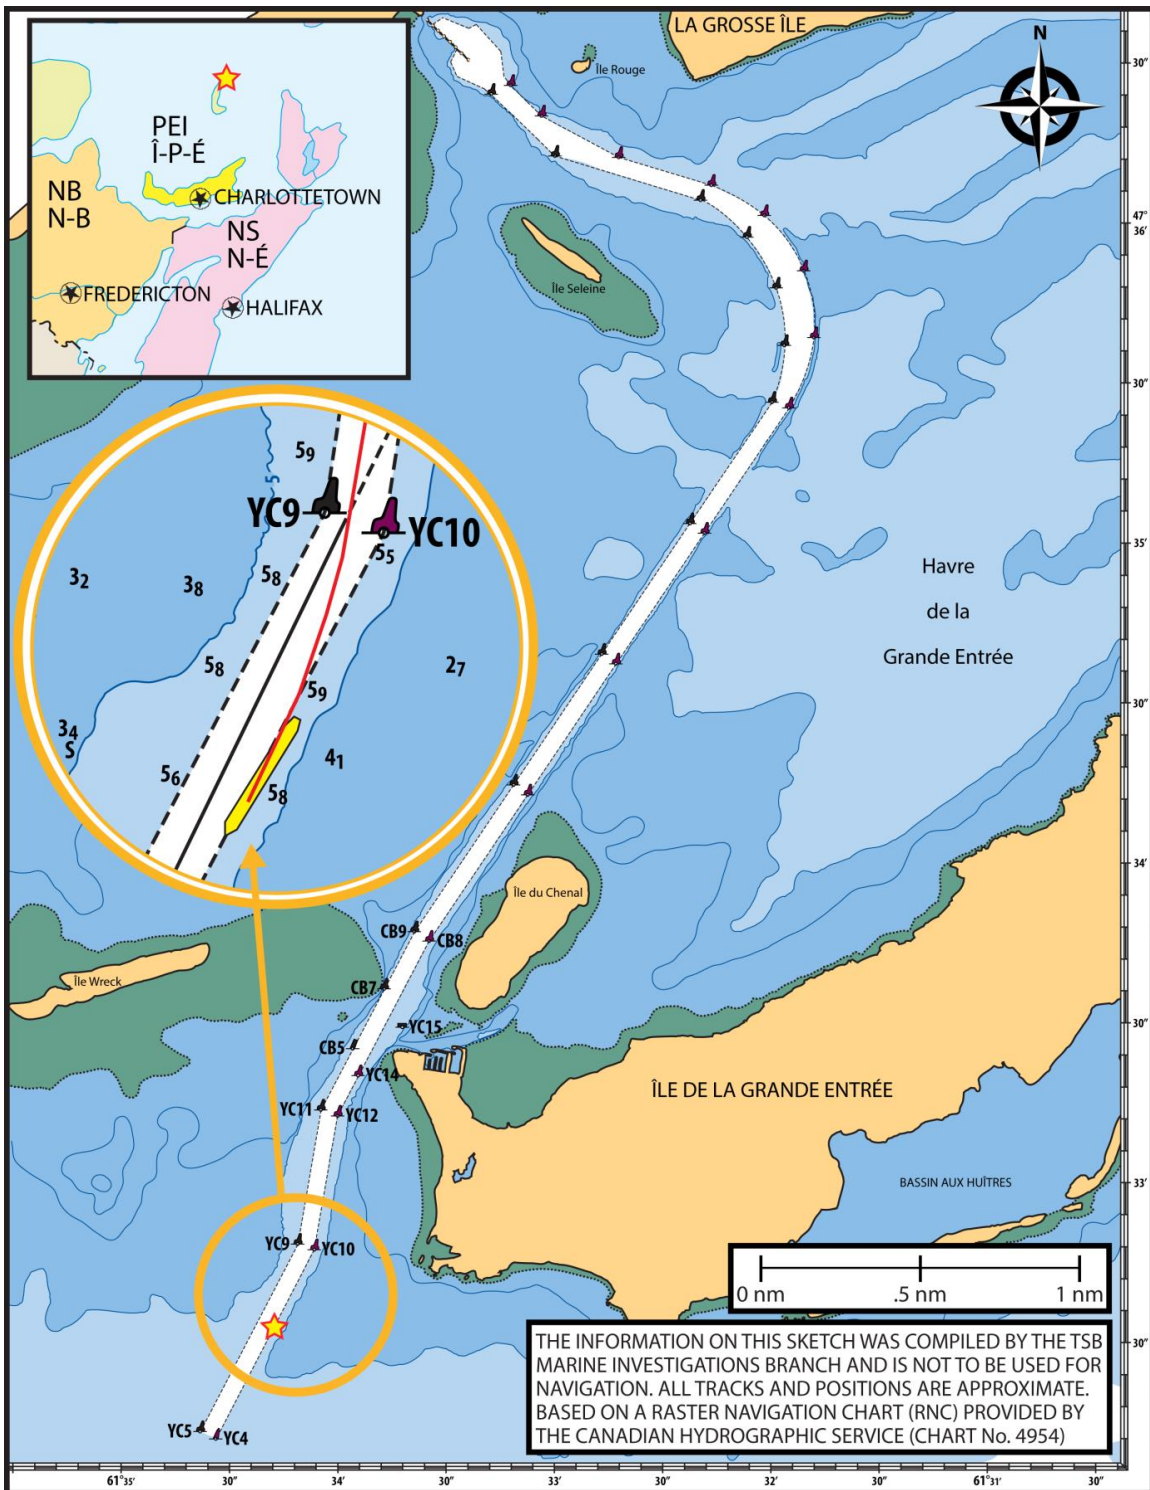
Appendix B – Area of the occurrence

When buoy YC10 passed amidships, the rudder was returned to amidships to slow the turn to starboard and settle up on the next course, which was marked by a set of ranges. Once the vessel was past and clear of buoy YC10, the OOW advised the master. Visually referencing the buoys ahead, YC4 and YC5, as well as the difference between the heading and the CMG on the ECPINS, the master determined that the vessel was on the port side of the channel and setting further in that direction. The ranges marking this leg of the channel, which were located astern of the vessel, were not referenced. The master ordered the helmsman to apply starboard helm and, at 1327:23, the *Atlantic Erie's* rate of turn began to increase. However, approximately 15 seconds later, the vessel made contact with the bank southeast of the buoyed navigation channel at a speed of 7.5 knots. The rate of turn and the vessel's speed began to reduce and, at 1329, the *Atlantic Erie* grounded just outside the navigation channel between buoys YC10 and YC4 (Appendix B).

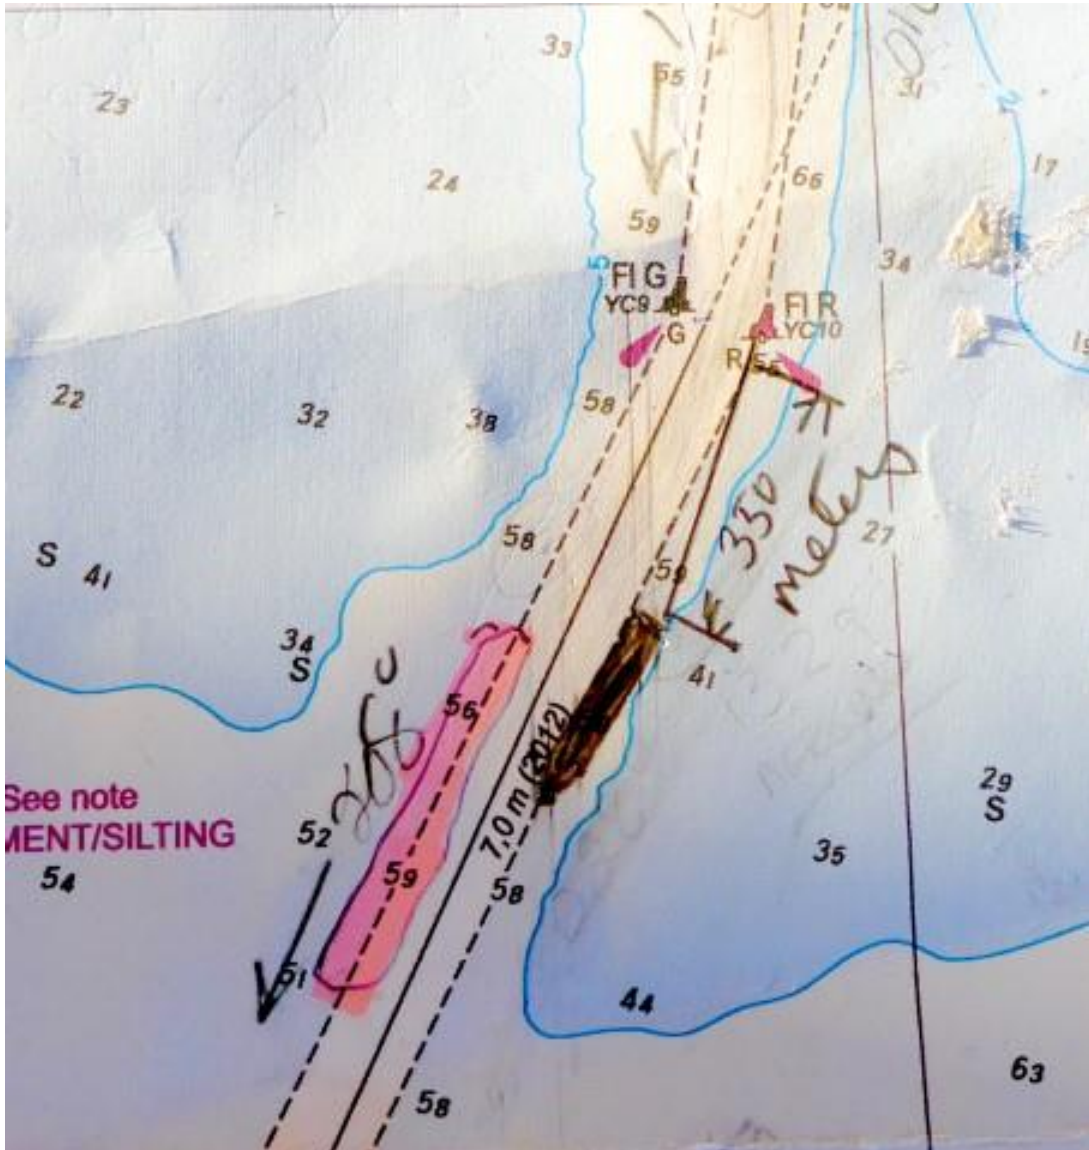
*Appendix C – Notations on chart no. 4954*

This photograph of chart no. 4954 carried on board the *Atlantic Erie* shows the shallow area marked in pink. The vessel's aground position, marked in black, was added by the crew following the occurrence.

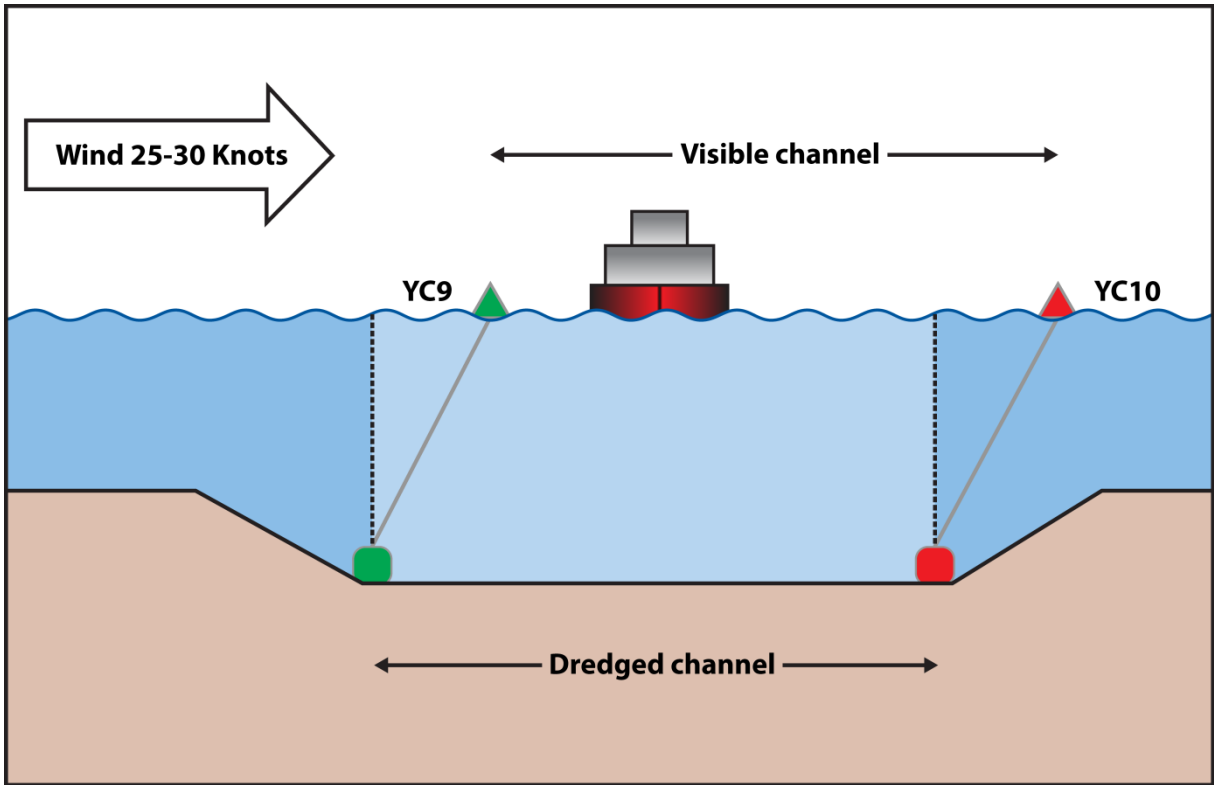
*Appendix D – Effect of environmental conditions on buoy positions*

On approach to the turn, the strong wind and cross current were setting the buoys to the east, giving the master the impression that the vessel was close to the starboard side of the channel when it was in fact near the centre (Appendix D). The outdated ECPINS chart likely corroborated the master's belief that the vessel was on the starboard side of the channel, because it no longer depicted the channel accurately and therefore showed the vessel on the starboard side, rather than near the centre where it actually was (Appendix E).

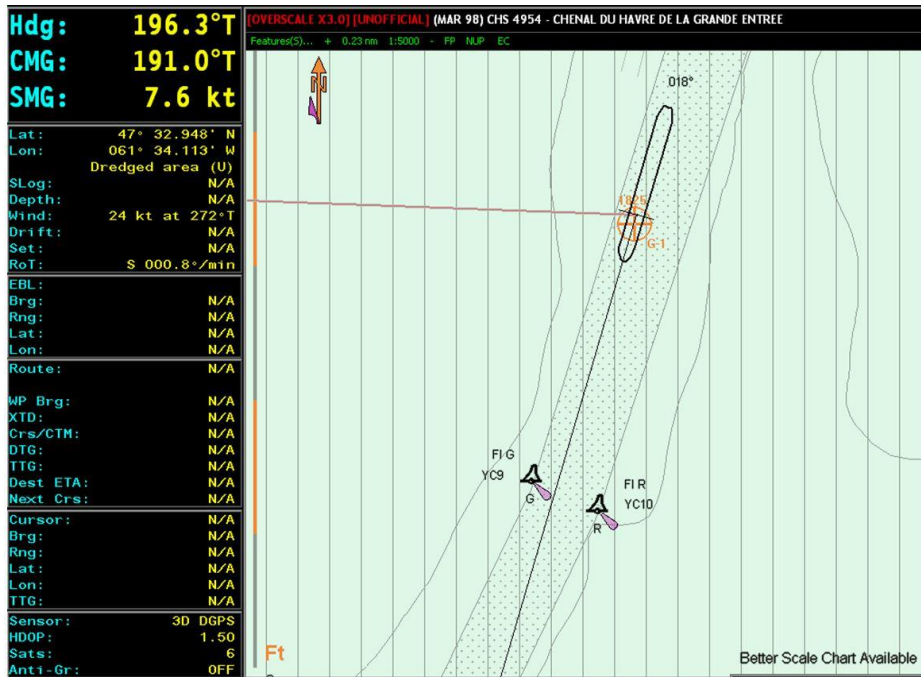
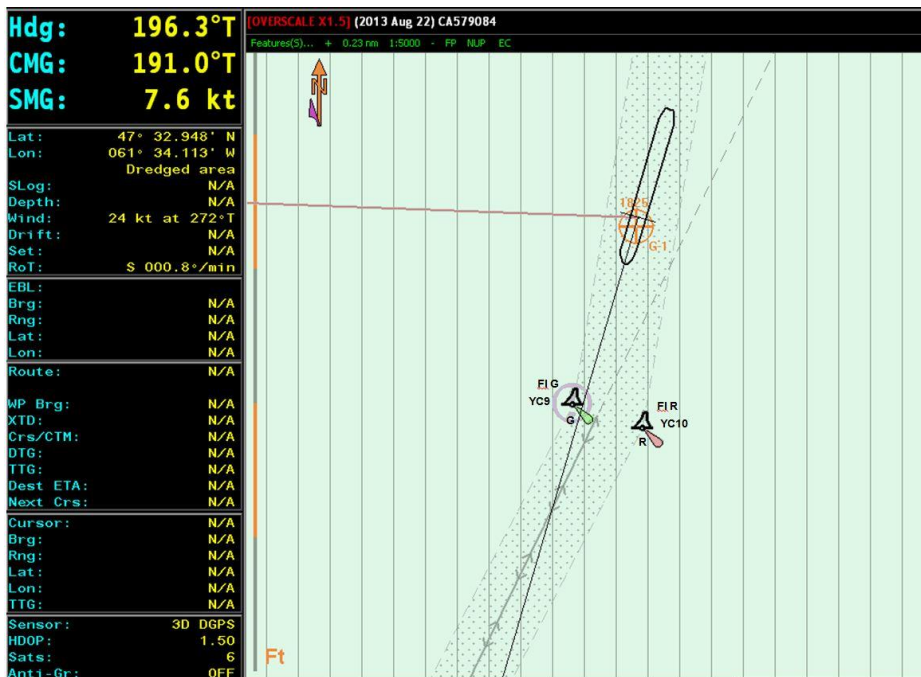
*Appendix E – Vessel's position as shown on the electronic chart precise integrated navigation system chart*

Electronic chart precise integrated navigation system screenshot at 1325:24 as displayed on board

Electronic chart precise integrated navigation system screenshot at 1325:24 showing vessel's actual position
