MARINE TRANSPORTATION SAFETY INVESTIGATION REPORT M17A0391

Lifeboat release hook failure

Passenger ferry *Northern Ranger*
Nain, Newfoundland and Labrador
11 October 2017

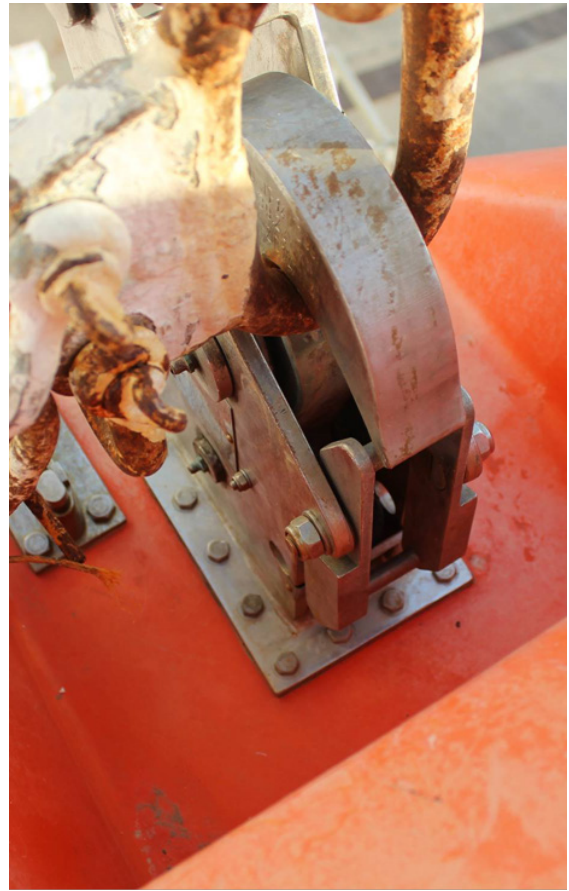
Figure 4. The Northern Ranger's starboard lifeboat release hook fitted with end link (Source: TSB)

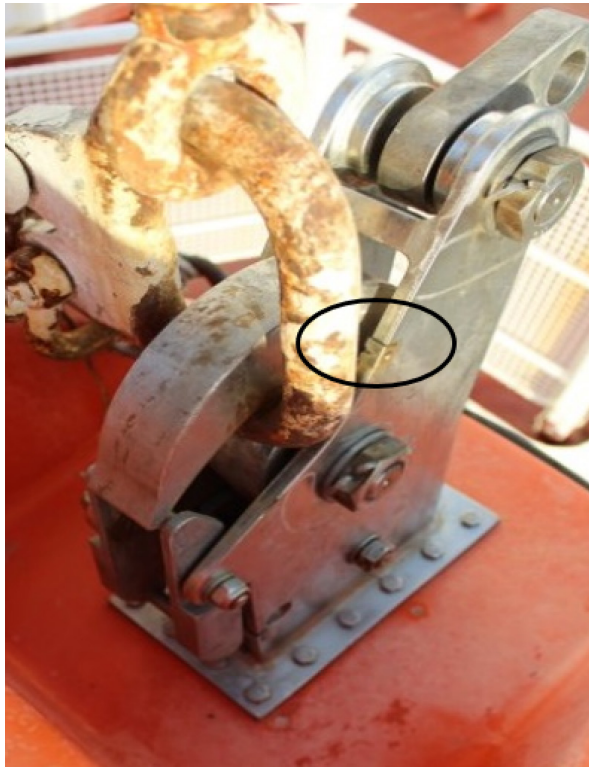
Figure 9. Lifeboat forward release hook in the closed position, with release hook lock-position indicators aligned (black circle). Operator's view would be obscured by end link. (Source: TSB)

In this occurrence, the forward release hook's lock-position indicators were obscured by the end link, and the forward hook operator's view of the locking plate indicators was obstructed due to the location of the forward hook relative to the deck design. These 2 conditions contributed to the forward hook not being reset and secured.

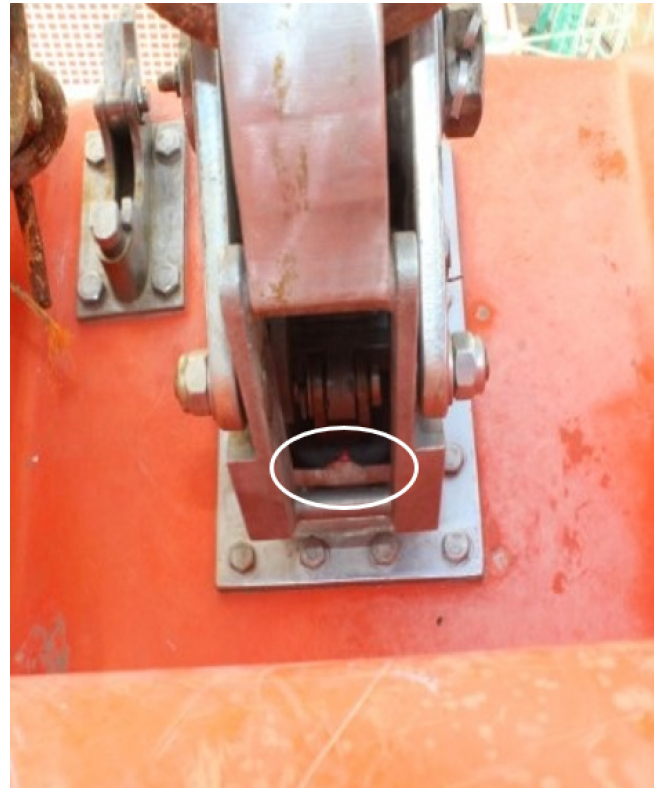
Figure 10. Lifeboat forward release hook in the closed position, with on- or off-load release mechanism lock-position indicators aligned (white circle). Operator's view would be obscured by deck design. (Source: TSB)

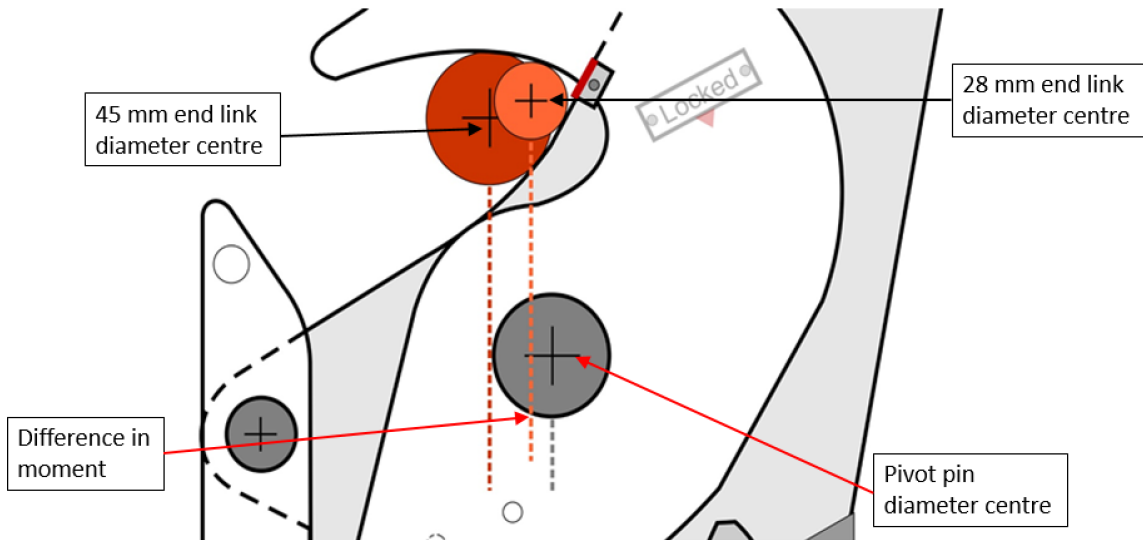
The release hooks used in this occurrence are designed such that, when supporting a load, there is a specific distance from the centre of the pivot pin (pivot point) of each release hook to the centre of the diameter of each end link. This distance creates a moment⁷ great enough to open each release hook if it is not reset in the locked position and is unsecured when a load is applied (Figure 13).

Figure 13. Illustration of release hook and end link moment (Source: TSB)

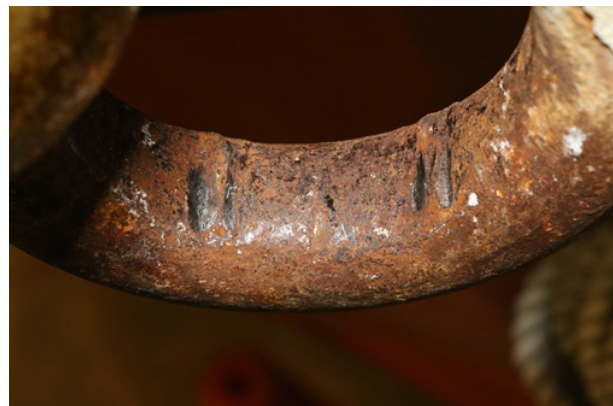
- The forward release hook was not forced open, cracked, or broken.
- The parts of, and the rigging between, the release hooks and on- or off-load release mechanism met the manufacturer’s design specifications.
- The 28 mm end links used in this occurrence showed plastic deformation of the inner diameter due to interaction with the throat of the hooks (Figure 15), whereas the

Figure 15. Deformation in the Northern Ranger’s forward end link (Source: TSB)

release hooks' contact surface did not show any deformation. The deformation increased the surface area of, and friction between, the contact points of the end links and the release hooks.

- When repeated hook releases occurred during testing for end link securement in an unsecured release hook, the end links experienced wear and deformation. The wear and deformation increased the surface area where the end links contacted the release hooks, creating greater friction in the contact area.
- Both the forward and aft release hooks took load, lifted their respective ends of the lifeboat, and remained closed until the side plate of each hook was struck with a rubber mallet.
- The 28 mm diameter end links used on the originally fitted davit, and in this occurrence, do not create a sufficient moment for the hooks to release as designed by the manufacturer when unsecured and supporting a load.
