MARINE TRANSPORTATION SAFETY INVESTIGATION REPORT M18A0001

BOTTOM CONTACT

Passenger ferry *Deer Island Princess II*
Little Letete Passage, New Brunswick
02 February 2018

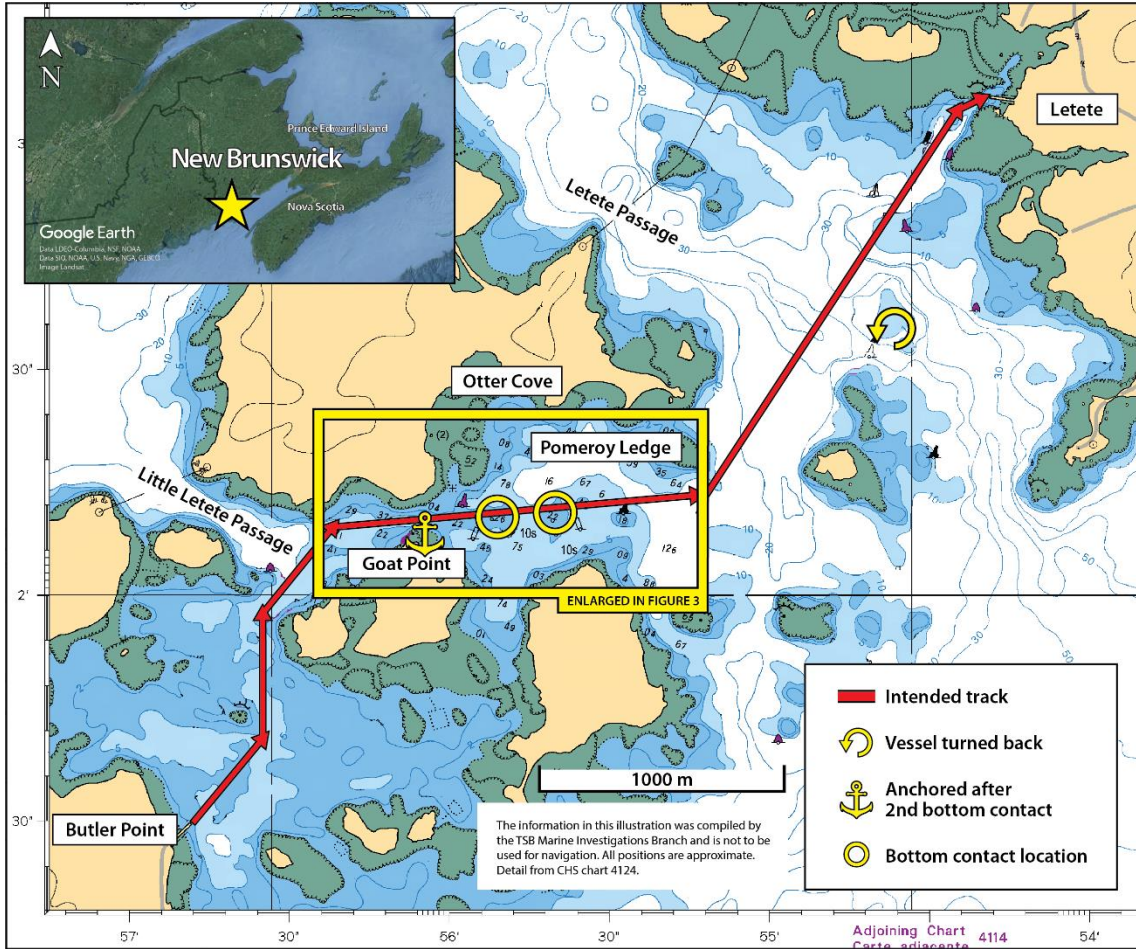
These were only predictions and did not consider the effects of meteorological conditions on the level of water at any given time. The actual water level observed at Saint John was 0.25 m below the predicted level. A similar reduction at Matthews Cove would have resulted in a predicted water depth of 1.75 m above the shoal, 25 cm less than the vessel's draft, allowing the vessel to make contact with the shoal marked by isolated danger buoy SJA.

A strong northwesterly wind was blowing out of Passamaquoddy Bay at the time of the occurrence. This likely created a negative surge that further lowered the water level at the occurrence site below predicted levels, allowing the vessel to make contact with the 2.6 m shoal normally marked by missing isolated danger buoy SJB.
