# Marine Transportation Safety Investigation Report M18C0030

## LIQUEFIED NATURAL GAS FUEL EQUIPMENT FAILURE

Roll-on roll-off passenger ferry *F.-A.-Gauthier*  
Matane, Quebec  
08 April 2018

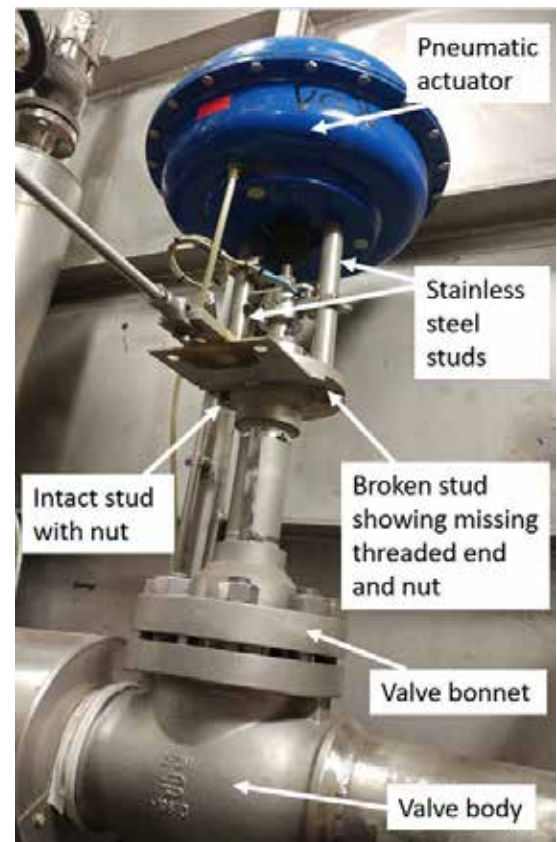
**Figure 2. Valve V08 on the port-side LNG fuel supply system**

The part of the valve that failed is 1 of the 2 stainless steel studs that fasten the valve's pneumatic actuator over the valve bonnet (Figure 2).

Following this occurrence, the system manufacturer and the valve manufacturer initiated a joint study to prevent this particular failure from happening again. Specifically, the manufacturers are focusing on either redesigning the support stud with a different material, or redesigning the supporting arrangement of the pneumatic actuator, using 3 studs instead of 2.

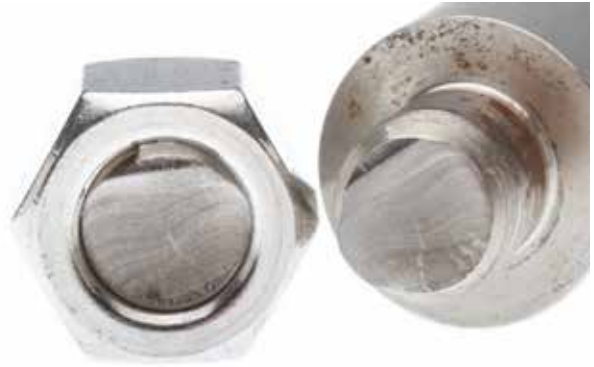
**Figure 3. Failed stud showing both halves of the fracture surface**

The TSB conducted an examination and a failure analysis of the broken stud. These concluded that the valve assembly stud failed at the root of the thread due to the initiation of multiple fatigue cracks (Figure 3 and Figure 4). The relative size of the fatigue area, when compared to the final overstress area, suggests that the loads applied to the studs were relatively low, and were possibly due to the reported abnormal vibrations that were present on the valve assembly prior to the failure.

The investigation determined that vibrations within the LNG storage tank's connection space, which may have acted on the space since the vessel had been commissioned, likely caused the stud to fail and break apart and resulted in the small gas leak. More precisely, although a vibration damping arrangement was securing the body and bonnet of valve V08 against an adjacent platform, the pneumatic actuator was oscillating freely and transmitting these stresses to its fastening studs, gradually causing one of them to fail.
