## **MARINE TRANSPORTATION SAFETY INVESTIGATION REPORT M18P0087**

### **UNCONTROLLED FALL OF RESCUE BOAT**

*Queen of Cumberland*  
Swartz Bay, British Columbia  
18 April 2018

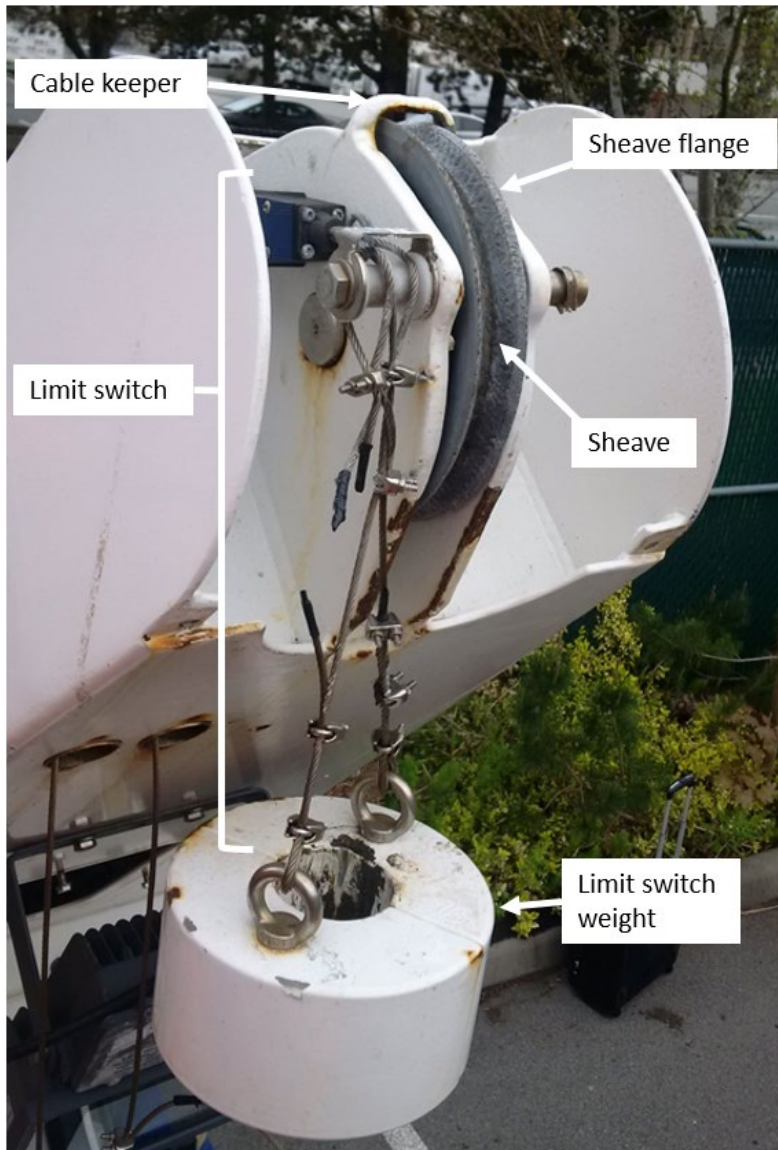
Figure 4. End of the davit arm (sheave cover has been removed to allow viewing of components) (Source: TSB)

The hoist cable on the davit was suspended from a sheave 9 inches in diameter at the end of the davit arm (Figure 4). The sheave had a V-shaped groove designed for a 10 mm wire. The sheave was protected by a sheave cover. An arched cable keeper was welded over the uppermost part of the sheave, just inside the sheave cover, to help prevent the hoist cable from coming off the sheave. Beside the sheave was the davit's over-hoist limit switch.

- The limit switch was rigged incorrectly, with the weight suspended from a single point on the left-hand side of the sheave (Figure 4). The correct rigging of the limit switch is shown in Figure 5. At the time of the occurrence, the hoist cable passed through the limit switch weight. Testing determined that the incorrect rigging of the limit switch did not affect its functionality; it was designed to provide overhoist protection and not protection from a sideload.

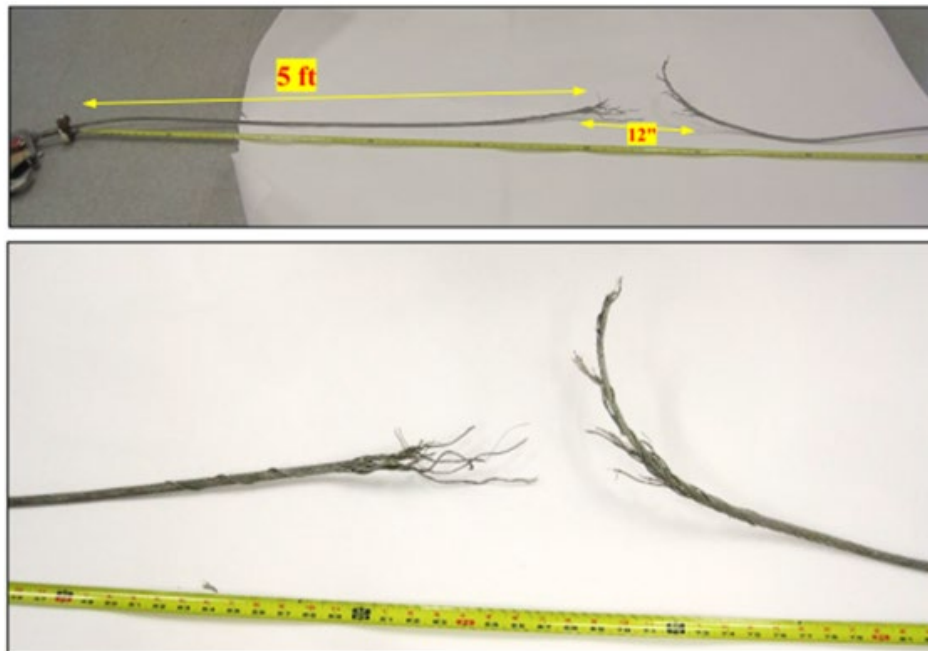
Figure 6. Parted hoist cable (Source: Acuren Group Inc.)

- The hoist cable was a non-rotating galvanized wire rope 10 mm in diameter and 19 × 7 in construction.<sup>11</sup> Aside from the area around the broken point, the wire rope was in good condition, without broken wires, notable wear, kinks, cracks, or corrosion.
- The hoist cable parted approximately 1.5 m from the hook (Figure 6).

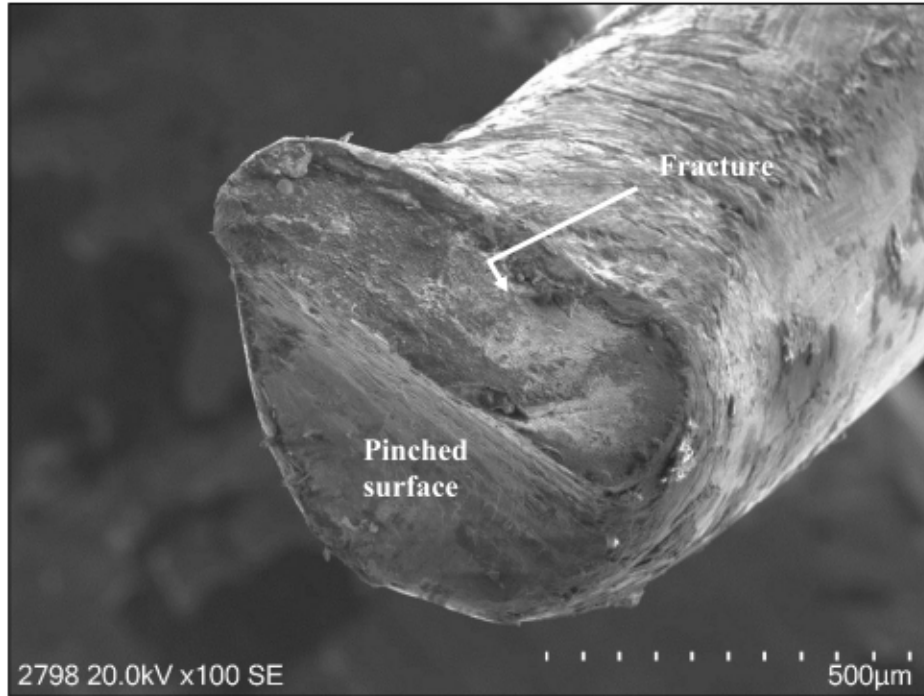
Figure 7. Magnified image of wire damage (Source: Acuren Group Inc.)

- Individual wires in the hoist cable, up to 19 inches above the broken point, had sustained severe kink damage and/or had broken.
- At the point where the hoist cable parted, all of the individual wires in each strand had broken at one cross-section. The wires had all sustained severe pinch damage close to the point where they had broken (Figure 7).

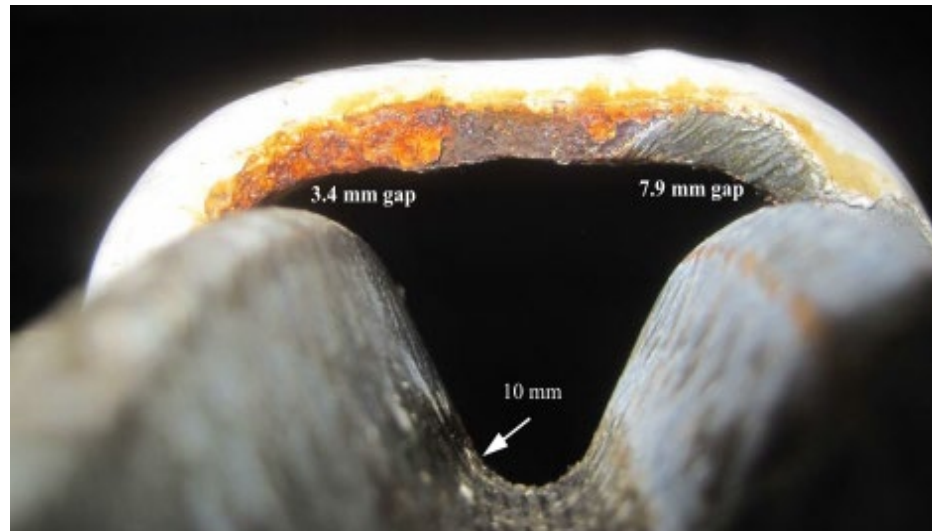
Figure 8. Original 3.4 mm gap worn to 7.9 mm (Source: Acuren Group Inc.)

- All of the individual wires broke after more than 50% of their cross-section had been pinched.
- The original 3.4 mm gap between the top of the sheave flange and the underside of the cable keeper had worn to 7.9 mm wide (Figure 8).

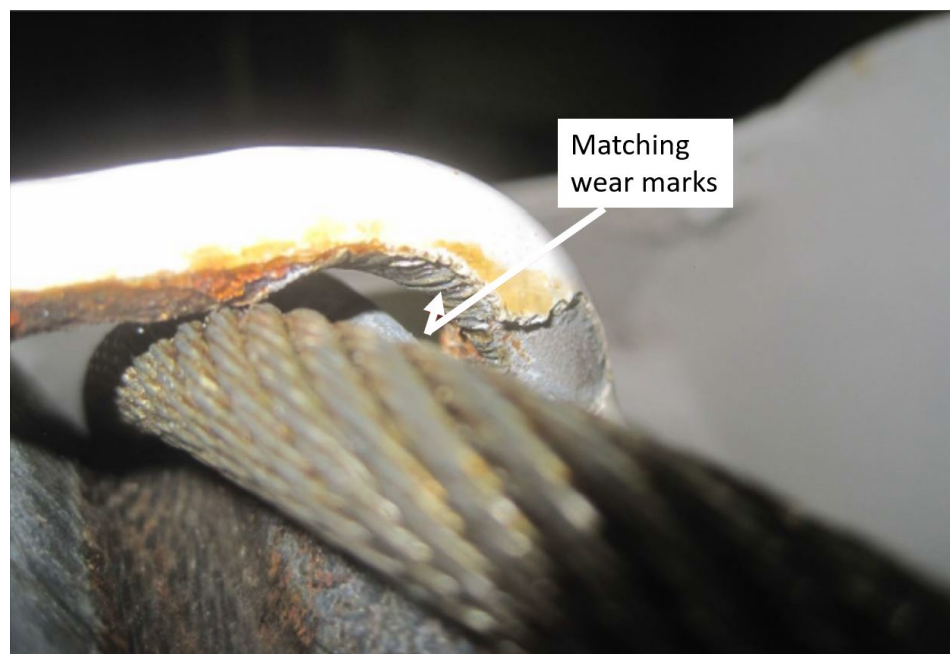
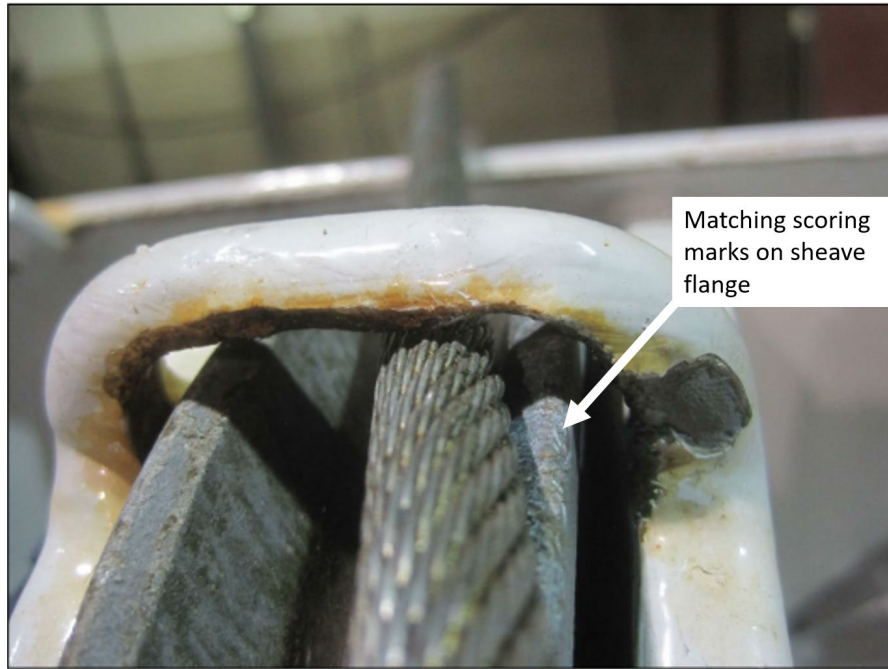
- The right-hand side of the cable keeper, immediately above the top of the sheave flange, had coarse scoring grooves consistent with the hoist cable running through the gap between the top of the sheave flange and the cable keeper (Figure 9 and Figure 10).

Figure 9. Matching wear marks on cable keeper (Source: Acuren Group Inc., with TSB annotations)

Figure 10. Matching scoring marks on top of sheave flange (Source: Acuren Group Inc., with TSB annotations)

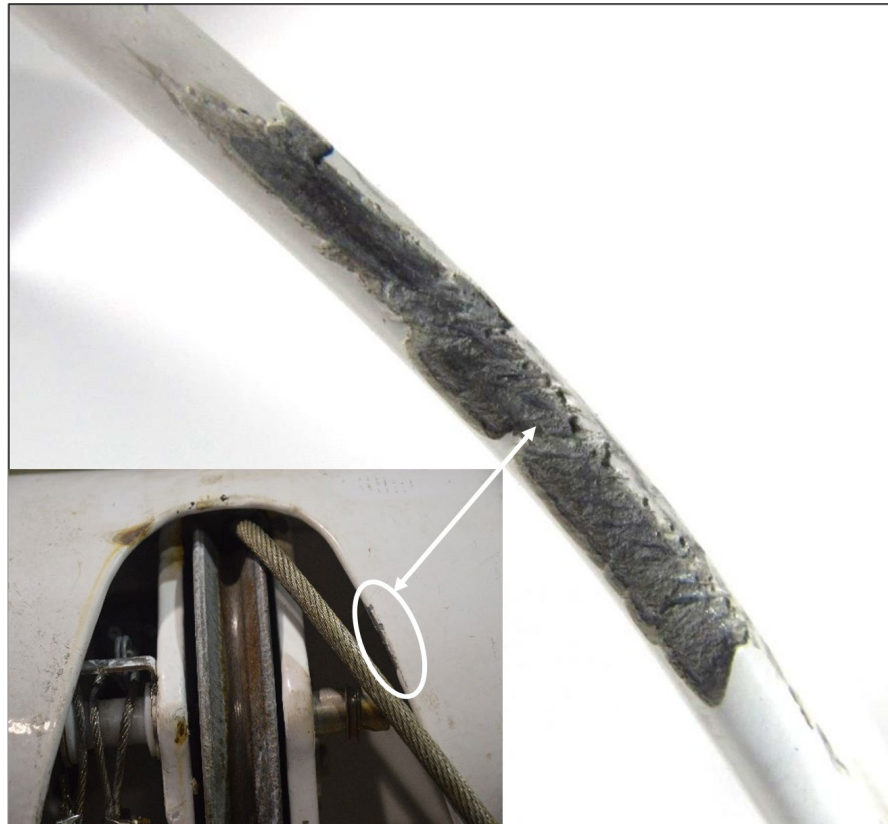
Figure 11. Damage to right-hand edge of sheave cover plate (Source: Acuren Group Inc.)

- The right-hand edge of the sheave cover was damaged (Figure 11).

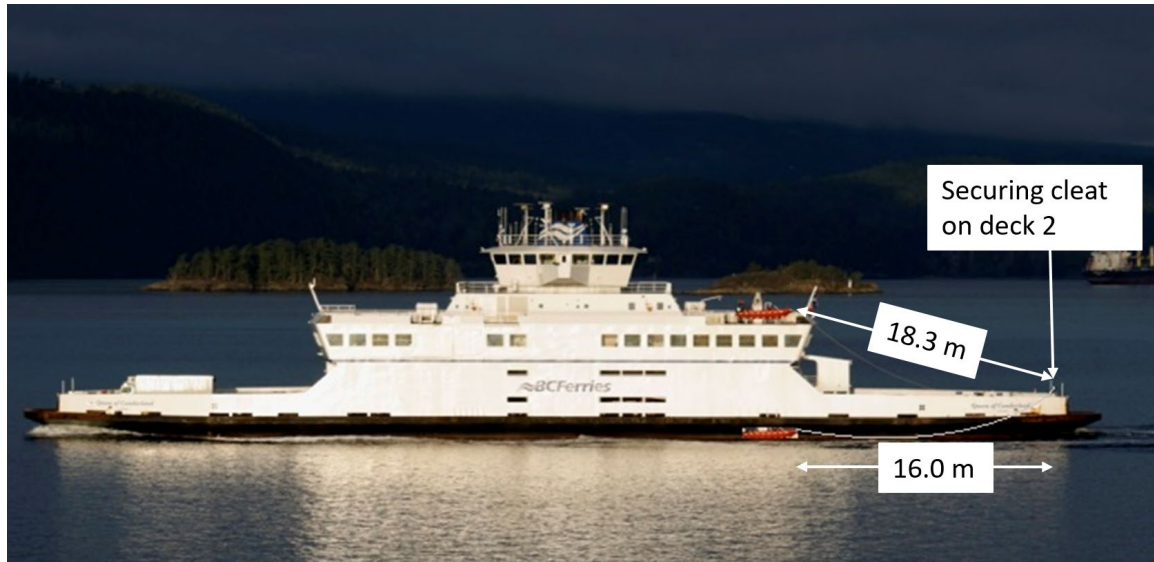
public access. Following an internal audit, the location at which the painter was secured was changed so that it connected between the bow of the rescue boat (using the toggle) and the cleat on deck 2. This change resulted in the distance from the cleat to the rescue boat being less when the rescue boat was in the launched position than when it was in the stowed position. The distance from the rescue boat's stowed position on deck 5 to the cleat was approximately 18.3 m, and the distance from the rescue boat in the water under the fall to the cleat was approximately 16.0 m (Figure 13). There was no formal risk assessment conducted when the painter was relocated.

Figure 13. Distance between the rescue boat and the cleat on deck 2 when the rescue boat is in the stowed position versus when it is in the water (Source: Dennis J. Dubinsky, with TSB annotations)

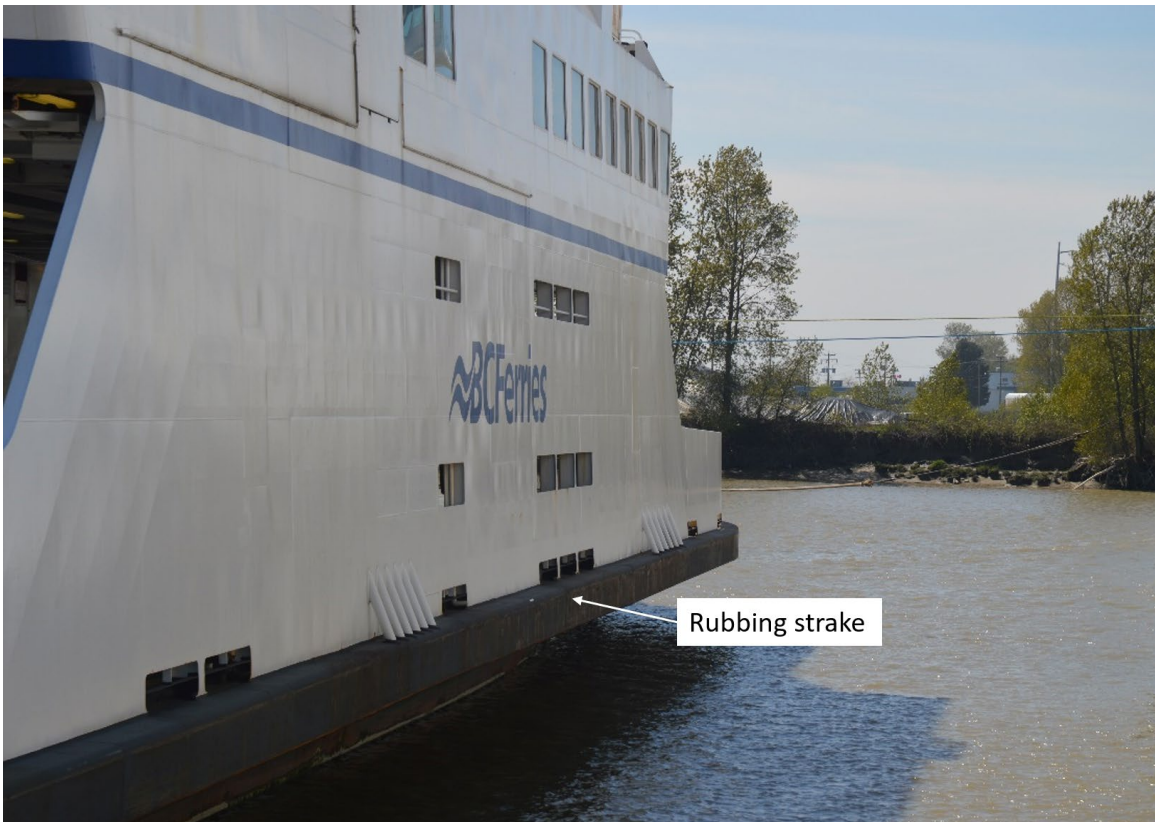
Figure 15. Rubbing strake on the Queen of Cumberland (Source: TSB)

The rescue boat crew needed to regularly use boat hooks to fend the rescue boat off the side of the vessel to ensure that the rescue boat cleared the rubbing strake during lowering and hoisting.

The davit on the *Queen of Cumberland* does not slew out far enough. Crews need to fend off to clear the rubbing strake. Self-launch is extremely difficult and dangerous. Under non-ideal weather or conditions where the ship is listing, launch would be impossible.<sup>18</sup>

This ALERT had not been resolved at the time of the occurrence. Modifications involving the installation of a flat bar between the shipside and the edge of the rubbing strake were planned for the upcoming refit in November 2018 to manage the hazard. A similar installation had already been completed on another vessel in the fleet, the *Queen of Capilano* (Figure 18).

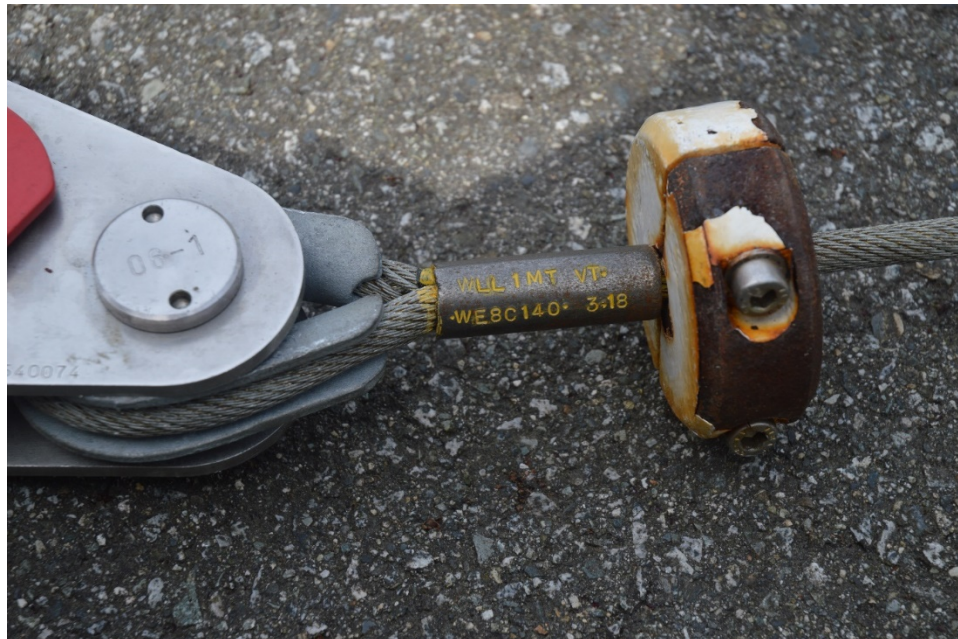
Figure 17. Mechanical splice with safe working load of 1 metric tonne (Source: TSB)

- The replacement cable had a mechanical splice at the hook end that indicated a safe working load of 1 metric tonne (Figure 17). This was below the maximum safe working load of the davit, which was rated at 1.3 metric tonnes.

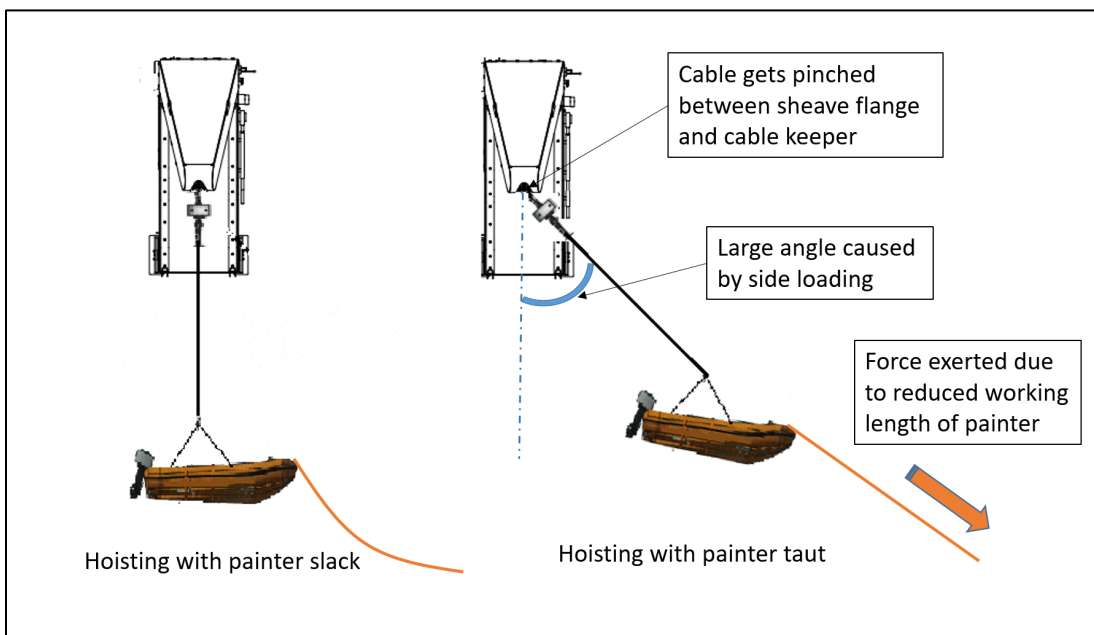
Figure 19. Comparison of hoisting with the painter slack versus taut (Source: TSB)

The reduced painter length was sufficient while the rescue boat was positioned under the davit, at the water level. However, as the rescue boat was hoisted up, the distance increased between the rescue boat and the cleat where the painter was secured. This caused the painter to become increasingly taut as the rescue boat was hoisted. The taut painter caused the rescue boat's bow to dip slightly toward the cleat and exerted a side load on the hoist cable as the rescue boat was being raised (Figure 19).

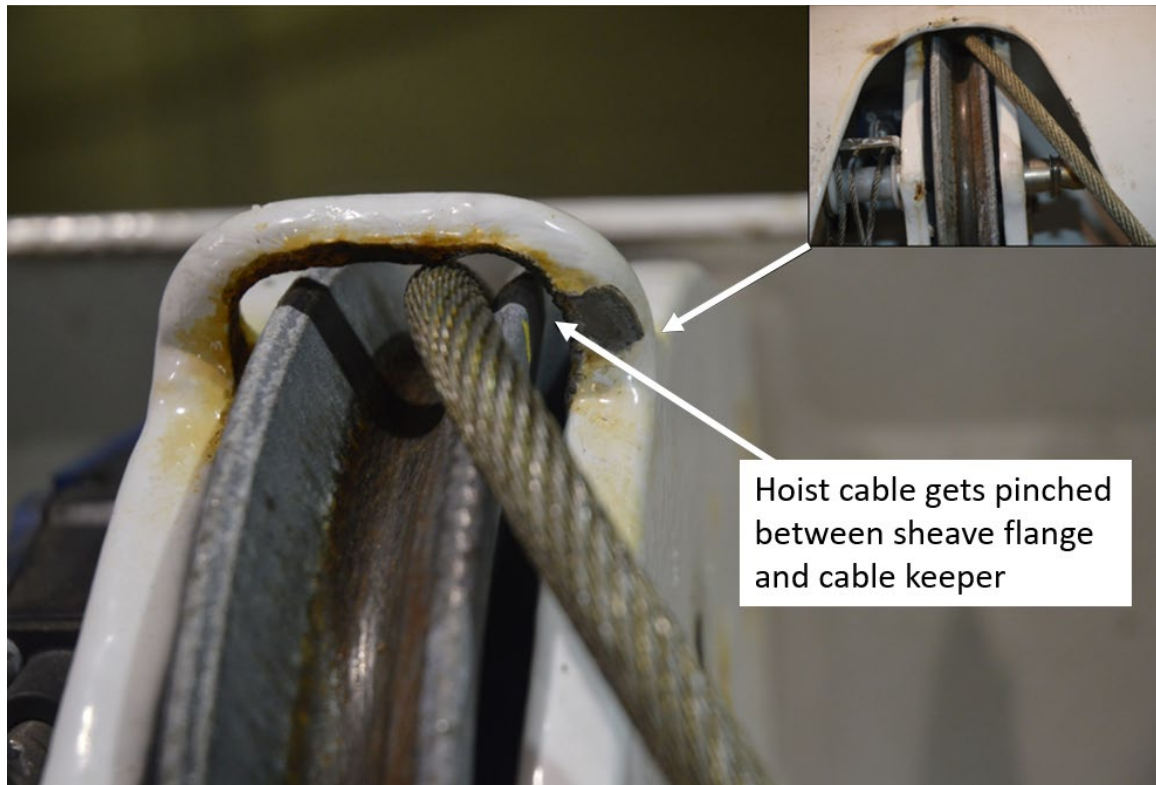
Figure 20. Cable pinched in gap between cable keeper and top of sheave flange (Source: TSB)

This side load caused the hoist cable to reach an angle of approximately 45°, which resulted in the cable coming off the davit sheave and becoming pinched in the 3.4 mm gap between

the side of the sheave flange and the cable keeper (Figure 20). Examination of the damage to the top of the right-hand sheave flange, the cable keeper, and the sheave cover opening indicated that the cable had been pulled hard to the side with a significant force<sup>41</sup> as the rescue boat was being raised. The pinching action caused individual wires to break and ultimately resulted in the failure of the cable. The rescue boat and its crew fell to the water from a height of approximately 11 m, causing injuries to the rescue boat crew.
