Marine Transportation Safety Investigation Report M19C0043

STRIKING OF A WHARF

Roll-on/roll-off passenger ferry *Apollo*
Godbout, Quebec
25 February 2019

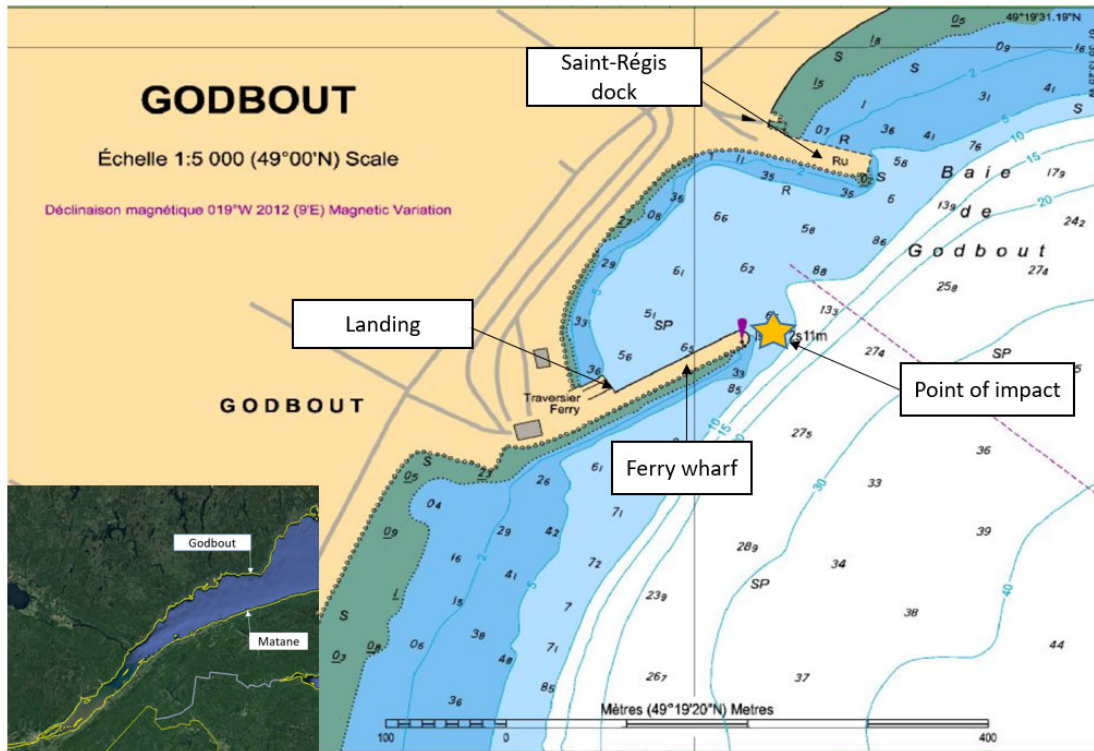
Figure 2. Site of the occurrence (Main source image: Canadian Hydrographic Service, Chart CA1236, with TSB annotations. Inset image source: Google Earth, with TSB annotations)

The vessel did not respond as expected due to water flow reduction on the rudders caused by the successive speed reductions. To compensate, the master reversed the starboard propulsion while keeping the port propulsion ahead and simultaneously activated the bow thruster. The vessel stopped turning to port but continued moving forward. When it became evident to the master that a collision with the end of the ferry wharf was unavoidable, to minimize the force of impact and subsequent damage, the master reversed the port engine so that both engines were working astern. The vessel continued to move forward slowly and deviated toward the ferry wharf because of the grey ice⁵ that covered the harbour.

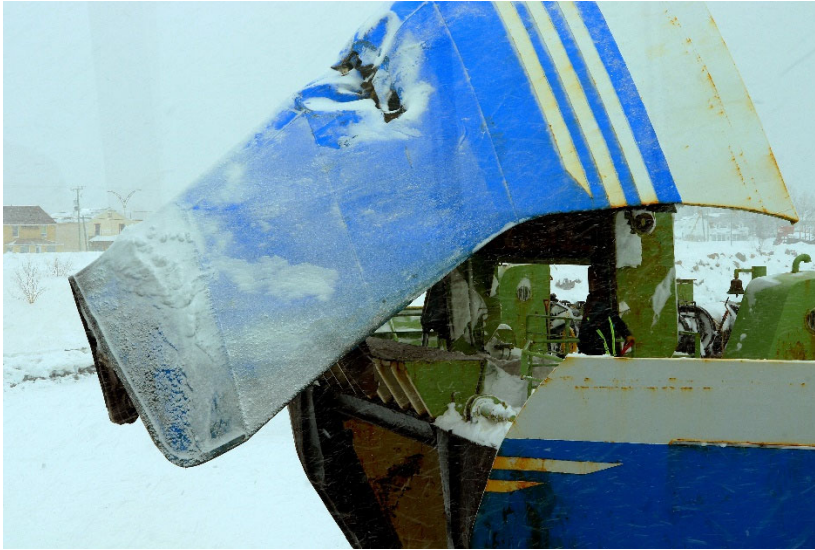
At 1018, the vessel made contact with the end of the ferry wharf (Figure 2). At 1019, following the impact, the crew briefly inspected the vessel to ascertain the extent of the damage. The inspection revealed a hole in the bow visor of about 1 m high by 2 m wide, with buckling over an area of about 9 m². At 1045, the vessel was secured at the ferry berth and the passengers disembarked. Despite the damage from the impact, the crew was able to open the visor and proceeded to unload the vehicle deck.

Figure 3. The damage to the *Apollo's* bow visor (Source: Alexandre Boudreau)
