Marine Occurrence Report

Capsizing

of the Open Fishing Vessel CFV #132145
off Green Island
Bonavista Bay, Newfoundland
05 July 1993

Report Number M93N0001

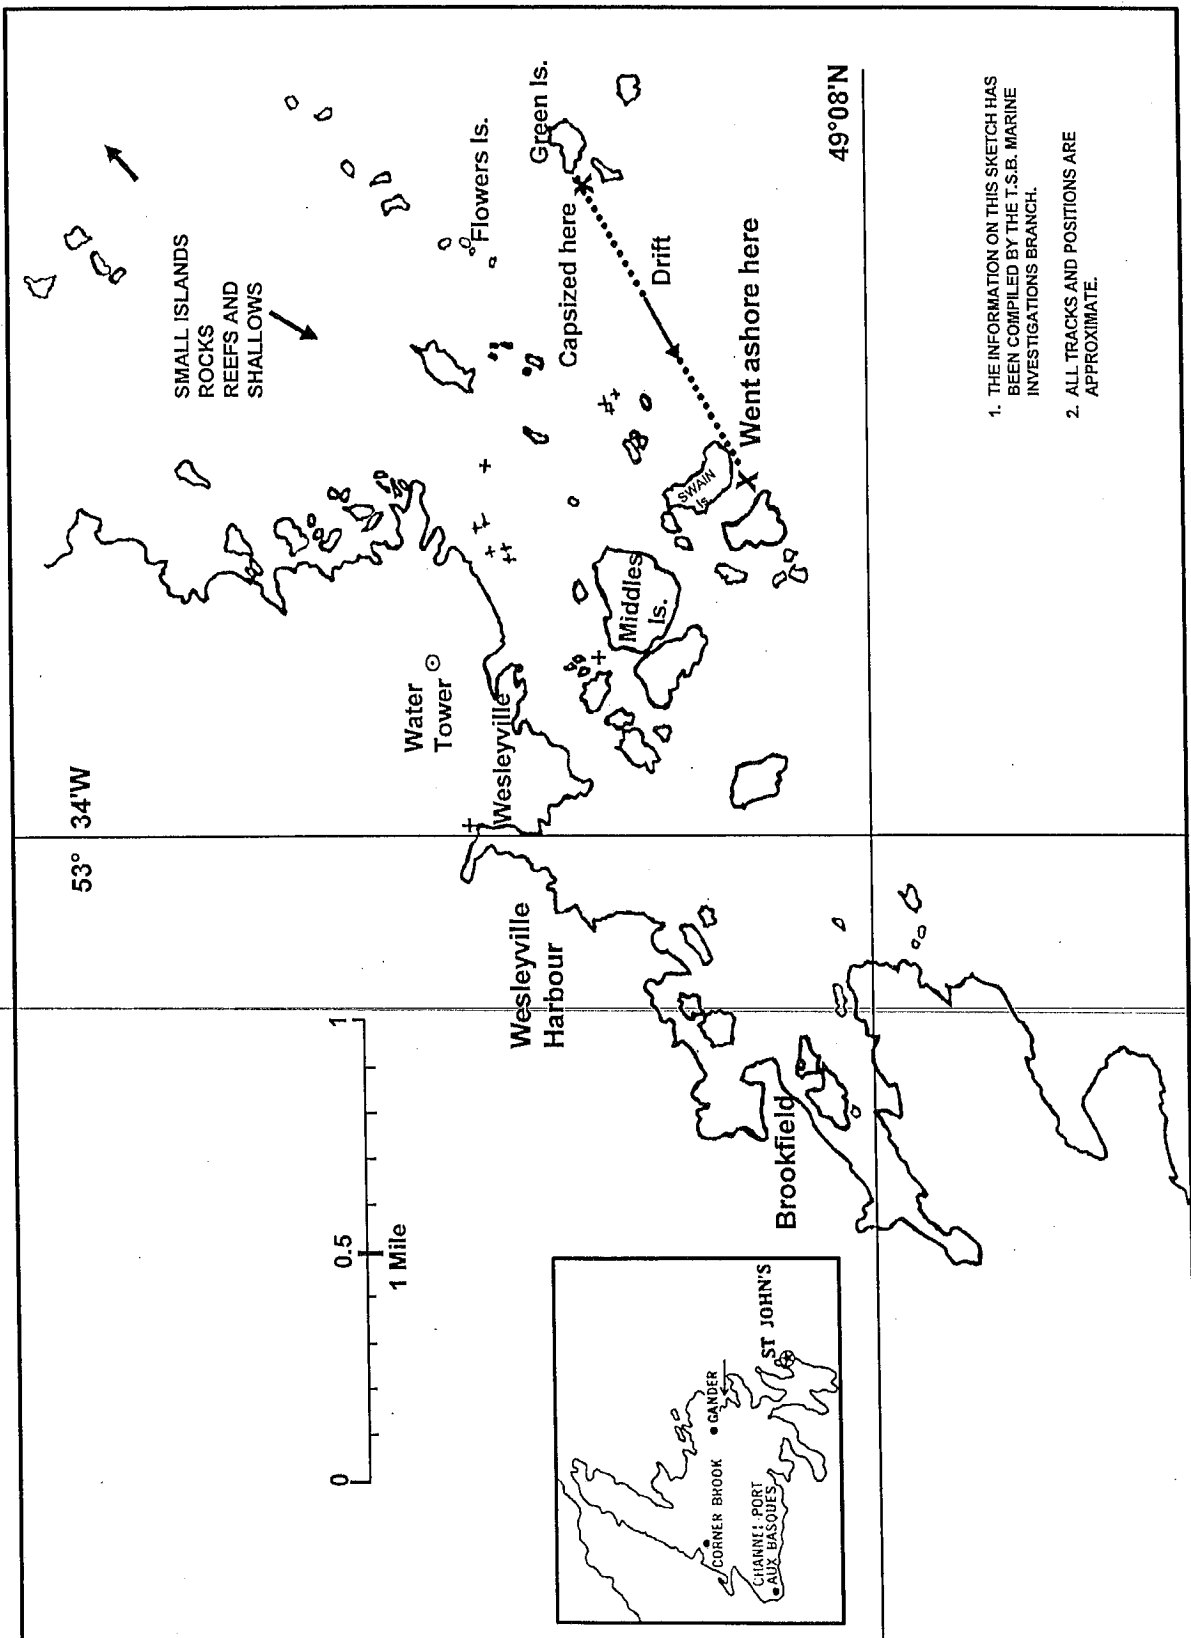
Appendix A - Area of Occurrence

- Units of measurement in this report conform to International Maritime Organization (IMO) standards or, where there is no such standard, are expressed in the International System (SI) of units.
- See Glossary for all abbreviations and acronyms.
- All times are NDT (Coordinated Universal Time (UTC) minus two and a half hours) unless otherwise stated.
- See Appendix A for a sketch of the area.

At about 1100, an open boat passing near Swain Island saw the two survivors on shore waving and shouting and rescued them. Swain Island is about 3.5 nautical miles (M) to the west of Flowers Island and about 0.75 M south-west of Green Island.

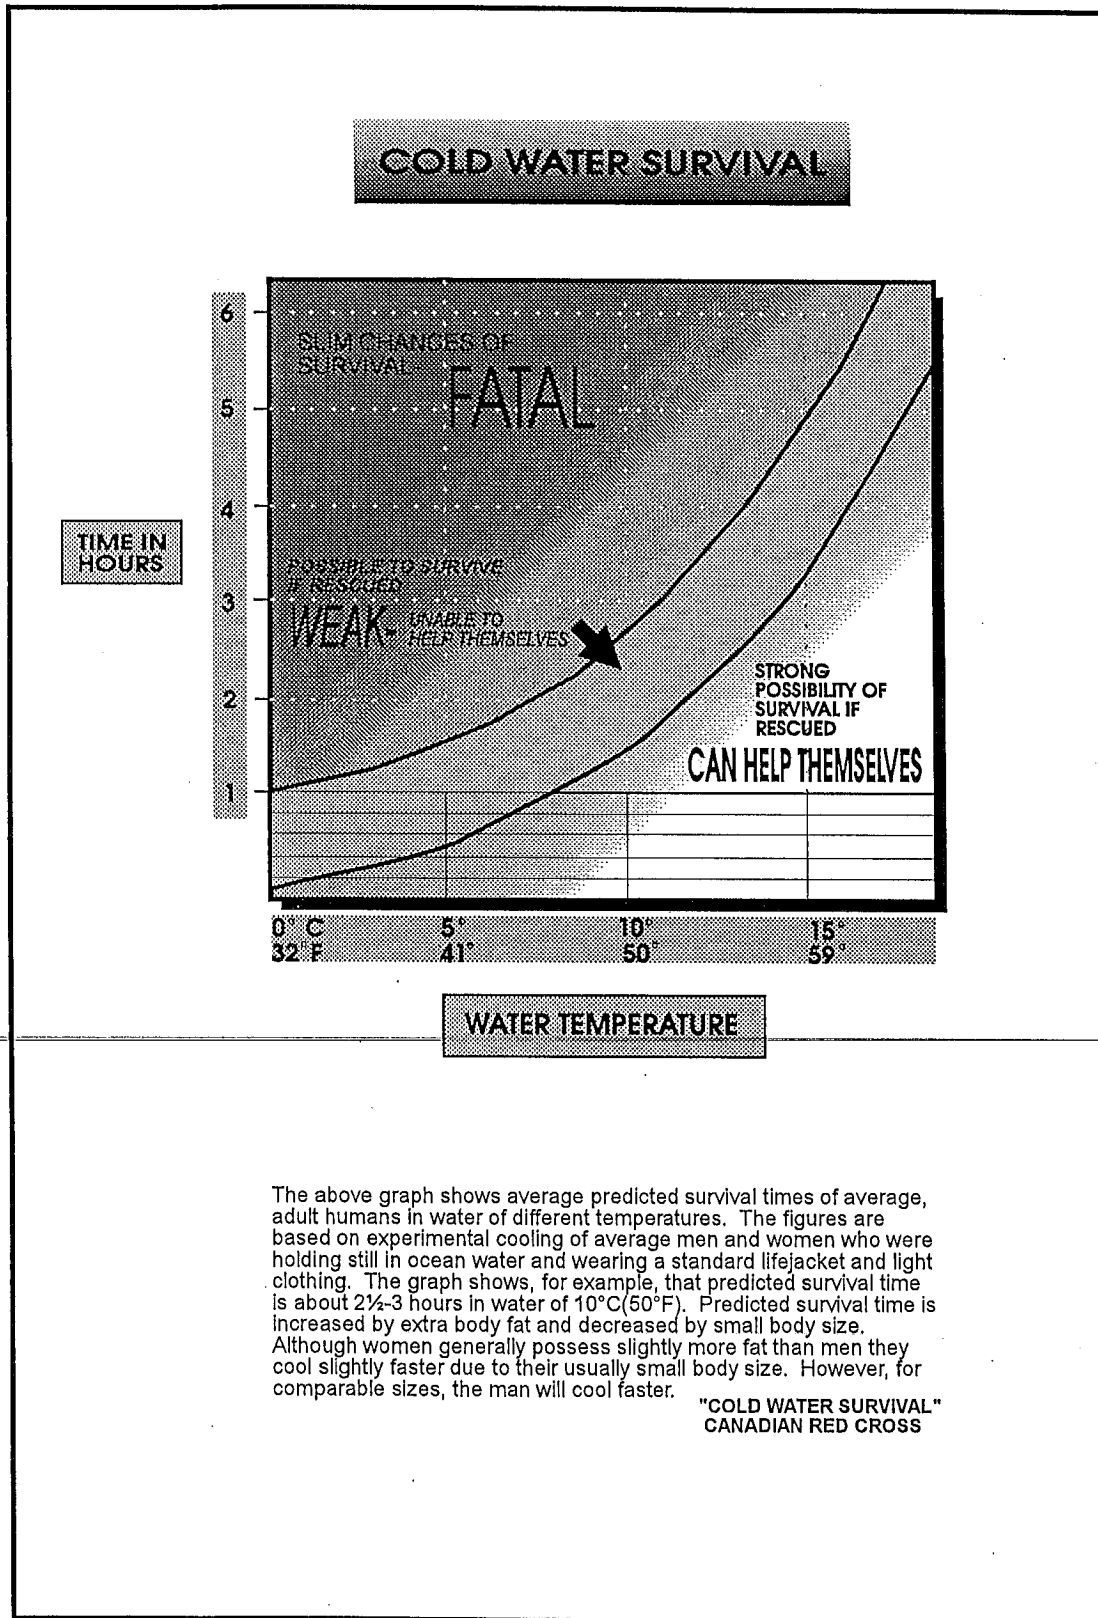
Appendix B - Cold Water Survival Graph

Appendix B shows the predicted survival time of an average adult wearing a standard lifejacket and light clothing in water of different temperatures. The graph shows that such a person, if continuously immersed in water of 5°C, could expect to survive for about one and a half hours before succumbing to hypothermia.
