Marine Occurrence Report

Grounding

Loaded Bulk Carrier "CSL ATLAS"
Lower Cove
St. George's Bay, Newfoundland
18 December 1993

Report Number M93N0002

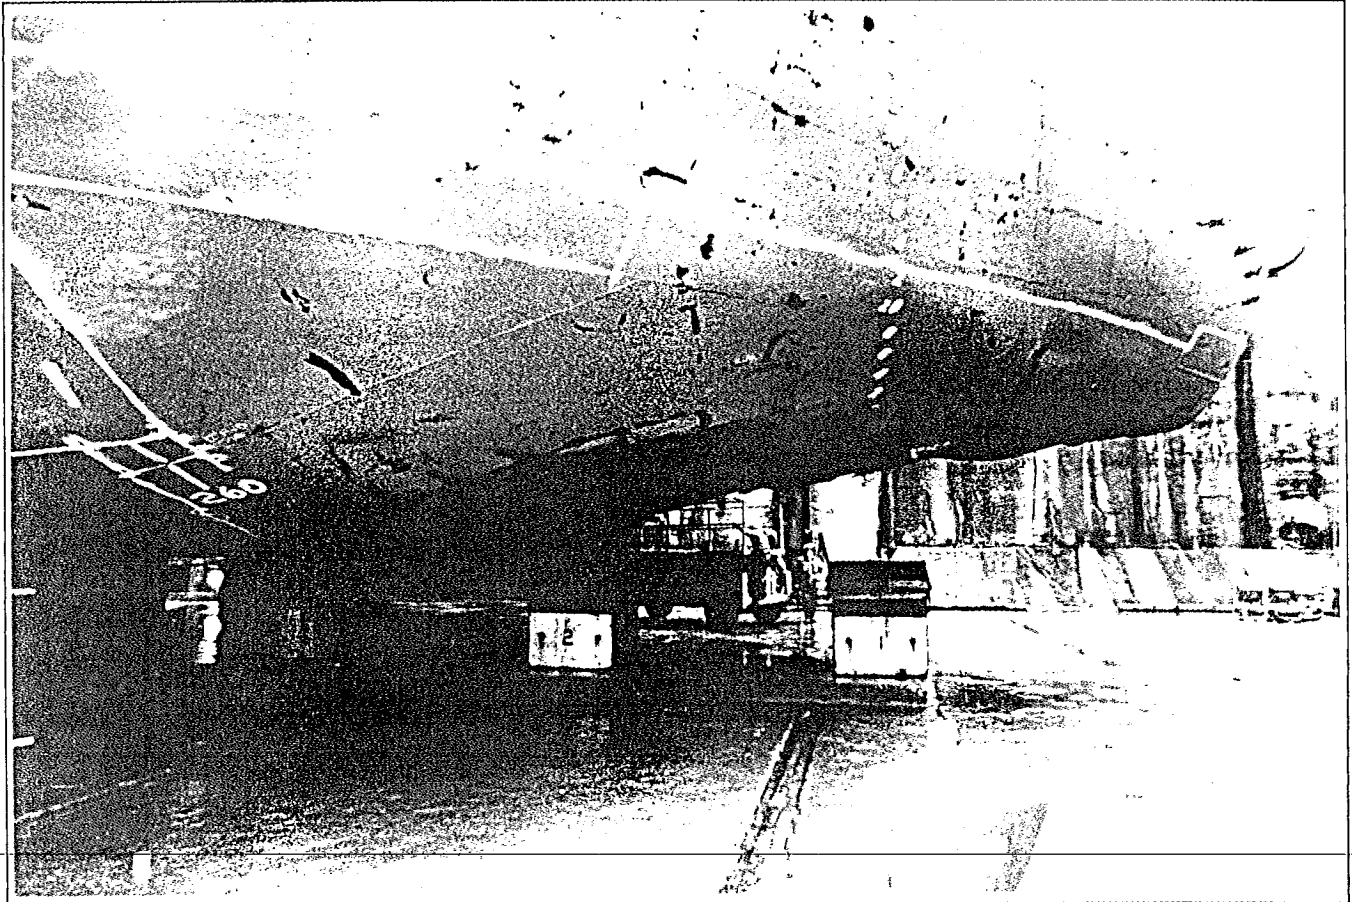
Extensive damage was sustained by the forward bottom shell plating. In addition to the three holed compartments, the plating was severely rippled from the centre line to the turn of the bilge, and the forefoot was set up extensively. The damage ran in a fore-and-aft line, on either side of the keel, from the stem to the collision bulkhead.

The forefoot was lifted extensively and the damage ran in a fore-and-aft direction, indicating that the damage resulted from a high impact grounding from directly ahead while the vessel was moving ahead.

The type and extent of the damage incurred by the vessel does not support the master's testimony that the vessel struck a pinnacle while moving ahead, drifted ashore and grounded laterally.

Showing bottom damage. (Photograph courtesy of Newport News Shipbuilding.)

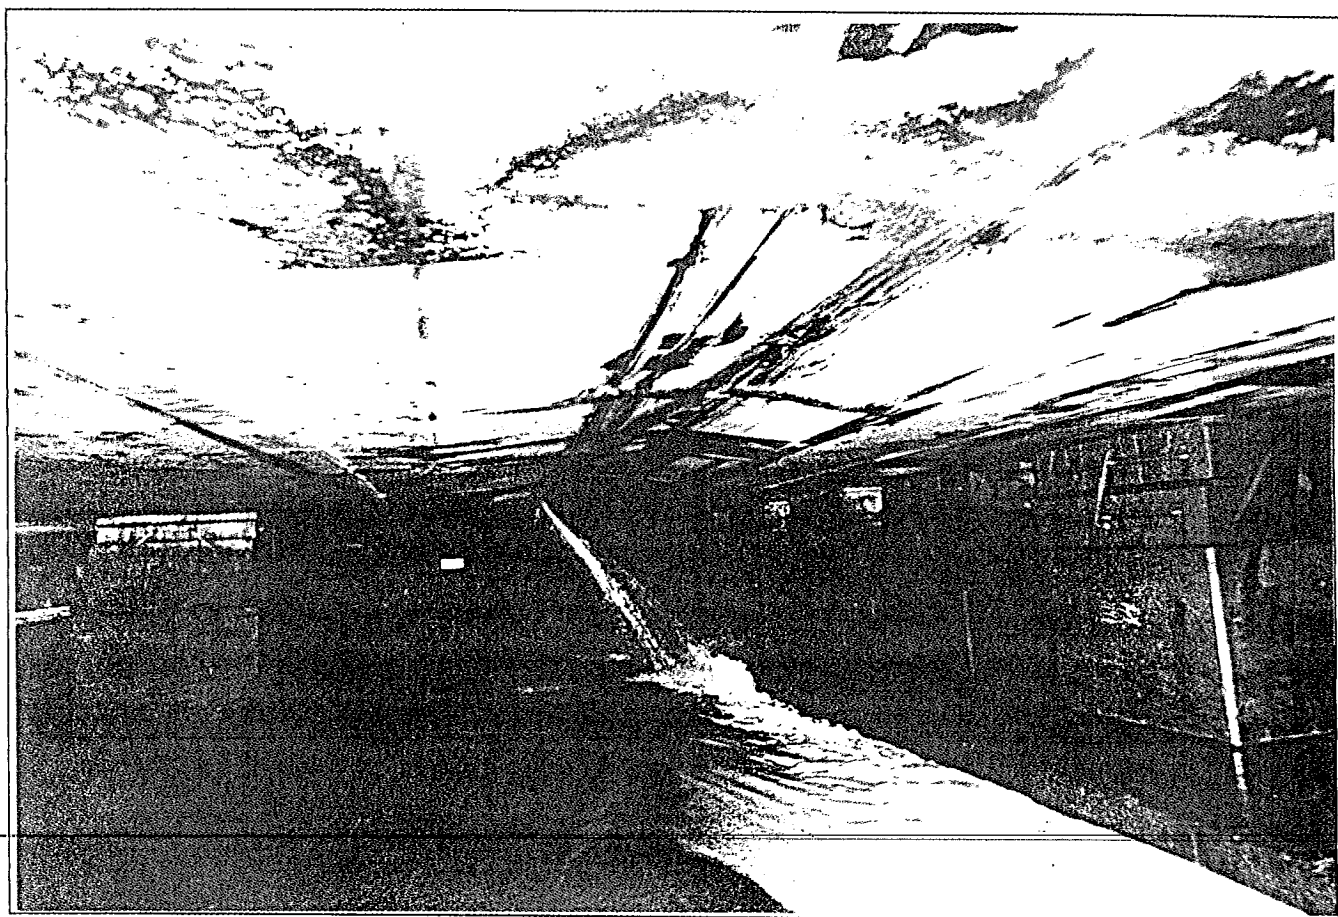
Showing bottom damage. (Photograph courtesy of Newport News Shipbuilding.)

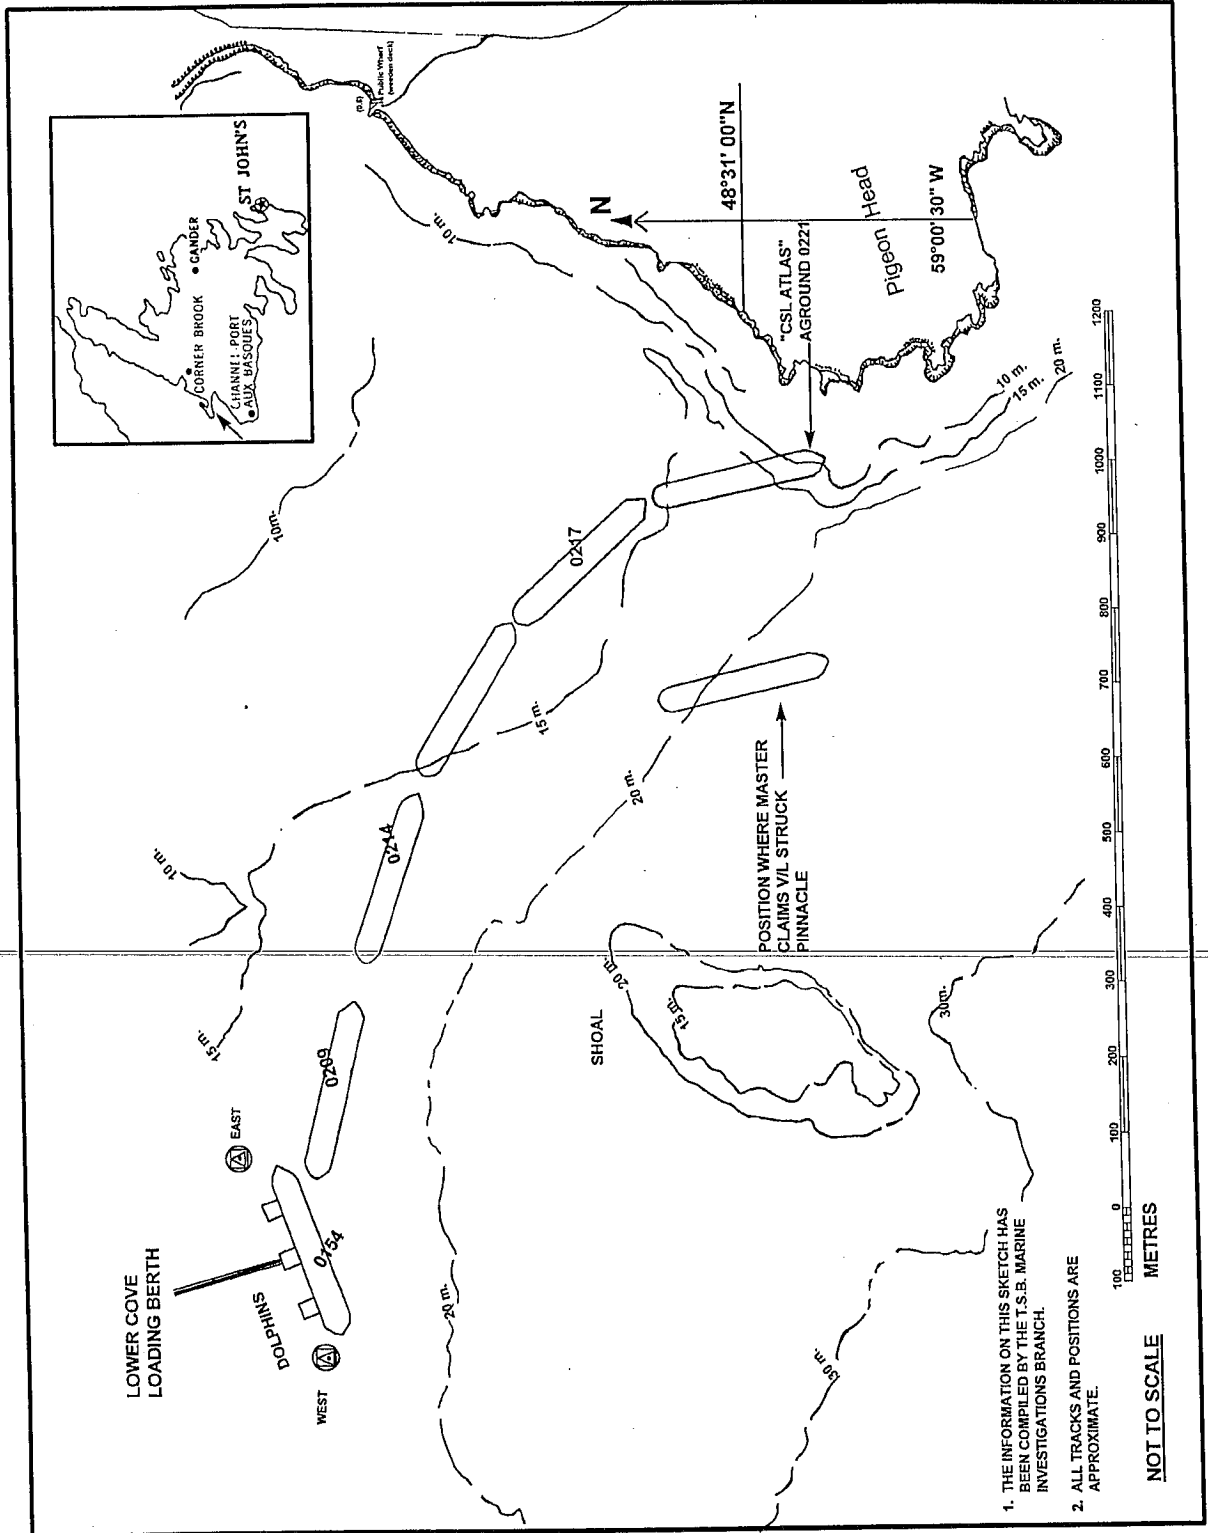
Appendix B - Sketch of St. George's Bay Showing the Reconstructed Track of the Vessel

It can be seen from the sketch of the area (see Appendix B) that, at about 0215, the vessel crossed the 15 m contour when vibration was felt. The vessel would have had an UKC of less than 1 m when making the starboard swing to clear Pig Point with engines at "full ahead".

Given the manoeuvres carried out from the time that the vessel crossed the 15 m contour, the vessel's grounding was inevitable.

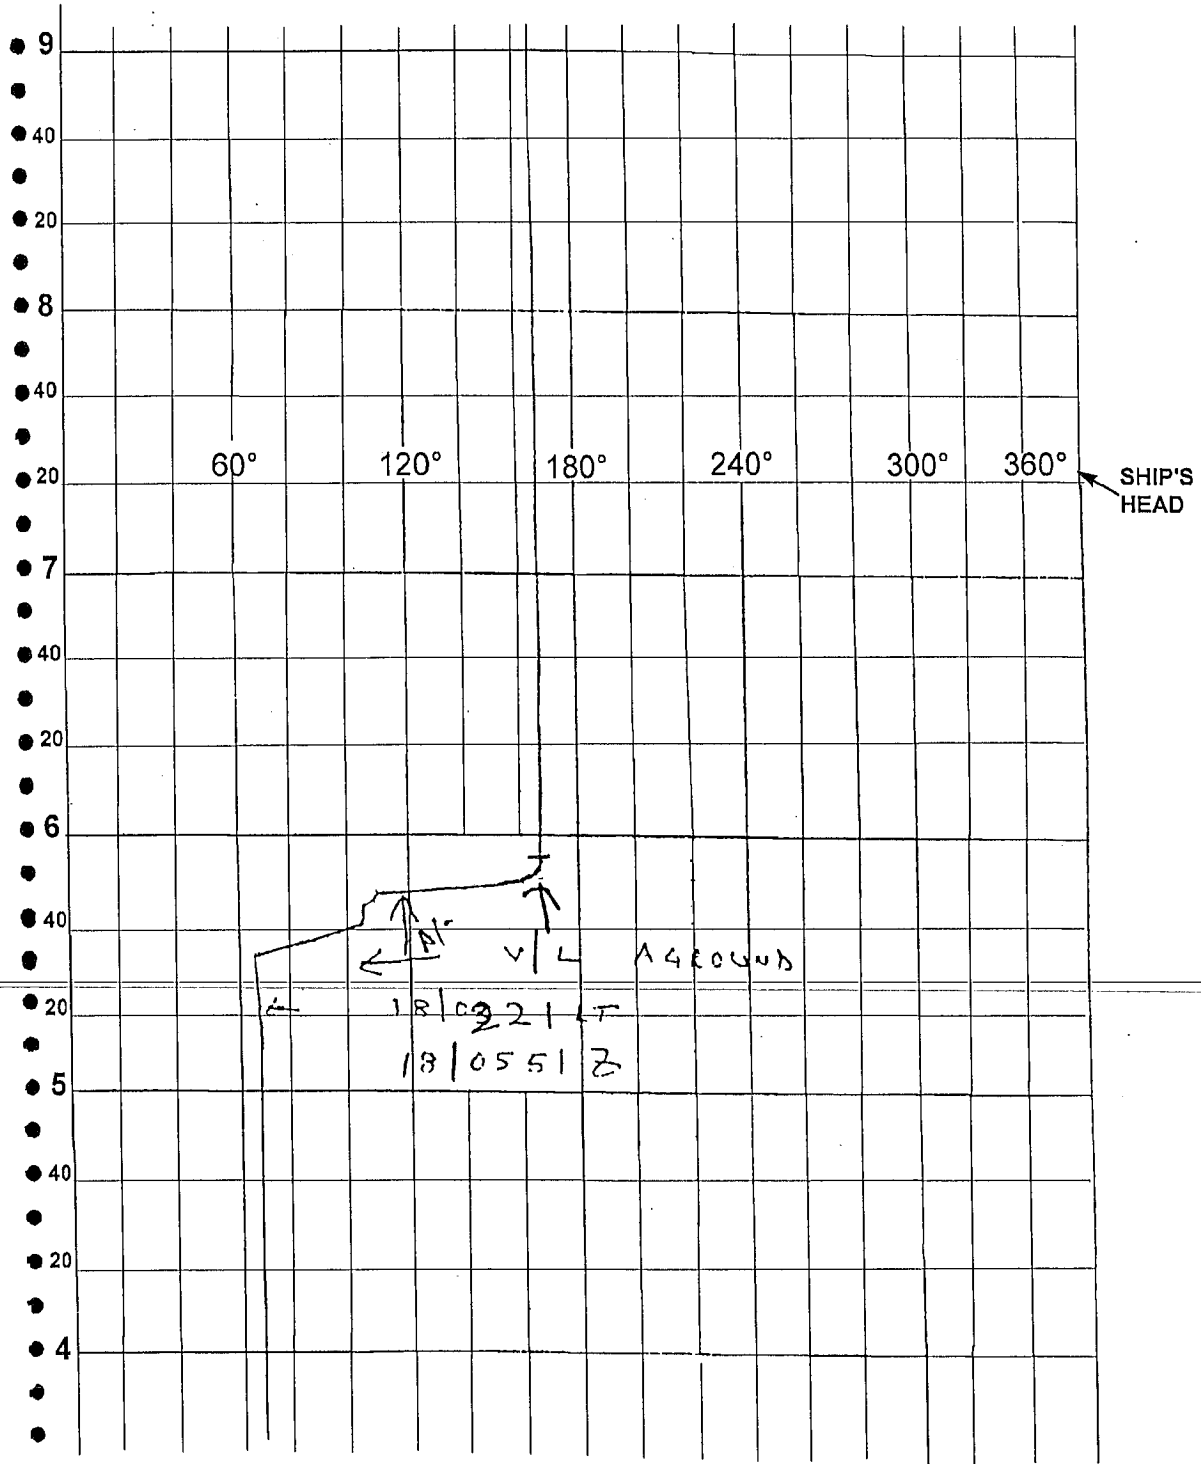
Appendix D - Course Recorder Track - Enlarged

TRACE ANNOTED BY VESSEL'S
PERSONNEL TO INDICATE GROUNDING
AT 0221 LOCAL TIME.
