## Marine Occurrence Report

### Grounding

Bulk Carrier "TRANS ASPIRATION"  
Kestrel Rock, Prince Rupert Harbour,  
British Columbia  
02 December 1993

Report Number M93W0011

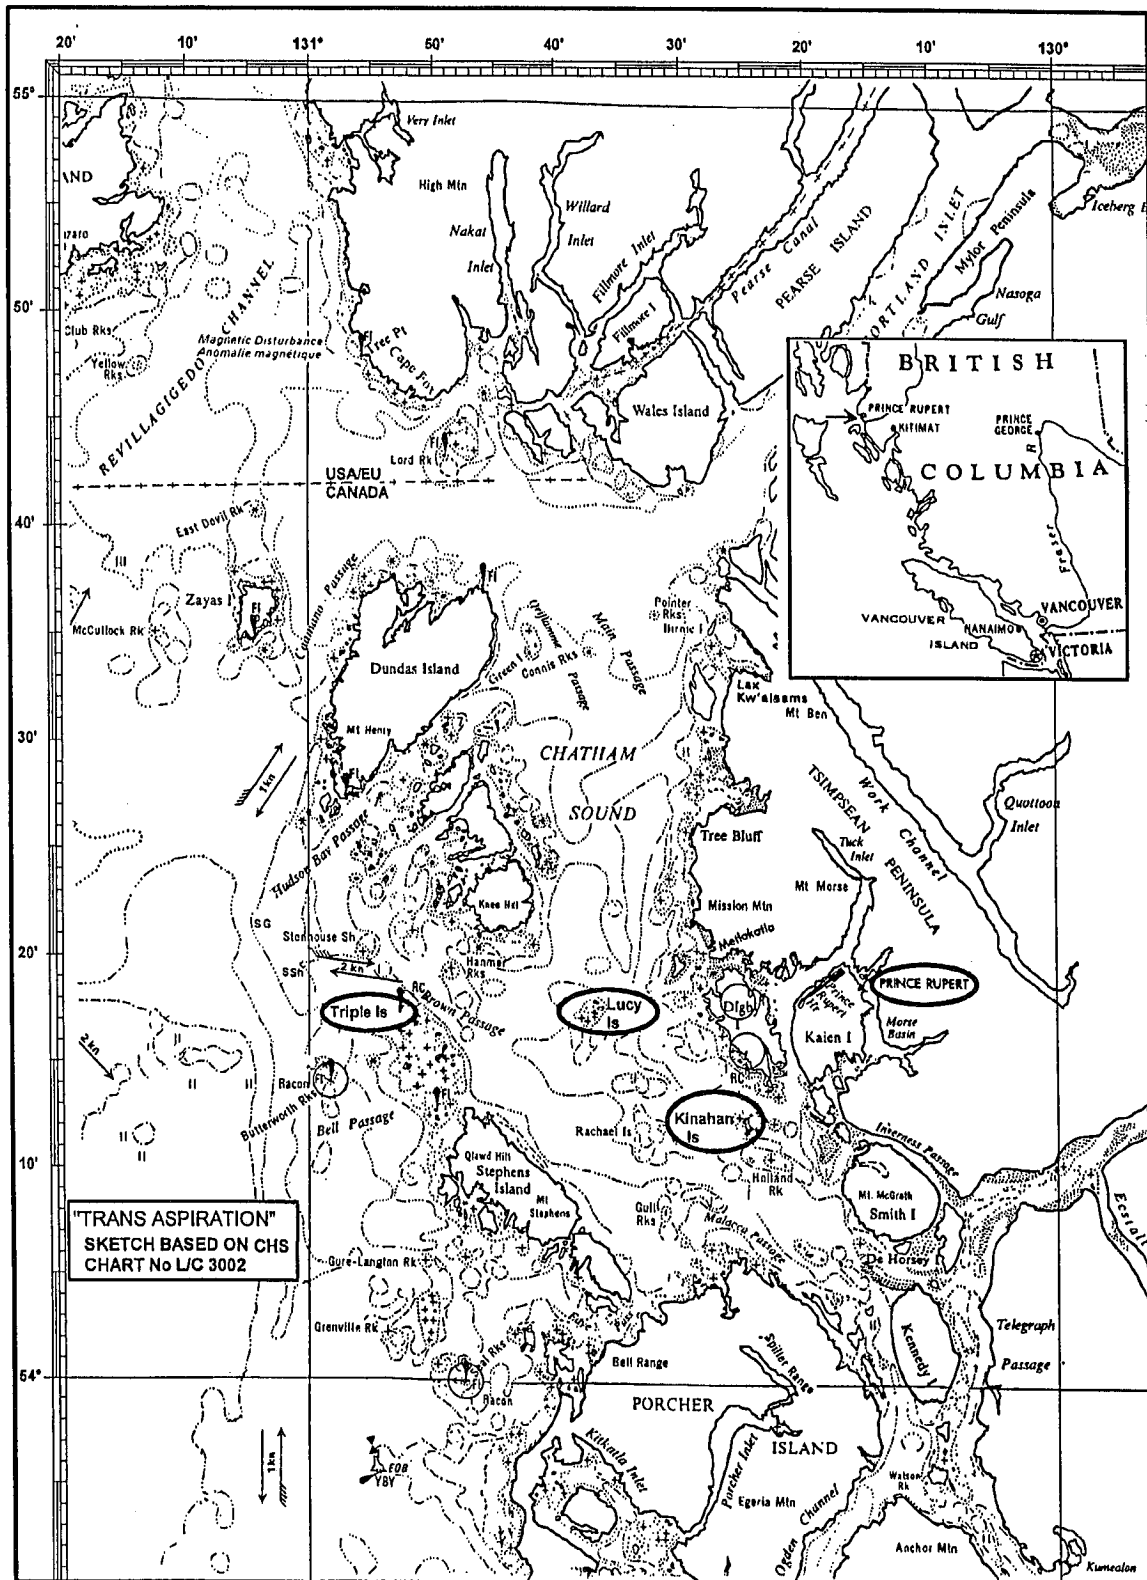
# Appendix A - Sketch of the Area Showing Position of Grounding

At 2050, the "TRANS ASPIRATION", reportedly moving ahead at about 10 knots, struck Kestrel Rock. The pilot immediately ordered hard-a-port, stop engines and then full astern. The vessel came to rest in position 49°13'18"N, 130°22'18"W, heading 245° (G).

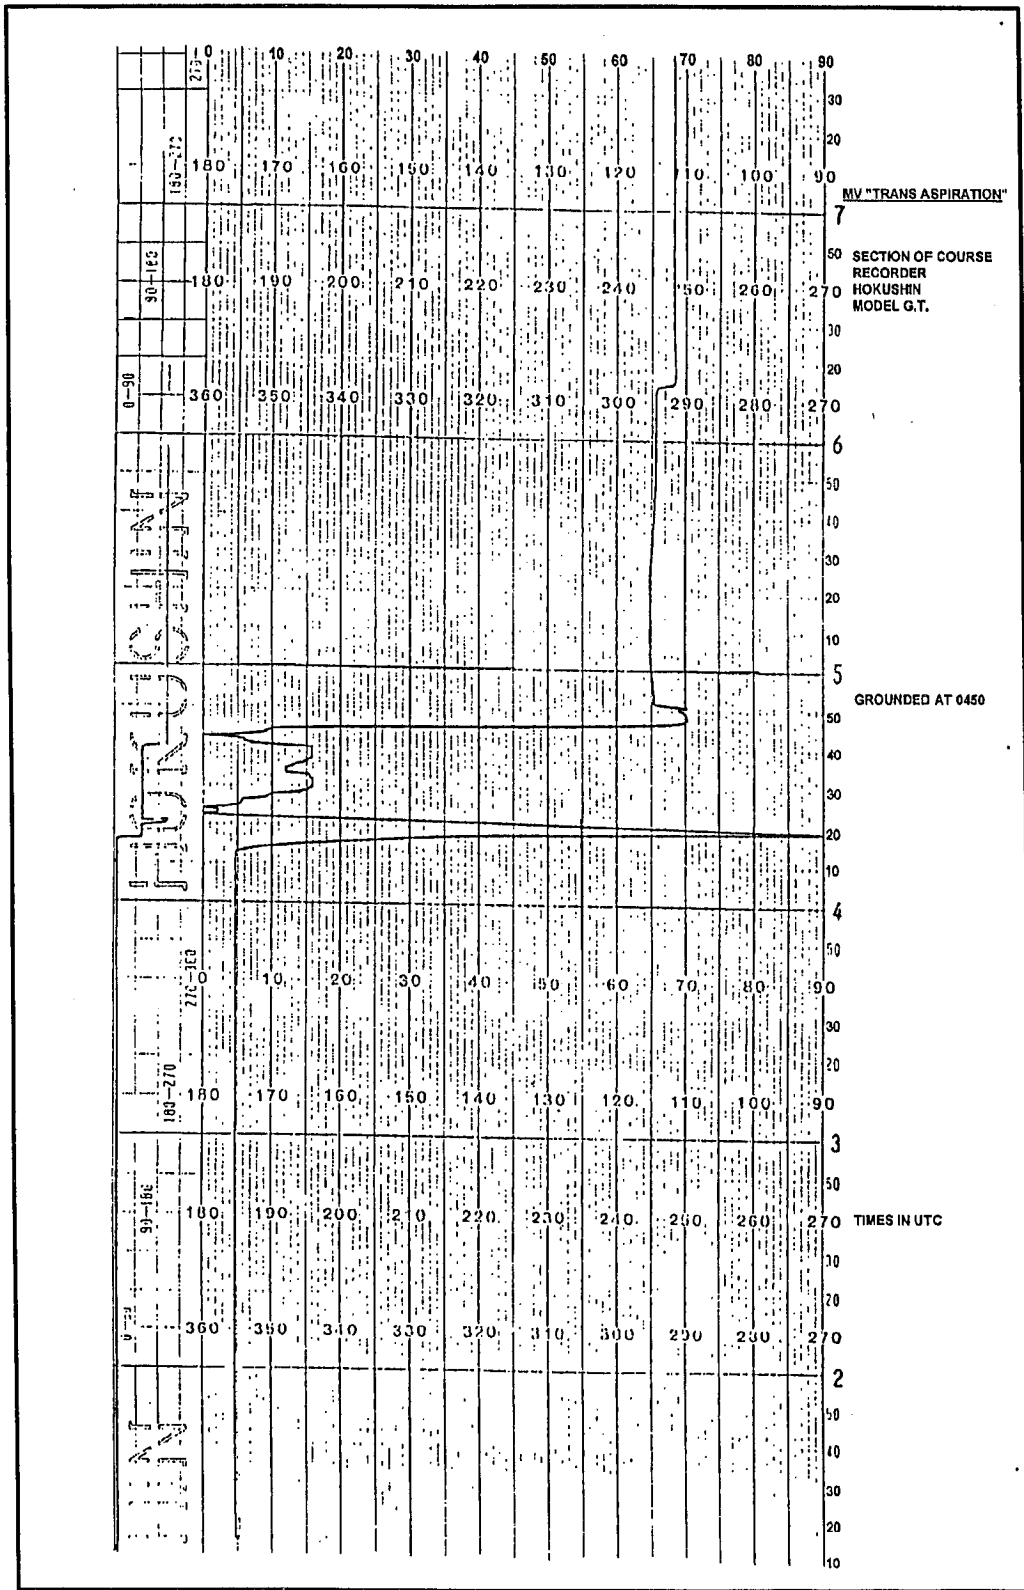
Appendix B - Course Recorder Trace

The course recorder graph indicates that it was reset at approximately 1710, 02 December 1993, and the trace shows that, while the vessel was alongside the dock, the master gyro was reading approximately one degree high (1° W).

The course recorder indicates that the "TRANS ASPIRATION" swung to starboard after leaving the dock, coming to a heading of 180° briefly before steering between 164° and 168° while transiting between Casey Point and Spire Ledge. At 2040, an alteration to starboard was made coming briefly to 180° at 2042:30 and to 190° at 2044:30. At 2045, the course was again altered to starboard until the vessel was on a heading of 250° at 2047. The "TRANS ASPIRATION" grounded approximately three minutes later, heading 245°.

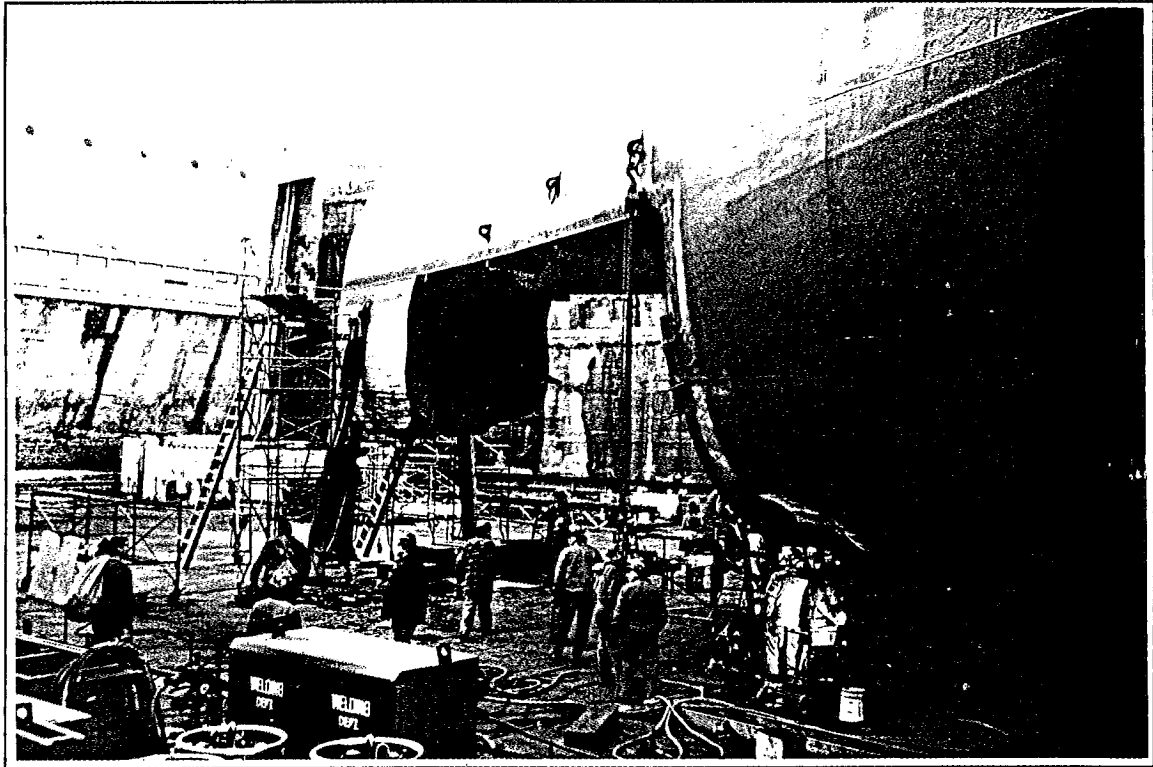
Damage was limited to the underwater area forward of the collision bulkhead. There was severe buckling, crushing and fracturing to frames, transverse floors, the centre line girder and bow shell plating within that area. The forepeak tank had been breached.

Damaged bow section.
