Marine Occurrence Report

Collision

Between the Bulk Carrier "SEALNES"
and the Fishing Vessel "MR. FISSION"
in the Approaches to Vancouver Harbour
British Columbia
19 December 1993

Report Number M93W0012

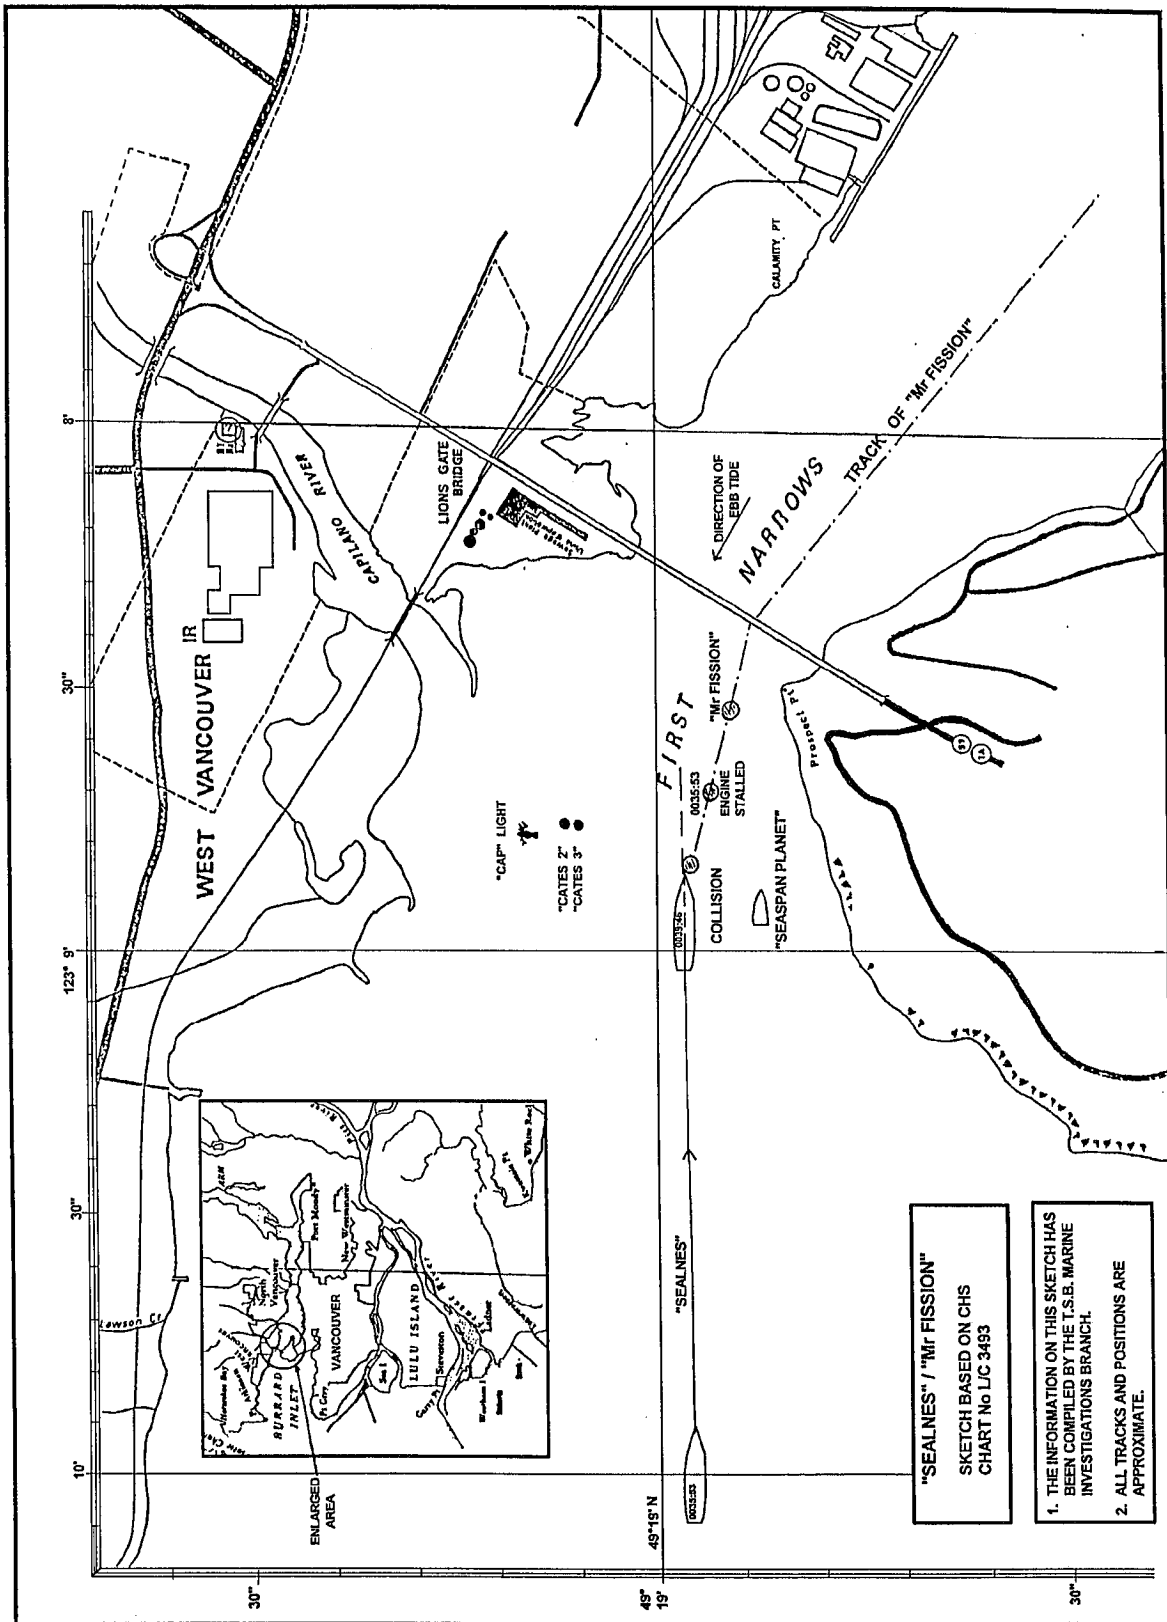
Appendix A - Vancouver Harbour and Approaches

"SEALINES" / "MR FISSION"
 SKETCH BASED ON CHS
 CHART No LC 3493
