MARINE INVESTIGATION REPORT

M98C0004

GROUNDING

OF THE TANKER "ENERCHEM REFINER"

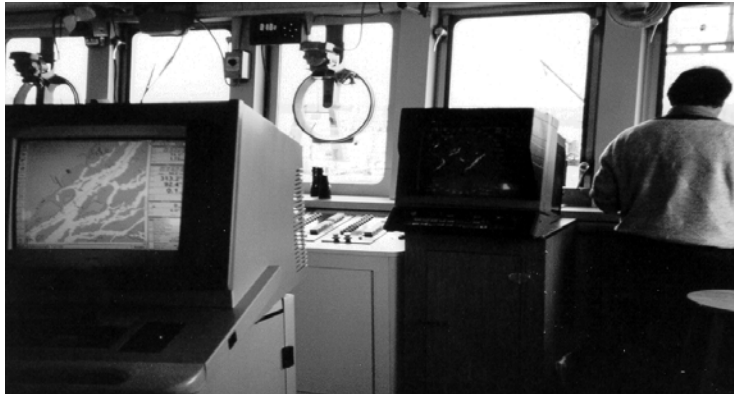
### 1.8.1 *Bridge Layout*

The bridge was comprised of a console located to the starboard of the centre line against the bridge front bulkhead which included engine controls. The starboard radar was positioned to the right of the console. The ECS was positioned aft of the starboard radar between the radar and the chart table. It was mounted on a swivel permitting the display to rotate some 180°. The steering position was located along the centre line of the vessel, aft and to port of the console. The port radar was positioned behind the bridge front bulkhead and to port of the centre line.

On this vessel, the ECS was mounted on a swivelling base, and its console was positioned behind the radar instead of beside it. Had the ECS been positioned ahead of the navigator in the direction of the vessel travel, visual references could have been maintained and the radar could

have been accessible for traffic and target monitoring. At the time of the occurrence, the radar overlay feature on the ECS was not available for use. Since the ECS was positioned behind the radar, the mariner was required to move back and forth between the two stations.

When fitting vessels with an ECS, ergonomic principles should be employed whenever possible in order to reap all of the system's benefits.

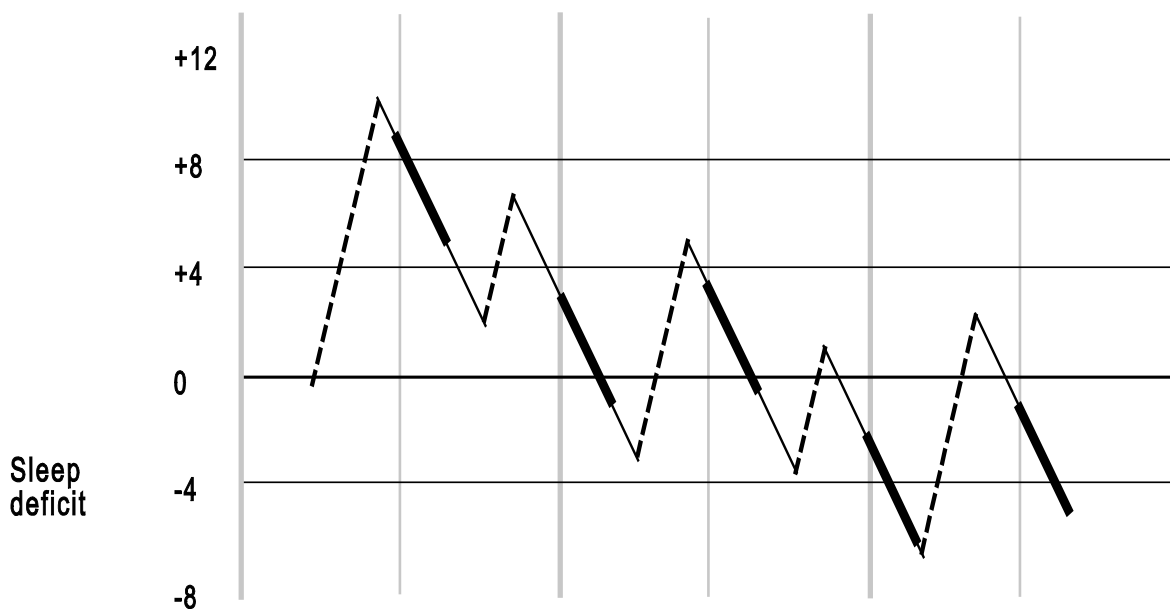
The sleep credit diagram depicts an overall downward trend in the 2/O's sleep credits over the three days prior to the occurrence.

Though fatigue is not necessary to explain the actions of the 2/O, his actions are consistent with errors involving decreased concentration and memory typical of the fatigued state. While preparing for the turn in reduced visibility, the 2/O's attention had shifted to identifying the next set of ranges, the Butternut Ranges. Having fulfilled his immediate goal of locating the ranges, the 2/O did not revert to the immediate task at hand, which was to execute a course alteration at buoy D-63. He continued with other duties instead, and it was not until the vessel had passed D-59 to port that he realized that the vessel had overshot the turning point.

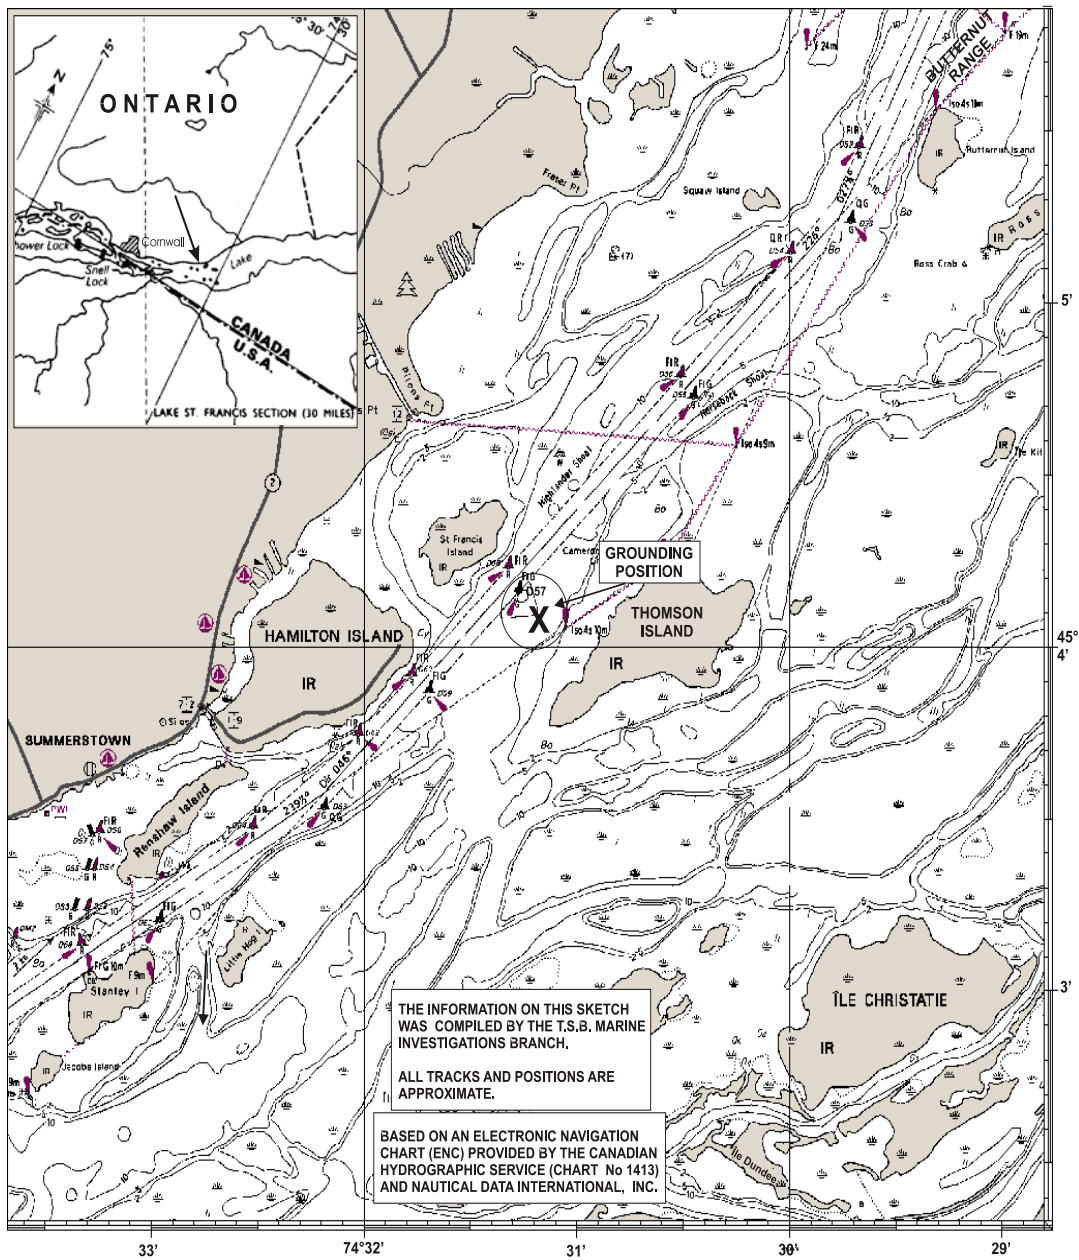
Appendix A - Sketch of the Occurrence Area

While on a course of 061° and approaching buoy D-64 (see Appendix A), the 2/O was using binoculars to visually identify the next set of ranges in order to ensure the next alteration of course. The 3/O was engaged in verifying the position of recently established floating aids vis-à-vis known landmarks. The vessel's speed over the ground in the channel was about 10 knots; there was no other traffic in the vicinity. The vessel passed buoy D-64 at approximately 1245 and proceeded past the course alteration point.

Each officer was qualified to pilot the “ENERCHEM REFINER” for this sector of the Seaway. As such, each was capable of meaningfully contributing to the safe navigation of the vessel. However, as the division of responsibility was not clearly defined, each officer assumed that the other had total control of the situation. Prior to the occurrence, each officer was engrossed in his respective task, the 2/O in identifying the leading markers ahead and the 3/O in verifying the positions of floating aids. Despite reduced visibility and difficulty in identifying range lights, the vessel's speed was not reduced. Both lost track of time and, by the time both realized that the vessel had overshot the alter-course position, it was too late. Despite hard-to-port helm and an engine movement, the vessel grounded in the vicinity of buoy D-57, some 0.75 miles beyond the intended alter-course position.
