MARINE INVESTIGATION REPORT
M98L0097

GROUNDING

BULK CARRIER *FEDERAL FRASER*
LÉVIS, QUEBEC
2 AUGUST 1998

Report Number M98L0097

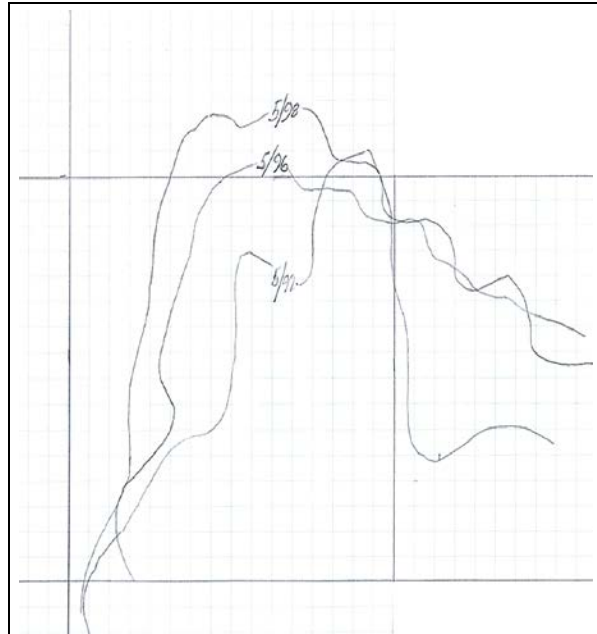
Comparison of the bathymetric surveys of 1992, 1996, and the post-occurrence survey of 1998 showed that, over the years, the edge of the shoal at the entrance to the shipyard basin has extended westward as a result of silting (see Figure 1). In keeping with good seamanship, navigating personnel and the pilot chose to use the largest-scale chart as a reference. However, this chart did not bear any notice or warning concerning silting off the shipyard.

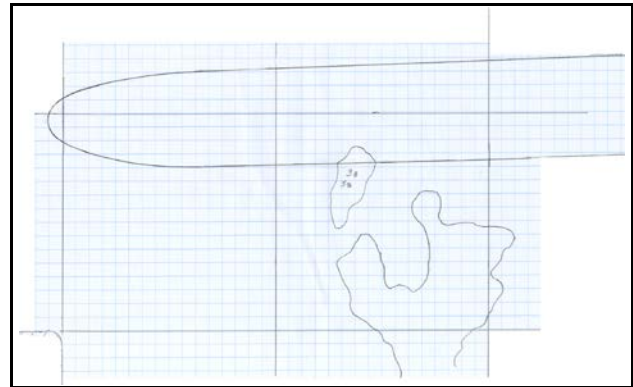
The underwater inspection showed that the damage was confined to the bottom plating, especially in way of the port bilge strake. It may be concluded from this damage that the vessel was moving transversely when it struck an object on its port side. The 3.8-m ridge is the only object northwest of the 5-m isobath and southeast of the vessel's course (see Figure 2). With a water level ranging from 4.1 m to 3 m during the grounding, this ridge was most probably the object that the *Federal Fraser* struck. It is conceivable that the depth of water over the ridge was less than or equal to 3.5 m before the vessel's impact and that the depth over it increased to 3.8 m as a result of contact with the vessel.

Based on the distance measured by radar, 0.15 nautical mile (278 m), and the estimated distance of 200 m between the bow and the radar antenna, the vessel's bow would have approached within about 78 m of the mole of Murphy wharf. An examination confirmed that the ridge is about 75 m from Murphy wharf. The contact of the stem with the shoal would have been sufficient to check and then stop the vessel. The information from ship sources and yard employees' observations confirm that the vessel stopped moving around 0200 about the same distance off the wharf.

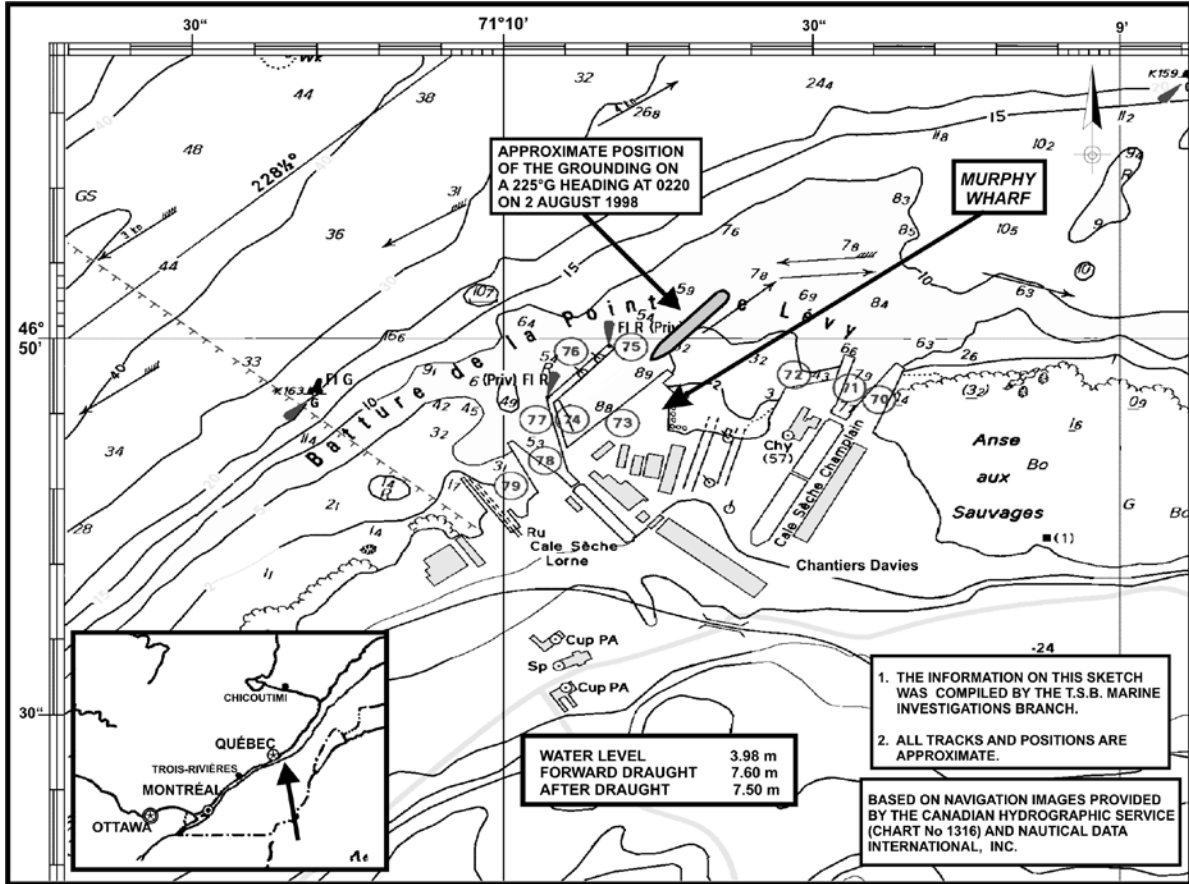
Appendix A – Sketch of the Occurrence Area

The approximate position of the grounding in way of the 3.8-m ridge shows that the vessel had drifted southeast of the alignment of the radar and yellow towers and that she was lined up approximately in the centre of the basin as reported.
