MARINE INVESTIGATION REPORT

M99F0038

MAN OVERBOARD/DEATH

THE RAIL BARGE "JUNEAU", ACCOMPANIED BY THE TUGS
"SEASPAN PACER" AND
"ESCORT EAGLE"

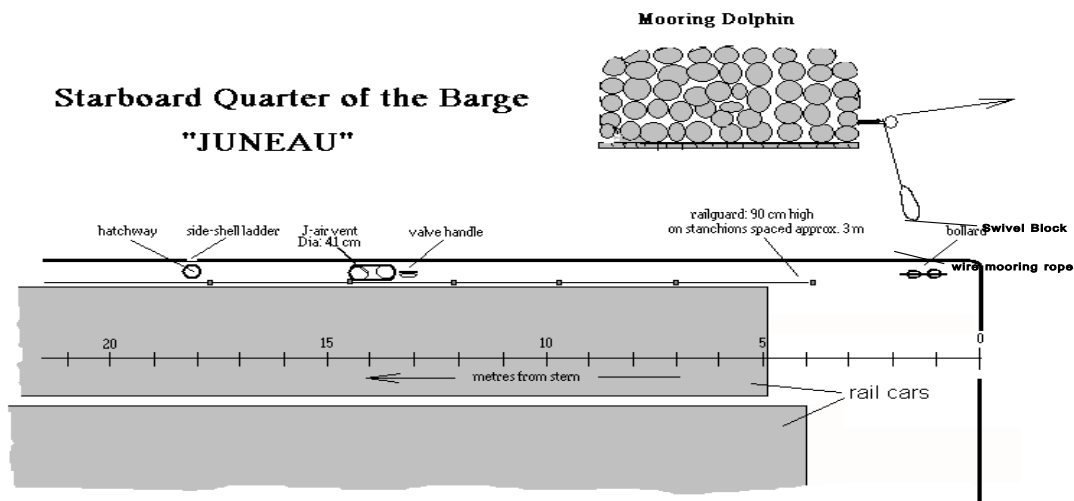
The “JUNEAU” has a wire rope safety line running along each side, supported by angle-iron stanchions welded to the deck. Positioned about 60 cm inboard from the edge of the deck, the line is about 90 cm high and ends

about 4 m from the stern (see Figure 2).

The walkway safety lines on the “JUNEAU” follow the same design and location (60 cm inboard of the edge) as those on the chip barges. For protection against falling overboard, a person must hold on to the line continuously while using the walkway. On the chip barges, the safety lines were attached—inboard of the edge of the deck—to pre-existing deck box stiffeners. The “JUNEAU” does not have such stiffeners, and neither the stanchions nor the lines were attached to any existing fixtures on the barge. When these safety lines were (fairly recently) installed, there was no pre-existing structure influencing their location, and they could have been installed in the best possible location—at the edge of the barge—thus guarding the walkway on the outside. The sister barge of the “JUNEAU” is fitted with a bulwark along the side, a safer method of guarding the edge of the deck.

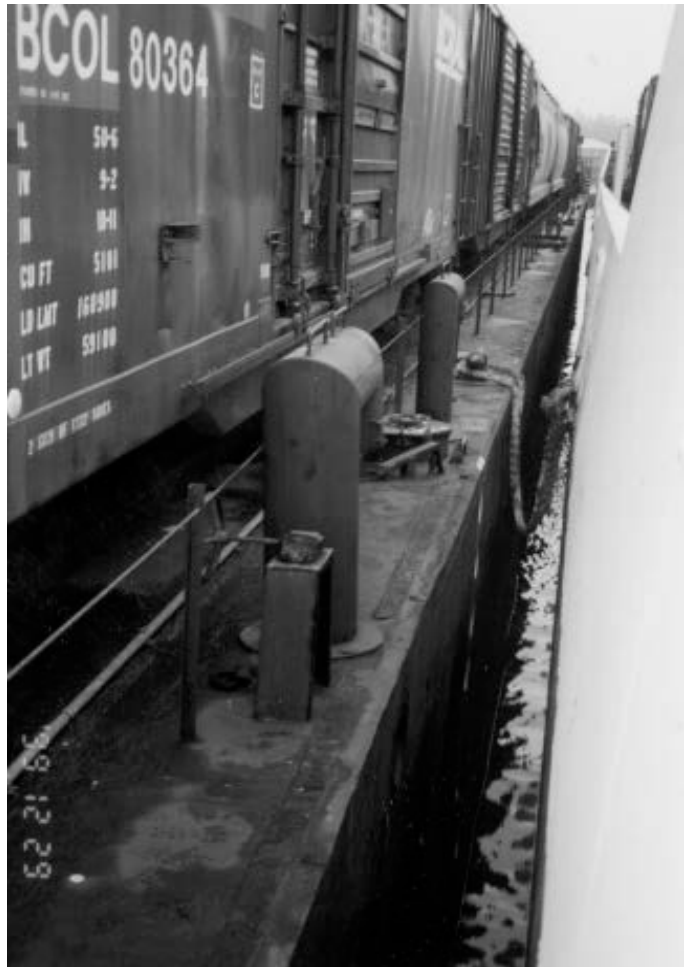
Item	Distance from edge of deck	Height	Distance from stern
a mooring bollard (two vertical posts, approximately 90 cm apart, and a horizontal bar) positioned longitudinally, next to the rounded corner of the deck			1.5 m
a valve handle with its support bracket	25 cm	60 cm	12.8 m
a vent pipe (an inverted J-shaped pipe, 41 cm in diameter) The inboard side of the vent is in line with the safety line. Its horizontal member is 1.2 m long and fitted with two bars on top. A flat ring plate of outer diameter approximately 51 cm is welded to the vent pipe where it passes through the deck.	20 cm	1.2 m	13.4 m

It was logical to place the bollards at the edge of the barge. While the manholes, cleats, handholds and other low-profile protrusions are obstacles, a trained seaman could easily pass by them. However, the 41 cm diameter vents in the 60 cm wide walkway were not placed with full regard to the safety of personnel, though handholds had been installed on the top of each vent. A person passing by the vent uses both hands to hold onto the bars on top of the vent. While passing a vent, a person’s centre of gravity briefly passes over the side of the barge; this occurs while the only available foothold is the 19 cm wide, uneven surface between the body of the vent and the edge of the deck.

It is possible for a physically fit person, with only one hand free, to pass the vent while grasping the bars with only one hand. However, such a manoeuvre is unsafe—especially when the deck is wet and footing may be easily lost.

- fuel and water vents were capped at deck level;
- containment berms around these vents were removed;
- additional handhold was installed on the top of the ballast vent; and
- vent lid dogs were removed.

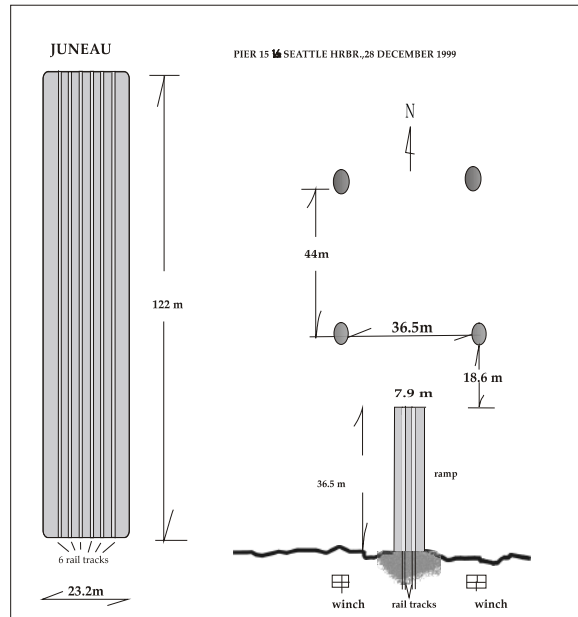
When the railcars are loaded and stowed on all six tracks, the entire width of the deck between the safety lines is occupied. The 60 cm space outside of either safety line is thence used as a walkway between the bow and the stern. Along the walkway are several items attached to the deck, including cleats, hatchways, eye pads and vent pipes.

The entire deck of the barge was used for loading rail cars. The nature of the load precluded the installation of any large fixtures within the loading area. The only available surfaces on which to place the bollards, manholes, cleats, vents, etc., without decreasing the loading space, was the 60 cm strip of the deck at the sides of the barge. The owners of the barge made use of the two strips, placing there all the auxiliary features.

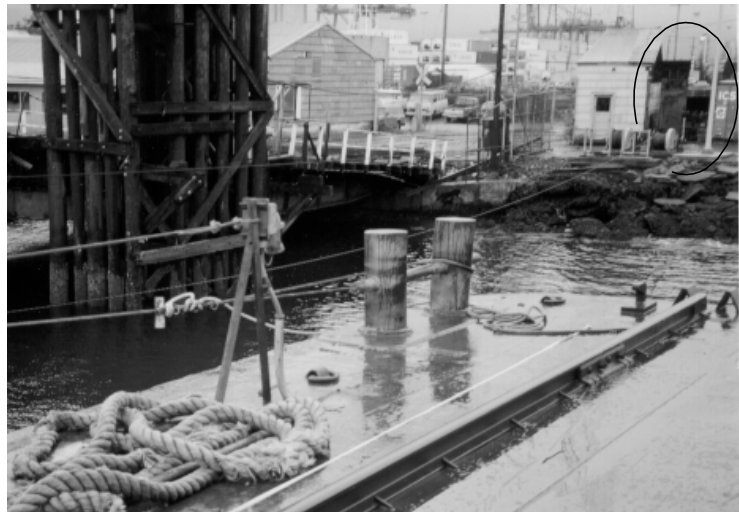
The weather was reported as foggy with light wind and calm water surface. The accident occurred at dawn, and it was still dark. There were no permanent deck lights on the "JUNEAU" and no deck lighting was provided; neither of the tugs was in a position to use its spot lights to light the starboard quarter of the barge. Some lighting was coming from the rail ramp but, with rail cars on the deck, the starboard quarter of the barge was in shadow.

The lack of dedicated lighting made sighting the deck fixtures difficult and, consequently, would have made passage across the deck—over and around the deck fixtures—more difficult to execute safely.
