MARINE INVESTIGATION REPORT

M99L0011

COMPRESSOR BURSTING

ON THE CONTAINER SHIP "CANMAR SPIRIT"

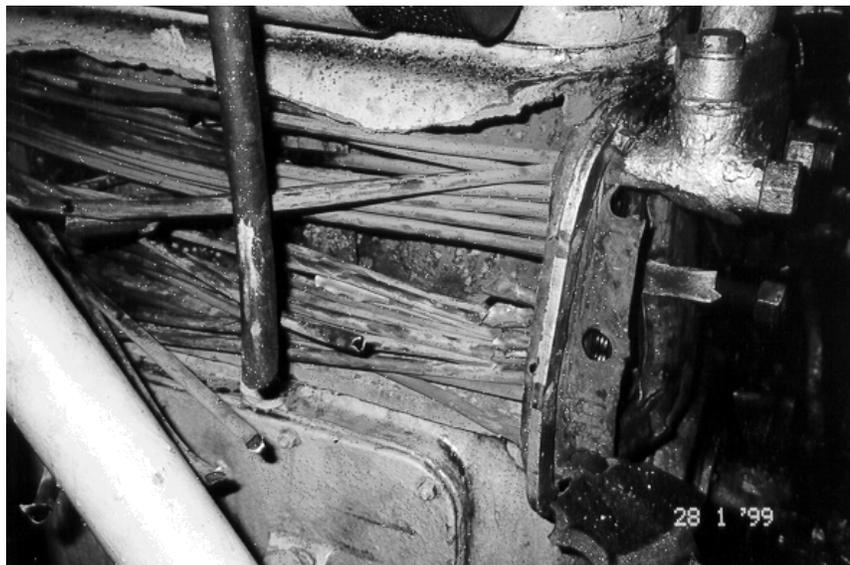
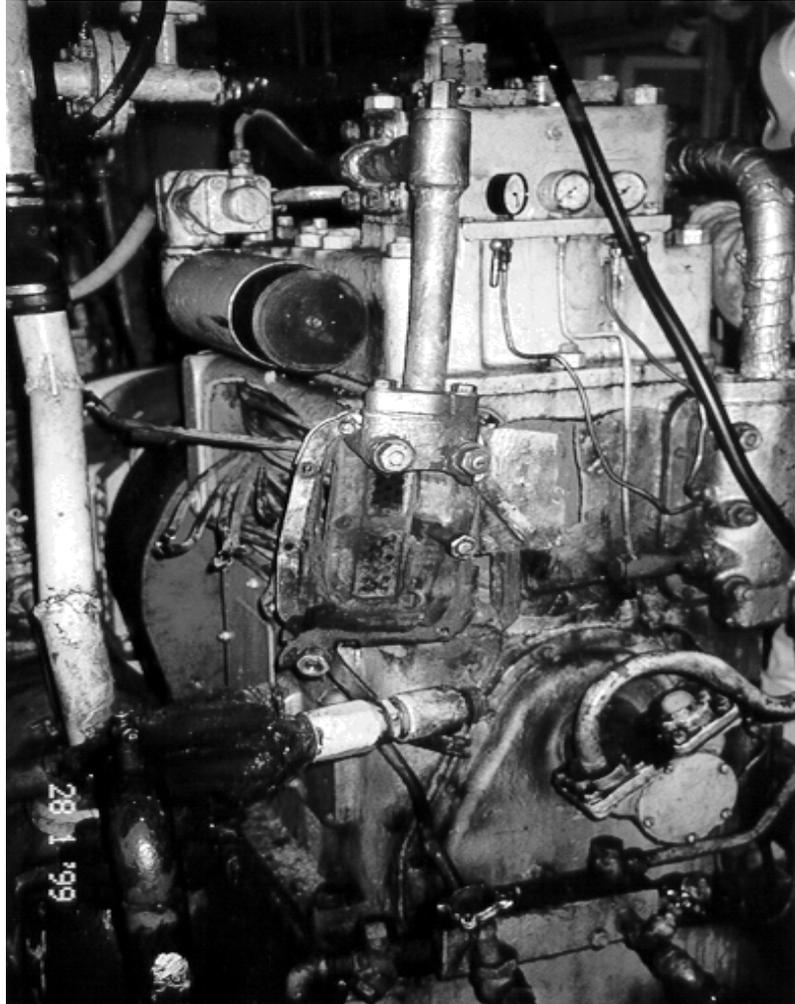
Appendix A - Photographs

The No. 3 compressor, which is of the non-oil-free, reciprocating, water-cooled type, was damaged beyond cost-efficient repair. The second-stage air cooler cover was burst and fragments of this piece were projected outward at high velocity in a shrapnel-like fashion. Other damage to the compressor included burst cooler tubes in the second-stage (after) cooler, burst compressor casing in way of the cooling water chamber and a flayed flexible delivery air line. Of the 33 second-stage cooler tubes, 18 were found to be ruptured.

The second-stage air cooler cover contains a drain valve, a fusible plug and the high-pressure relief valve. At the time of the failure, this cover fractured into many pieces that were projected outward at high velocity. An optical microscope examination revealed fracture surfaces consistent with a brittle mode of failure such as would be present in an instantaneous overstress. No evidence of pre-cracking was observed.

6. The fracture surfaces on the second-stage outlet cover were consistent with an instantaneous failure with no evidence of pre-cracking or previous repair. The cover fractured into many fragments that were projected outward at high velocity.

13. The compressor casing burst open in way of the cooling water chamber due to a severe and near instantaneous over-pressurization. The cooling water relief valve seems to have been operable but in all likelihood could not handle the rate of expansion associated with the complete and near instantaneous failure of the high-pressure cooler tubes at pressures at or above 4,000 psi.
14. The majority of the engine-room crew and the master were experienced mariners but this was their first tour of duty on board the "CANMAR SPIRIT".
15. Some of the crew members reported being under pressure and stress following the accident but relief and assistance were neither requested nor offered.
