MARINE INVESTIGATION REPORT

M99L0126

GROUNDING AND CONSTRUCTIVE TOTAL LOSS

THE BULK CARRIER *ALCOR*

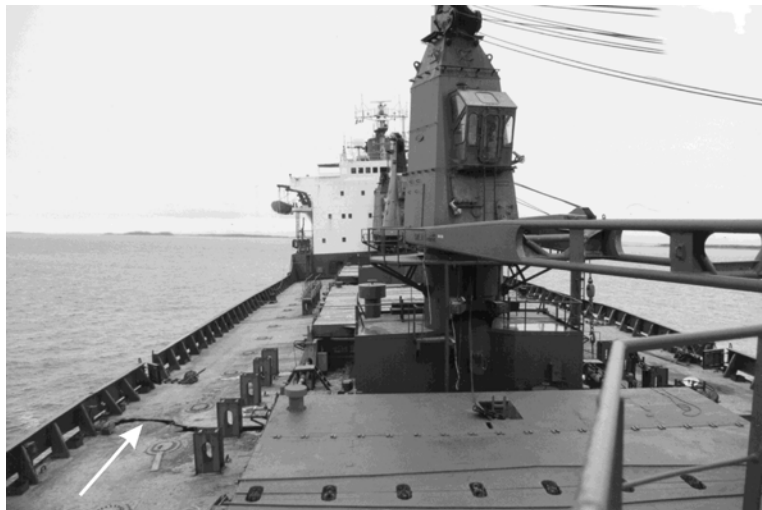
At approximately 0015 on 11 November 1999, a loud reverberation was heard throughout the ship. A large fracture had developed transversely across the main deck, near frame 110 on the starboard side, through the No. 4 hatch coaming, and across to frame 87 on the port side. The fracture extended down both sides and stopped just short of the hopper tanks. Holds 3 and 4 were opened to the sea and the fracture on the main deck was as wide as 0.52 m in some places (see Photographs 2, 3, and 4).

Tensile stress concentrations at minor discontinuities in the upper members of the hull girder initiated brittle fractures in the main deck plating that subsequently propagated across the deck, into the deck longitudinals, then through the sheer strake and gunwale, finally propagating down the side shell plating.

Principal fractures in the port and starboard side shell plating breached the watertight integrity of cargo holds 3 and 4 and upper wing water ballast tanks 2 (S) and 3 (P). The width of the fractures across the main deck plating near midships widened to approximately 0.52 m.
