MARINE INVESTIGATION REPORT

M99W0137

CAPSIZING WITH LOSS OF LIFE

THE INFLATABLE RIVER RAFT "FLIP"  
SULPHUR RIVER, GRANDE CACHE, ALBERTA  
12 JULY 1999

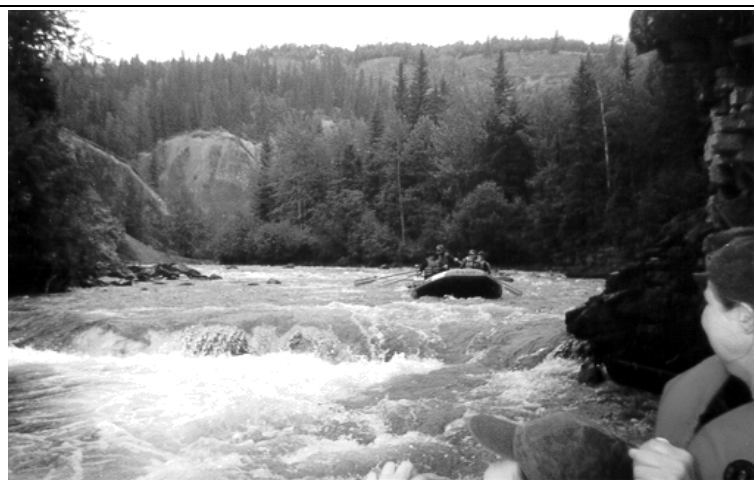
Approximately 5 km from the put-in point is an overfall, or drop,<sup>5</sup> approximately 90 centimetres high, referred to as the *ledge*. With minor variations, it continues unbroken across the river from bank to bank (see photograph 2). The rafts are designed with increased freeboard at each end, and the generally accepted approach for turbulent waters, such as the *ledge*, is head-on.

The "FLIP" went over the *ledge* with its starboard side leading; it rolled to starboard and then to port, and then capsized. All occupants were spilled out of the raft and into the water. Of the six occupants, two surfaced beneath the upturned raft while the remainder found themselves adjacent to it. The two passengers beneath the raft, by their own efforts, swam clear; one upstream, the other downstream. The raft was undamaged.

PHOTOGRAPH OF A RAFT APPROACHING THE "LEDGE"

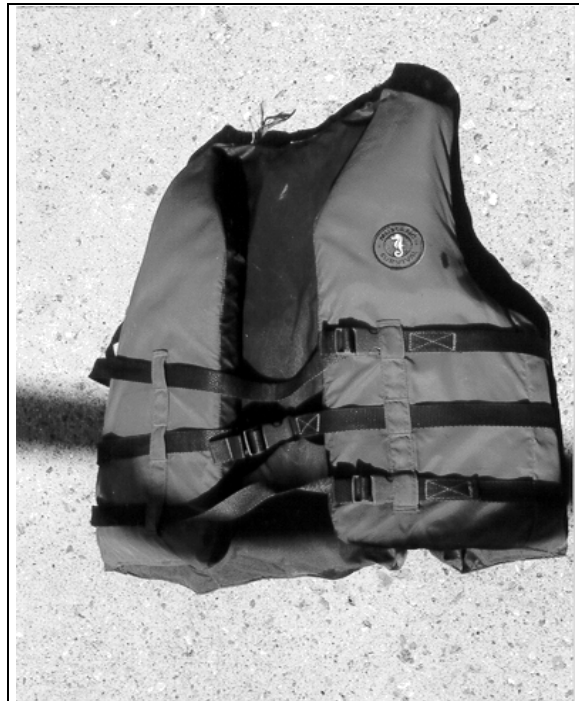
None of the PFDs provided by the trip leader for the use of his passengers were designed to meet the requirements for a “standard lifejacket” in either performance or flotation. In particular, a PFD is not designed to turn an unconscious person in the water face up.

The PFD worn by the victim displayed signs of age and rough service. The PFD manufacturer’s information tag sewn on this PFD had, through use, become completely unreadable. The information tag of the PFD had been printed with the caution: “This device may lose buoyancy over a period of time and become no longer serviceable.” Other PFDs in the inventory of the trip leader were in a similar condition, some with torn fabric or missing buckles.

In this occurrence, the PFD was seen to have supported the victim face up when he was thrown from the raft when it capsized. The victim, who was later determined to have suffered a head wound, did not appear to be conscious. When he was recovered, however, he was no longer wearing the PFD. The PFD was recovered and was found to have remained buckled, indicating that it had slipped off the victim, who was most probably unconscious.
