## **PIPELINE INVESTIGATION REPORT**

**P09H0006**

### **SOUR GAS PIPELINE SENDING BARREL RUPTURE**

**WESTCOAST ENERGY INC., CARRYING ON BUSINESS AS  
SPECTRA ENERGY TRANSMISSION  
18-INCH ALASKA HIGHWAY PIPELINE  
KILOMETRE POST 0.0  
NEAR WONOWON, BRITISH COLUMBIA  
20 FEBRUARY 2009**

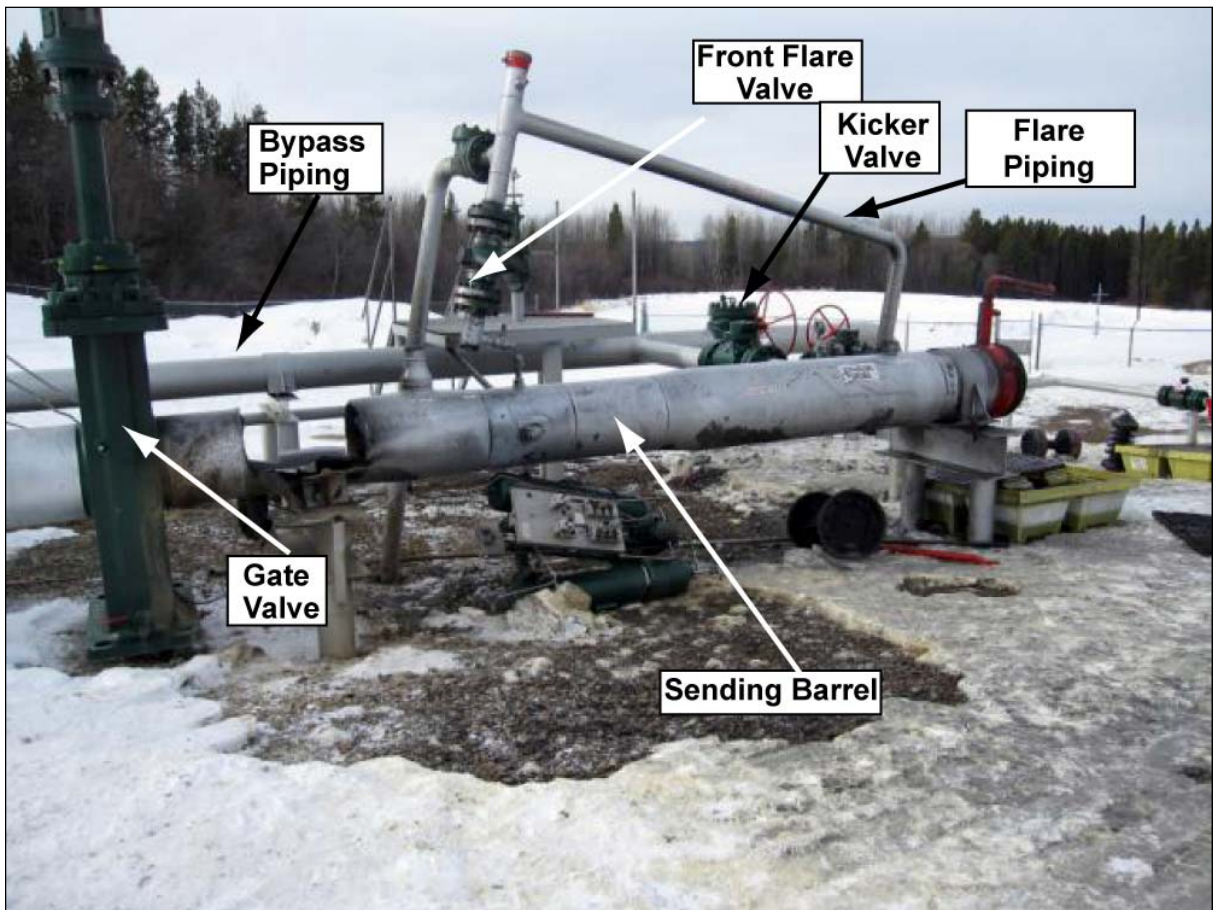
**Photo 1.** Failed sending barrel

The failed sending barrel was sent to the Acuren Group Inc. (Acuren) laboratory in Richmond, British Columbia, for a visual examination, non-destructive inspection, and destructive metallurgical testing. The laboratory analysis determined that the sending barrel failed in an overload condition that developed during launching operations. Internal corrosion had occurred on the top half of the barrel. The wall thickness at the failure location had been reduced by the corrosion to the extent that local permanent yielding had occurred at normal operating pressures. Fatigue cracks had formed due to pressure cycling during the cleaning pig launching process. TSB's Laboratory reviewed the results of the Acuren failure analysis report and determined that the nature of the work performed and methodologies were consistent with good failure analysis practice (LP 064/2009).

Internal corrosion had thinned the upper quadrant of the sending barrel to the extent that local permanent yielding had occurred at normal operating pressures, leading to the rupture. The relatively uniform nature of corrosion on the upper half of the sending barrel and the absence of corrosion products indicate an acidic vapour phase attack.

1. Internal corrosion had thinned the upper quadrant of the sending barrel to the extent that local permanent yielding had occurred at normal operating pressures, leading to the rupture.
2. Fatigue cracks had developed and grown due to the normal pressure cycles associated with pig launching operations.
3. The internal corrosion likely occurred due to acidic vapour phase attack resulting from the condensation of water vapour within the gas stream.
4. Methanol, which was in the sending barrel for at least 24 hours as part of the non-approved pre-loading process, minimized the effectiveness of the corrosion inhibitor on the internal surface of the sending barrel.
5. Due to the leaking front flare valve, continual product migration past the pipeline isolation gate valve and into the sending barrel had been occurring for at least eight months before the occurrence.

- It conducted ultrasonic thickness testing on each section of every sending and receiving barrel in its sour gas gathering systems.
- It completed an integrity inspection, including an external visual inspection and ultrasonic inspection and radiographs of suspect locations, on all sending and receiving barrels in its sour gas gathering systems, as well as an internal visual inspection on most barrels in its Grizzly Valley sour gas system. Since specialized equipment is required to complete an effective internal visual inspection of the remaining Grizzly Valley barrels, this inspection will be completed by July 2010 in coordination with the scheduled Pine River Plant outage.

- It added vapour phase corrosion inhibitor to all barrels in wet sour gas service after launching and receiving operations.
- It prohibited the pre-loading of sending barrels with methanol.
