**PIPELINE INVESTIGATION REPORT
P09H0083**

NATURAL GAS PIPELINE RUPTURE

**TRANSCANADA PIPELINE LIMITED
762-MILLIMETRE-DIAMETER PIPELINE
LINE 100-1 – MAIN LINE VALVE 111A-1
FROM KILOMETRES 11.12 TO 11.16
NEAR MARTEN RIVER, ONTARIO
26 SEPTEMBER 2009**

Report Number P09H0083

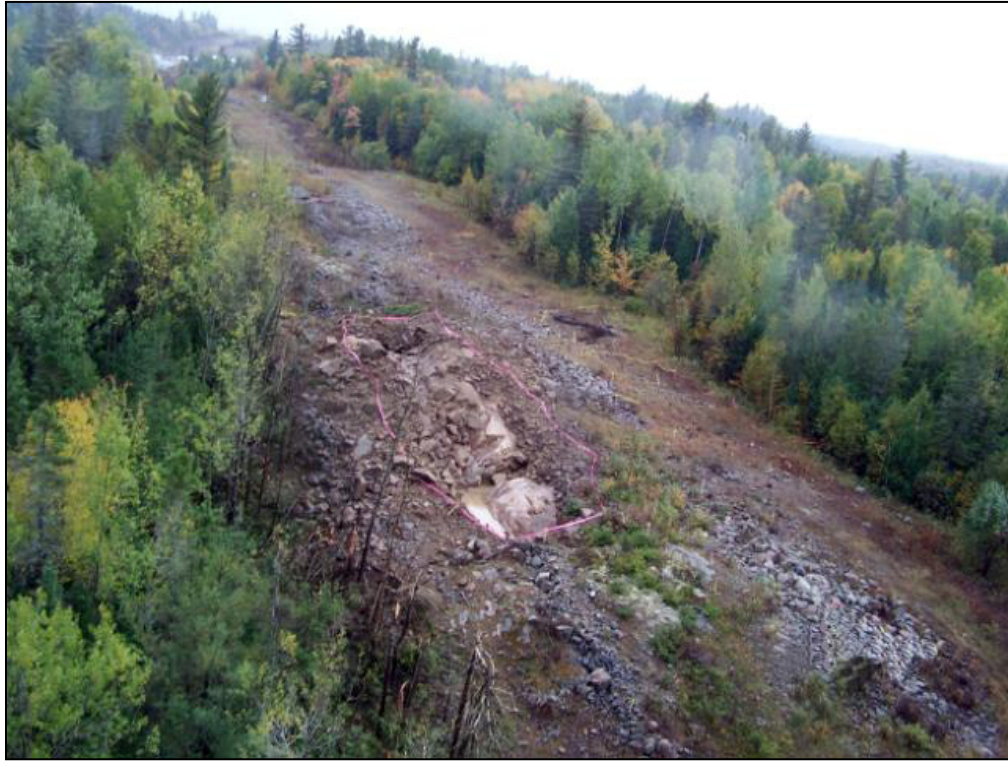
During the rupture, a section of pipe separated from the pipeline and was scattered throughout the area in more than 40 pieces of varying sizes (see Photo 1). The upstream and downstream joints of the pipe were severely damaged (see Photos 2 and 3). Pieces of pipe were found up to approximately 100 m away from the site of the rupture.

Photo 1. Aerial photo of the Marten River occurrence site.

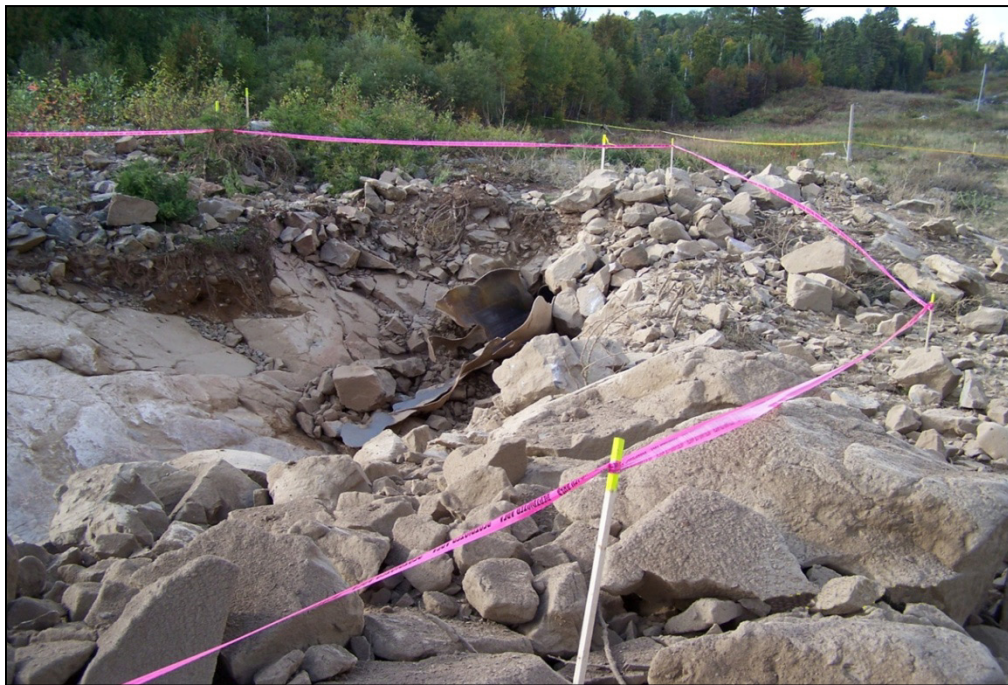
Photo 2. Line 100-1, upstream section of Line 100-1 at the Marten River occurrence site.

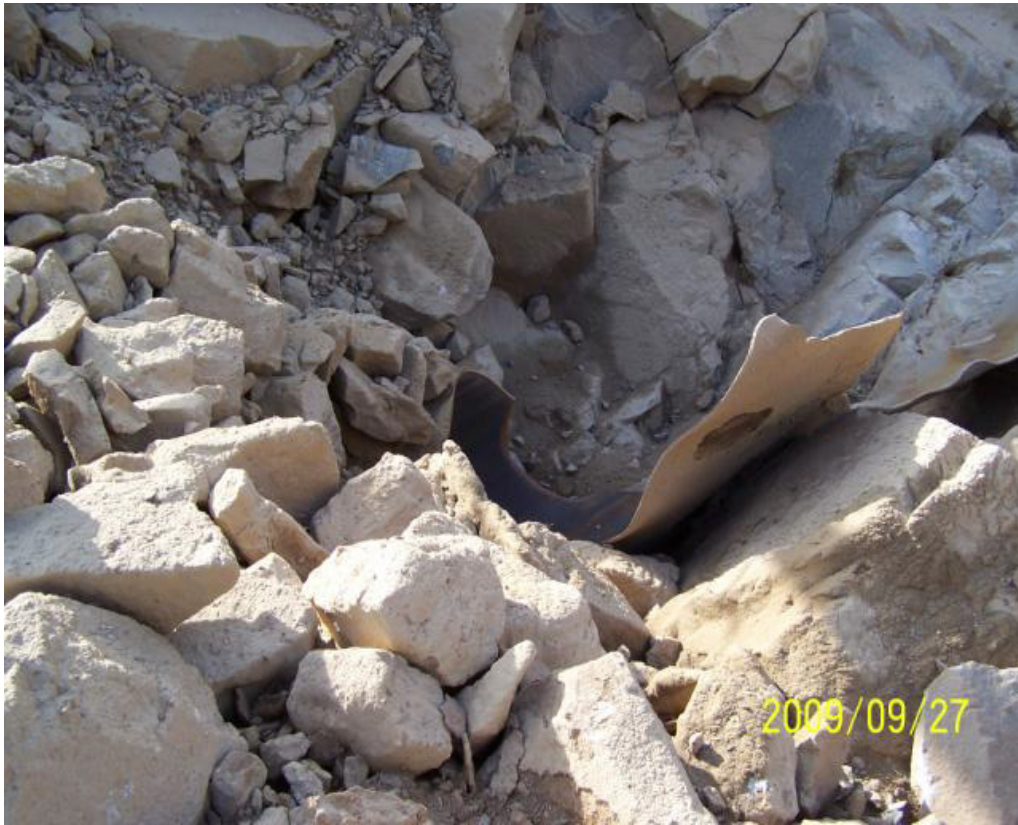
Photo 3. Line 100-1, downstream section of Line 100-1 at the Marten River occurrence site.

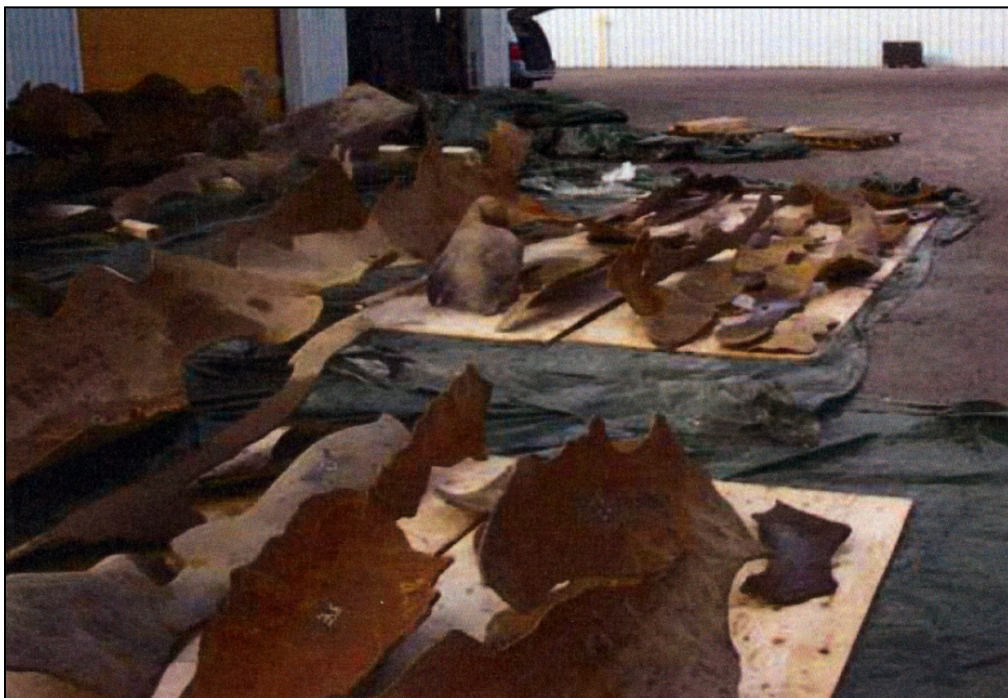
The upstream and downstream fracture arrests were cut off the ends of the pipe and retained for further examination. More than 40 pieces of pipe were also collected (see Photo 4).

Photo 4. Line 100-1, pipe pieces from the Marten River pipeline failure.

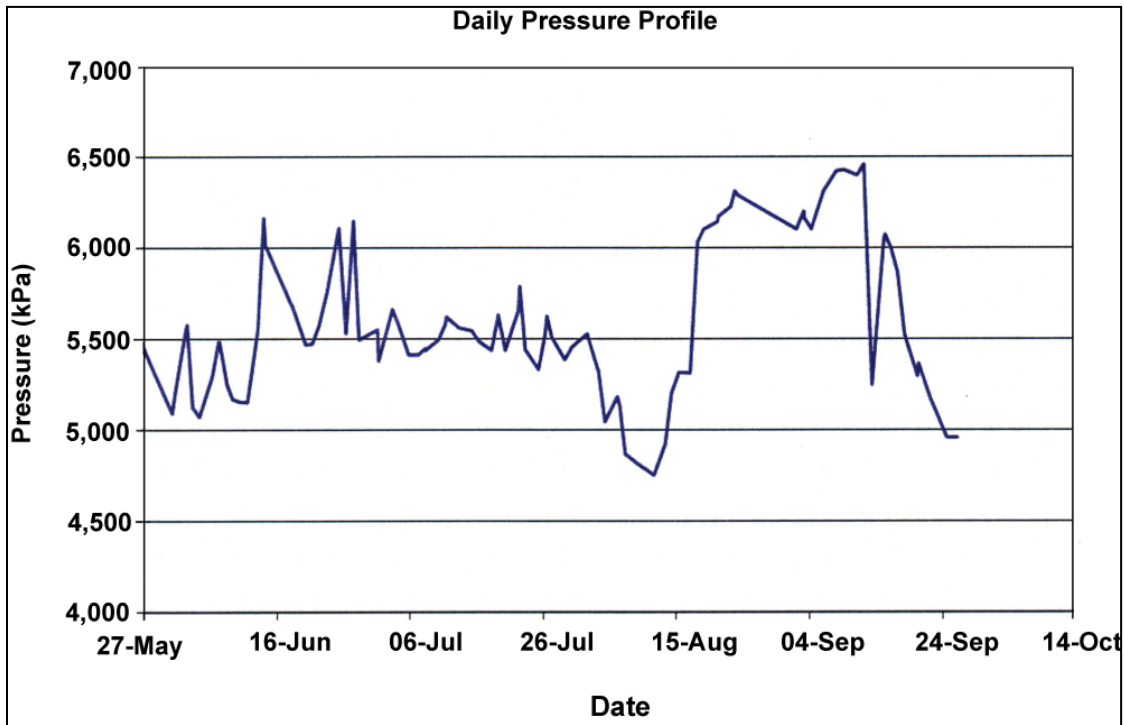
A review of the SCADA trend logs for compressor stations 110 and 112 indicated that, in the 5 months prior to the occurrence, no unusual operating event had taken place in this section of the pipeline (see Figure 5).

Figure 5. Line 100-1, daily operating pipeline pressures for the preceding 5 months.

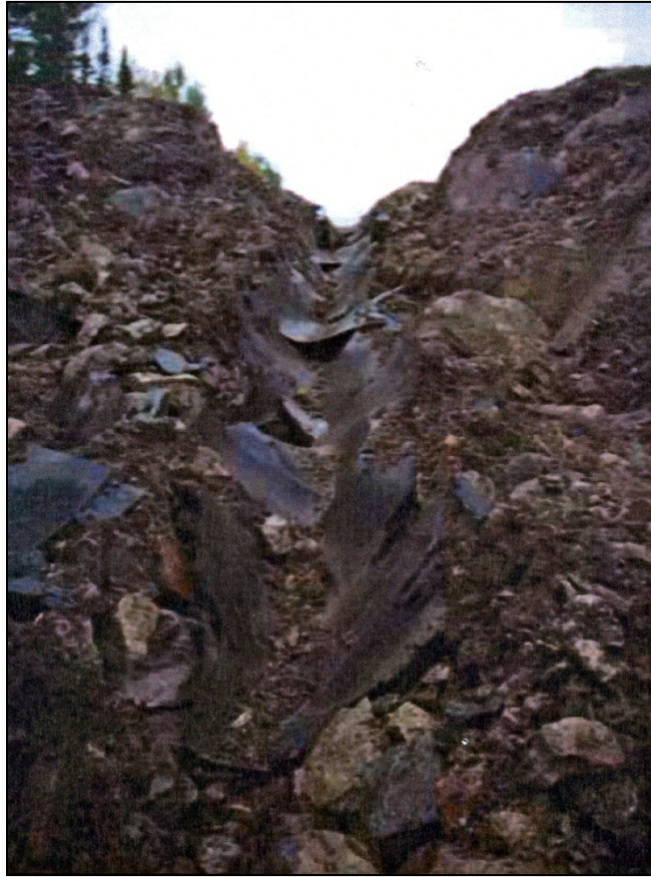
The exterior of the pipe at the occurrence site was coated in asphalt enamel. The exterior coating in the area where the pipe failed showed evidence of poor condition and extensive exterior coating disbondment (see Photo 5).

Photo 5. Line 100-1, disbonded exterior coating found in the ditch after the rupture.
