**PIPELINE INVESTIGATION REPORT
P11H0011**

**TRANSCANADA PIPELINES LIMITED
914.4 -MILLIMETRE-DIAMETER PIPELINE
LINE 100-2 - MLV 76-2 + 09.76 KM
NEAR BEARDMORE, ONTARIO
19 FEBRUARY 2011**

Natural Gas Pipeline Rupture

Report Number P11H0011

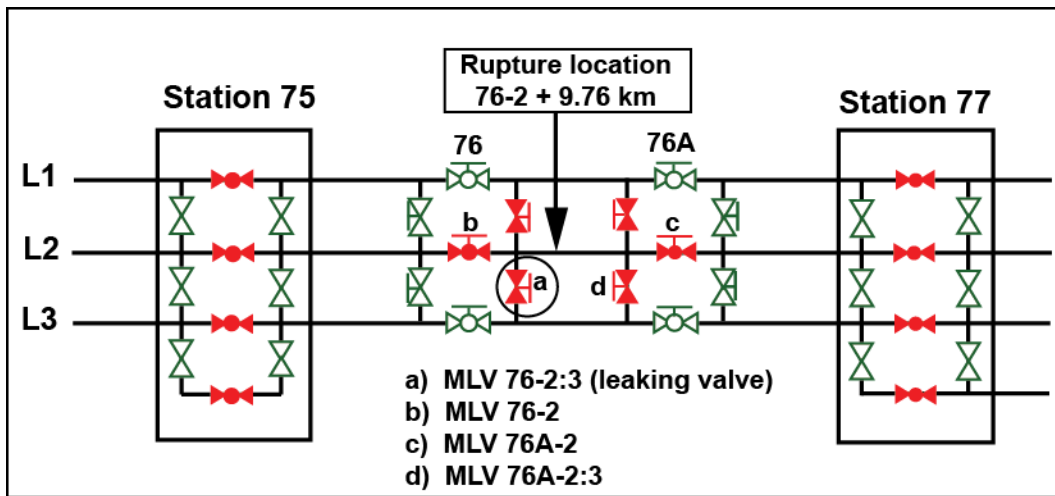
- At 0158 on February 20, the fire was still burning. It was determined that the normally-closed cross-over valve MLV 76-2:3 had not sealed properly, allowing gas to pass into the isolated section of Line 100-2 between MLV 76 and MLV 76A.

Figure 4 - Schematic of pipeline failure relative to compressor stations and valves (red = closed valve; green = open valve)

- At 0505 on February 20, to stop additional gas from leaking into Line 100-2 and fuelling the fire, TransCanada started isolating and evacuating Line 100-3 between MLV 76 and MLV 76A.

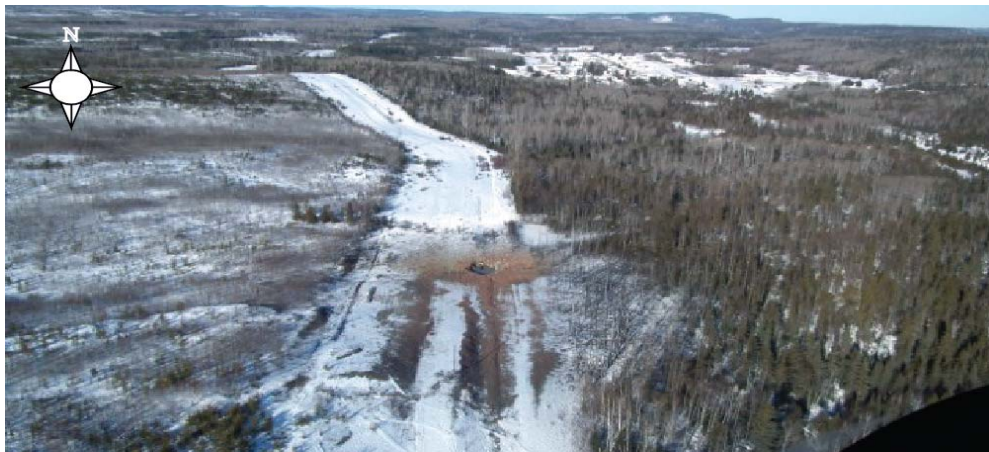
Subsequent to the company's initial survey, the company and the TSB undertook a detailed site examination. Three pieces of pipe had separated from the pipeline as a result of the rupture. One wrinkled pipe segment was ejected during the explosion and was found approximately 100 m north-east. The other two segments of pipe were found near the occurrence ditch to the north-east and to the south-east of the failed pipeline (Photo 1).

Photo 1. Aerial photo of the occurrence site with town of Beardmore, Ontario in the background.

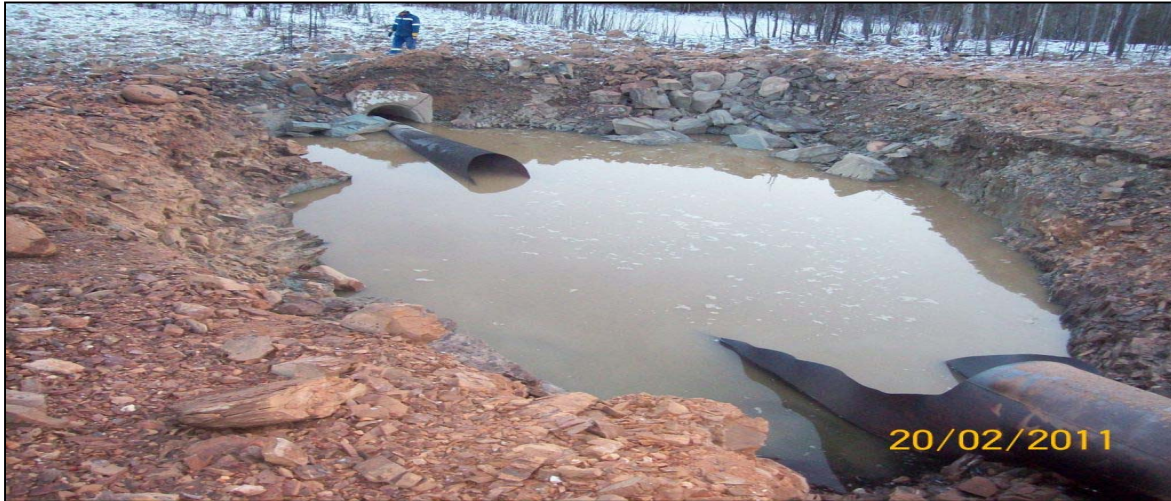
The ruptured pieces of pipe were sent to the Acuren Group Inc. Laboratory in Edmonton (the laboratory) for metallurgical analysis. Short portions of the pipeline still in place, which contained the downstream fracture arrest (Photo 2) and the upstream fracture arrest (Photo 3), were cut off and sent to the laboratory.

Photo 2. Downstream line-break section of Line 100-2 (top of photo)

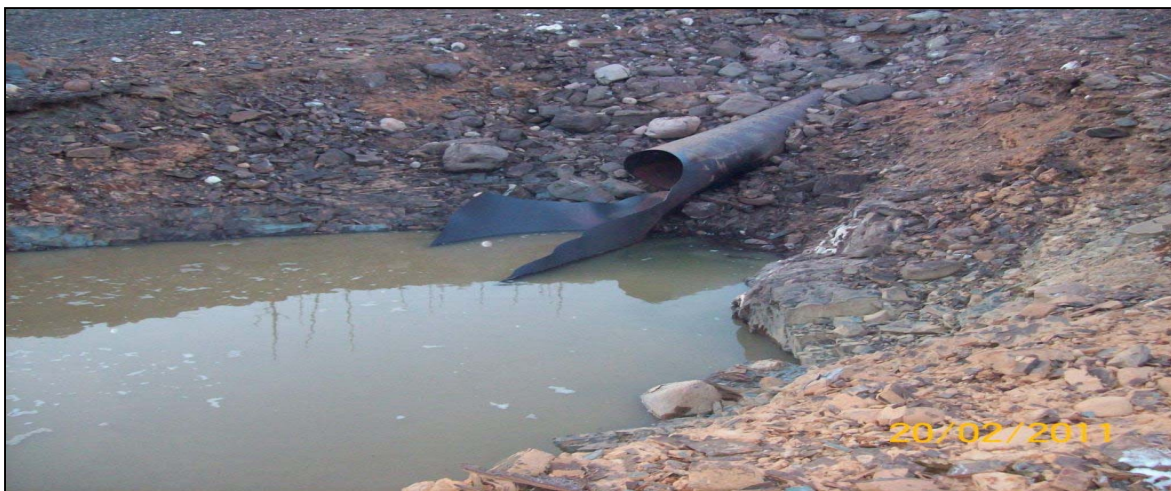
Photo 3. Upstream line-break section of Line 100-2

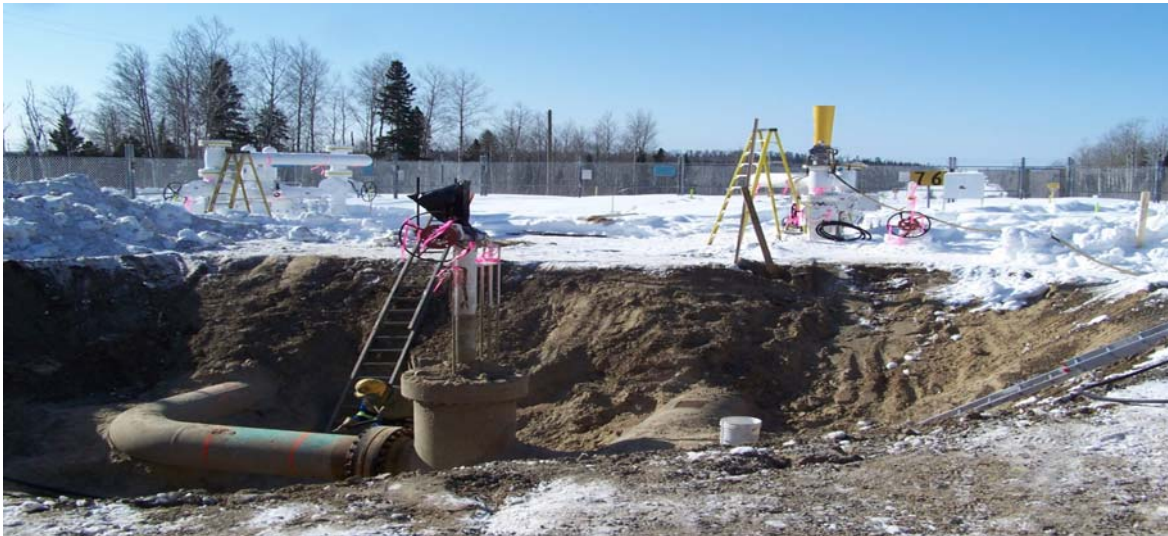
MLV 76-2:3 was found on site in its normal closed position. Before the occurrence, TransCanada had been aware that this valve was leaking internally, but not that the valve had been previously over-travelled.³ The over-travel resulted in damage to the valve seat, which allowed natural gas to leak.

Photo 4. Cross-over valve and associated piping between lines 100-2 and 100-3

While TransCanada personnel addressed the issue of natural gas leaking through MLV 76-2:3, Line 100-3 remained out of service. To address this leak, specialized grease was injected into the cross-over valve MLV 76-2:3. MLV 76A-2:3 was also greased. On February 22, the restart of Line 100-3 was aborted when natural gas was again detected to be leaking through MLV 76-2:3. Line 100-3 between MLV 76 and MLV 76A was then shut down, isolated and evacuated to stop additional gas from leaking into Line 100-2. TransCanada installed another valve and blind flanges to isolate Line 100-3 from Line 100-2 at the cross-over valve MLV 76-2:3 (Photo 4). At 0900 on February 25, after confirmation that there were no additional leaks, Line 100-3 was returned to normal gas service. On February 27, TransCanada resumed its normal gas delivery services via lines 100-1 and 100-3.
