**PIPELINE INVESTIGATION REPORT
P12H0103**

**WESTCOAST ENERGY INCORPORATED, CARRYING ON
BUSINESS AS SPECTRA ENERGY TRANSMISSION**

**IGNITION AND FIRE IN ISOLATION VALVE MOV-0409
ENCLOSURE**

**COMPRESSOR STATION N4
NEAR WONOWON, BRITISH COLUMBIA**

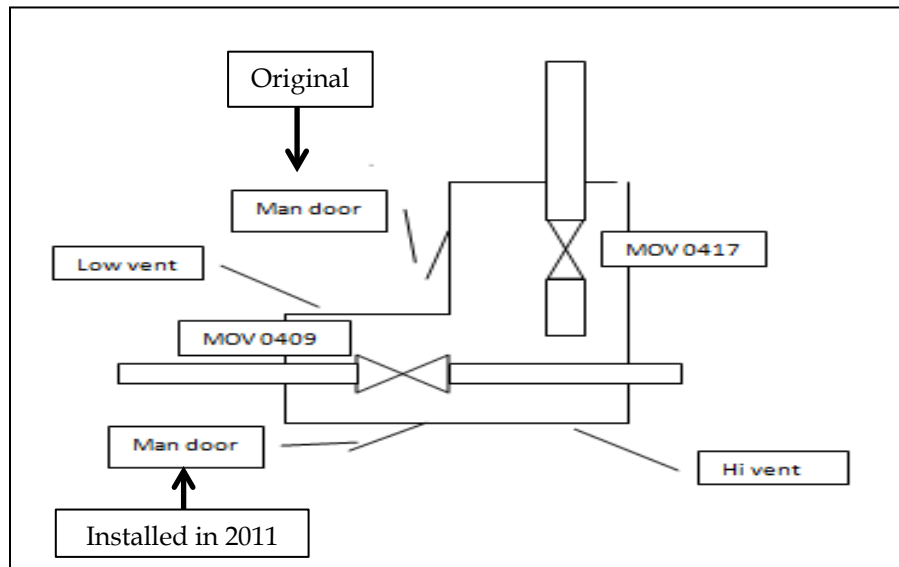
In 1993, MOV-0409 and MOV-0417 (in operation since the 1960s) were enclosed within weather protection enclosure structures. The 2 enclosures shared a common wall, with an opening to allow inside access between the enclosures (Figure 3). MOV-0409 controls the 91.44-cm (36-inch) loop discharge pipeline, and MOV-0417 controls the emergency blow-down pipeline for the compressor station. MOV-0409 and MOV-0417 are both equipped with 130 volts-direct-current (VDC) motor operators, enclosed within the limit-switch housing. There is no other electrical equipment in these enclosures. Under normal operating conditions, MOV-0409 is left in the fully-open position, meaning that high-pressure gas will flow through the valve unobstructed. If an emergency shutdown sequence occurred at the compressor station, MOV-0409 would move to the fully-closed position automatically. The maintenance work on MOV-0409 required the line to be pressurized.

Figure 3. Schematic of enclosure structure for MOV-0409 and MOV-0417 (Source: GC Phillips report)

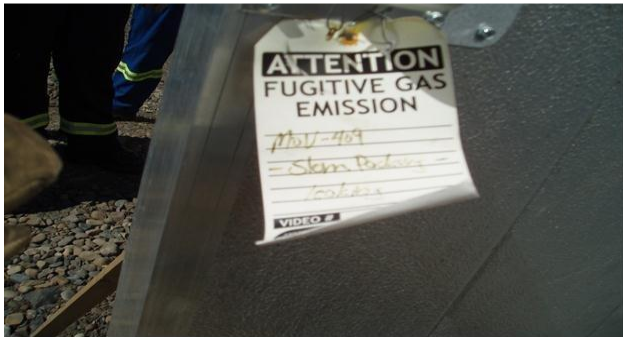
- Fugitive gas emissions 1 (FGEs) were surveyed and quantified at MOV-0409. (Note: Leaks had been detected from MOV-0409 since 2006 and tracked for at least the last 10 months.)
- A FGE tag (Photo 1) was affixed to the single entrance (i.e., man-door) to the combined enclosure structure located in the enclosure section for MOV-0417.

Photo 1. Fugitive gas emission (FGE) tag for MOV-0409

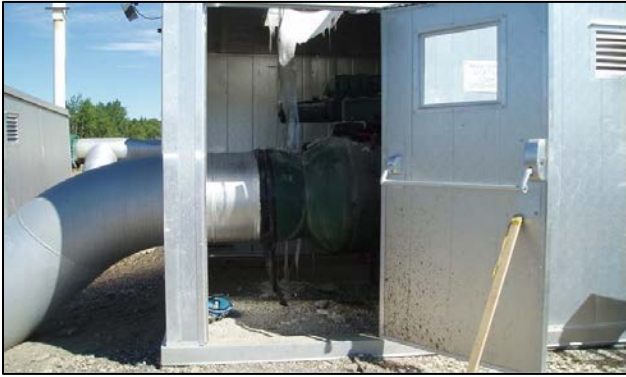
- Attempts were made to stop the stem leak by injecting high-pressure grease into the valve stem seal cavity.
- The tattle-tale vent (TTV) was replaced with a bull plug, in an attempt to minimize gas leakage into the enclosure structure.
- The FGE was recorded in the Spectra's malfunction notification system. As the repair required the valve and associated pipeline to be purged of gas, the repair was deferred until the next annual shutdown of CS-N4.
- An egress door was added to the MOV-0409 enclosure. This door did not include an air-quality testing port (Photo 2).

Photo 2. Egress door for MOV-0409 enclosure

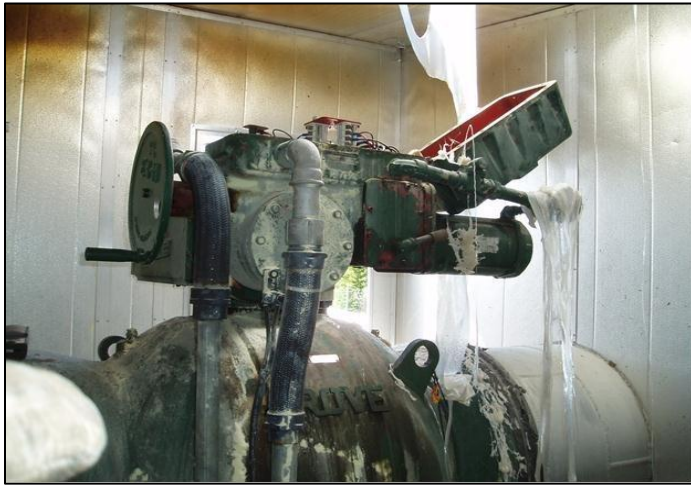
- SP-1 moved on to the MOV-0409 enclosure structure, and entered using the south man-door. The sound of escaping gas was apparent on entering the enclosure. (Note: SP-1 had occasionally worked around escaping gas, and consequently, the sound of escaping gas alone was not a deterrent to entering the enclosure.)
- SP-1 approached the valve, climbed up onto a concrete block that facilitated access to the valve operator, and started the inspection.
- SP-1 raised the operator cover to observe the action of the torque switches, while pushing the buttons located on the outside face of the cover (Photo 3).

Photo 3. MOV-0409 with operator cover fully open

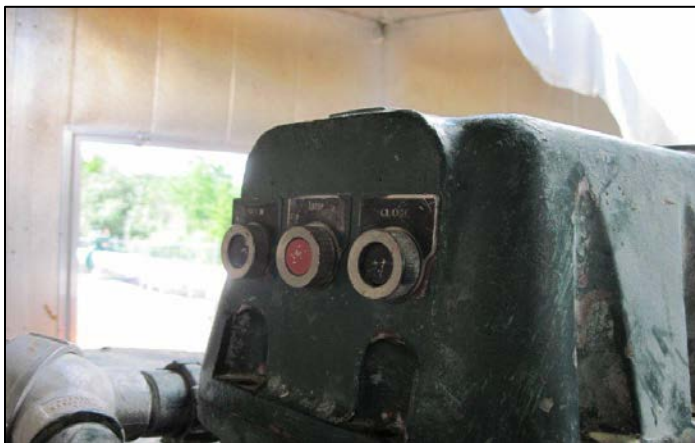
- Upon noticing an increased presence of gas, SP-1 closed the operator cover, and pressed the STOP button followed by the CLOSE button (Photo 4).

Photo 4. Manual control switches

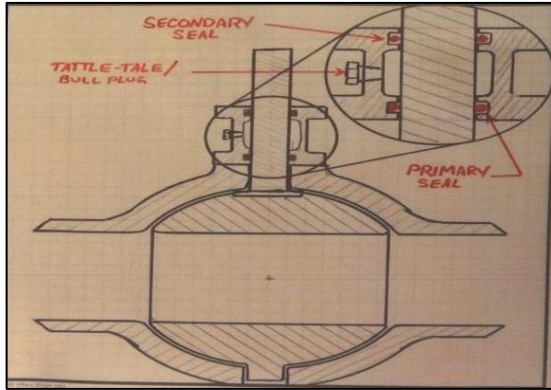
Figure 4. Schematic of MOV-0409, illustrating stem seals (Source: GC Phillips report)

1. The accident occurred when escaping natural gas from a leaking valve stem found an ignition source and ignited.
2. The valve stem was leaking due to the failure of 2 stem-seal o-rings for MOV-0409.
3. Ignition of the natural gas likely resulted when the MOV's close button was activated in an attempt to shut off the increased flow of gas. This action produced a sparking contact within the open electrical housing operator, and ignited the gas.
4. The enclosure structure had not been tested for the presence of gas before the start of the work, and the Spectra employees were not wearing personal gas detectors.
5. The work plan did not display the pre-existing hazard (i.e., FGE) associated with MOV-0409, resulting in a maintenance plan that did not address how the work was to be performed in the context of a leaking valve.

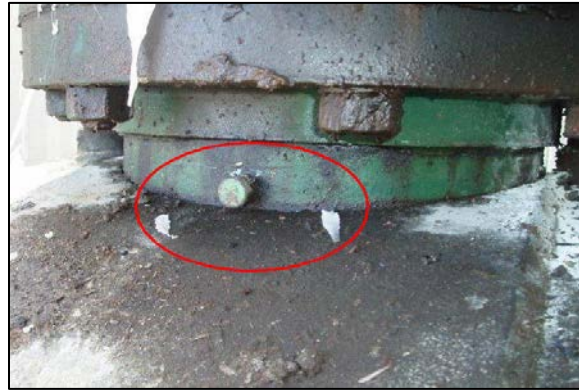
Figure 5. Bull plug installed on MOV-0409

- The absence of specific risk-assessed standard operating procedures, resulting in maintenance technicians developing procedures from a variety of procedural and manufacturer documents (e.g., TTV replaced with BP, removal of the limit-switch housing cover bolts while the equipment was energized).

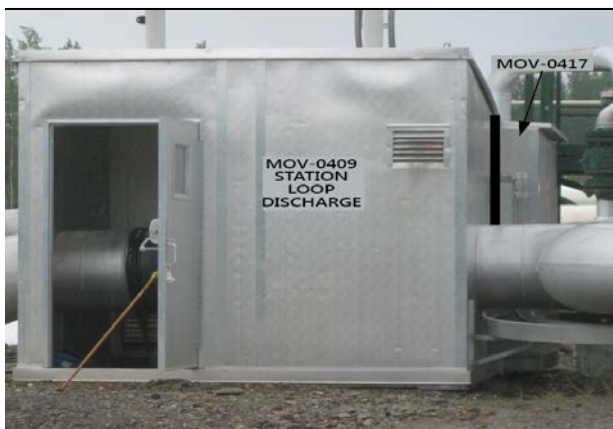
Figure 7. Upper passive-venting port

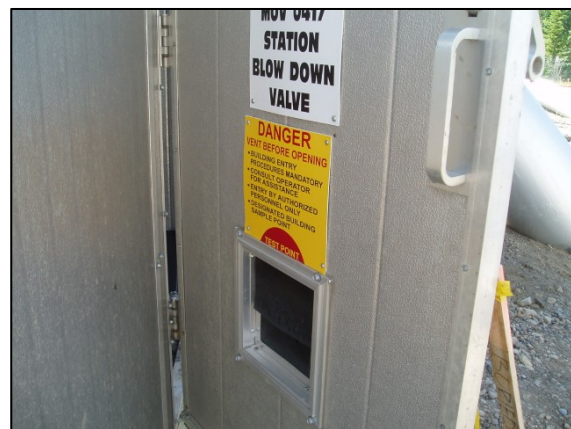
When the enclosure structure was originally constructed, access to MOV-0417 and MOV-0409 was through a single-entry door to MOV-0417. Within the enclosure structure for MOV-0409, an air-inlet vent had been installed low to the ground, and an exhaust vent had been installed approximately 1 m (3 feet) below the roof of the building (Figure 7). In 2006, the man-door to MOV-0417 was equipped with an air-quality testing port and associated signage (Photo 5).

Photo 5. Air-quality testing port and associated signage

3. A fugitive emission survey (FES) process has been developed and will take place before a major facility outage.
4. All valve enclosures on the transmission system have been audited, and deficiencies in internal-atmosphere test ports and required signage have been corrected.
