PIPELINE TRANSPORTATION SAFETY INVESTIGATION REPORT P18H0088

Pipeline rupture and fire

Westcoast Energy Inc.
36-inch transmission south mainline loop
Kilometre post 29.838
Prince George, British Columbia
09 October 2018

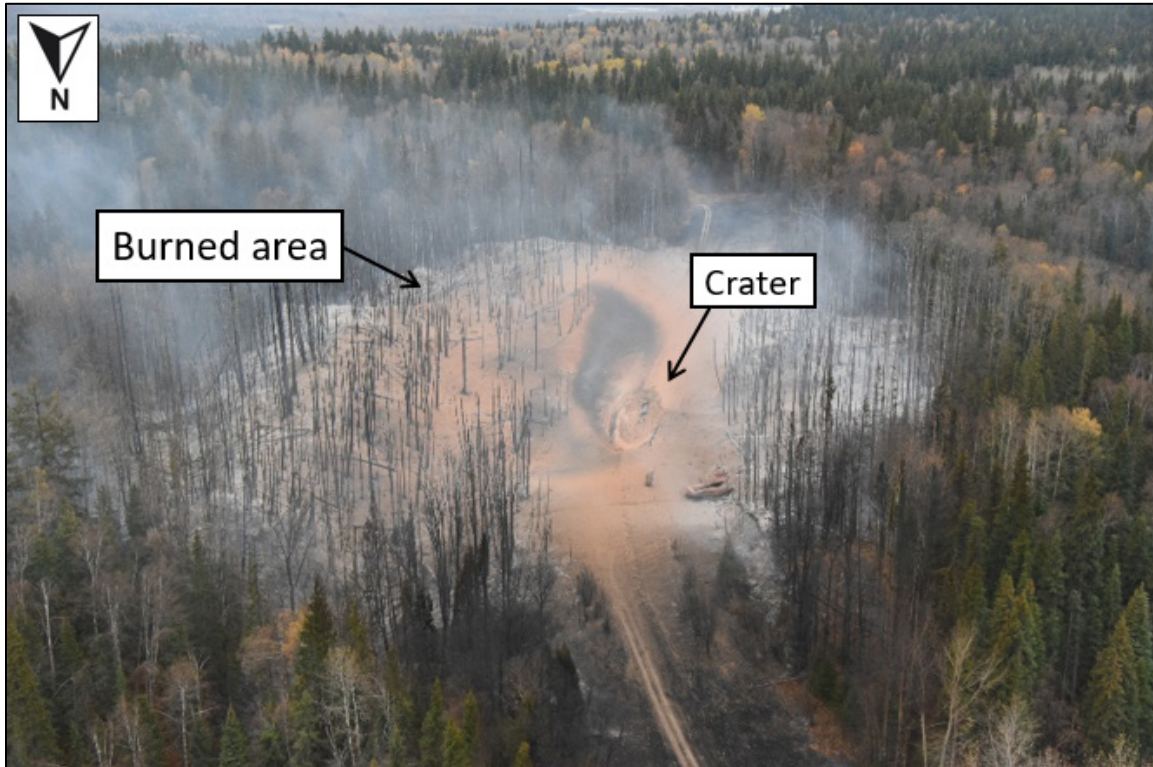
The area affected by the fire that resulted from the pipeline rupture covered about 52 000 m² (Figure 4).

Figure 4. Aerial view of the area affected by the fire that resulted from the pipeline rupture (Source: RCMP, with TSB annotations)

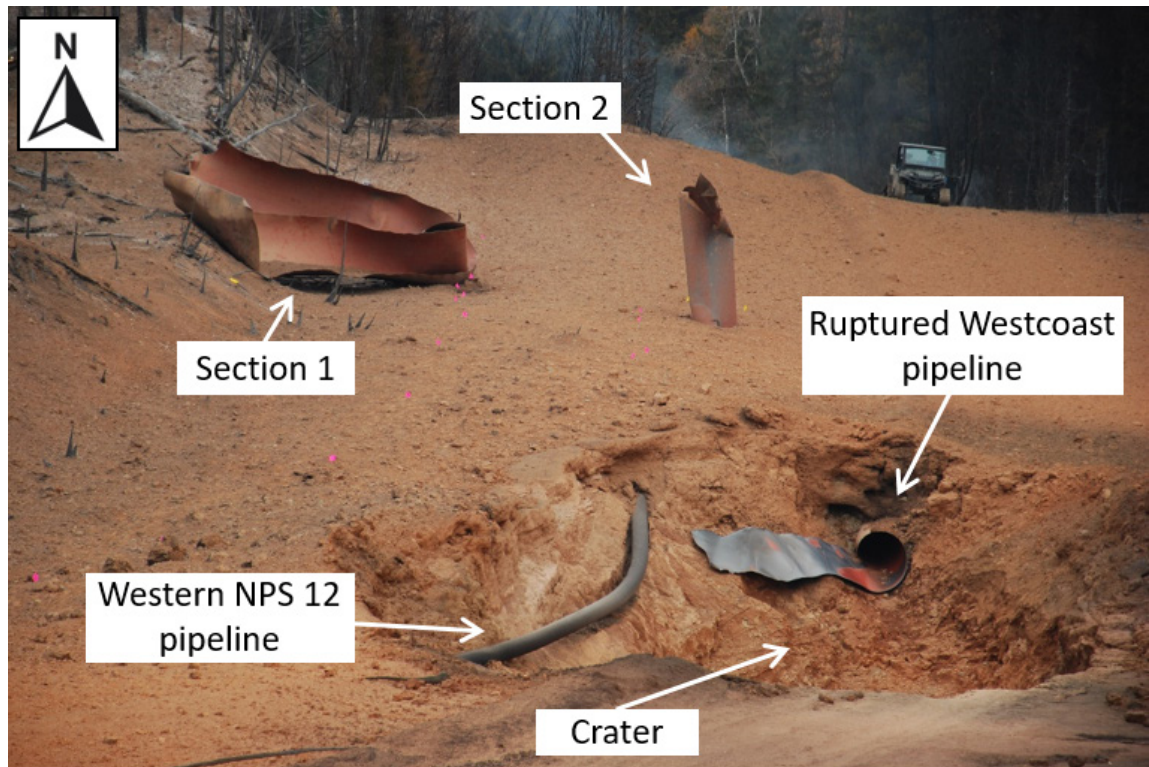
Two large sections of pipe were ejected from the crater (Figure 5).

Figure 5. Sections of pipe ejected from the crater as a result of the rupture (Source: TSB)

One section (labelled as section 1 in Figure 5) was split open longitudinally, formed a U shape, and landed about 25 m northwest of the north end of the crater, over the unexposed NPS 30 L1 pipeline. A second section (labelled as section 2 in Figure 5) was cylindrical in shape, slightly compressed, with the appearance of tearing at the end. This section landed upright 18.5 m north of the north end of the crater, east of the Western NPS 12 pipeline. A portion of section 2 was embedded in the ground.

No coating was observed on the ejected sections of pipeline; this was likely due to disintegration resulting from exposure to heat from the fire.

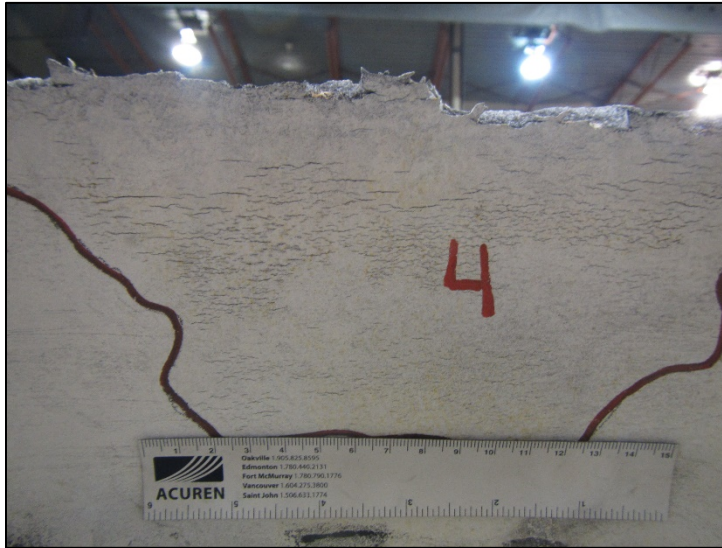
Using magnetic particle inspection, numerous indications consistent with colonies of stress corrosion cracking (SCC) were present on the outside surface of the examined pipe sections (Figure 7).

Figure 7. Stress corrosion cracking colony near the fracture surface from a ruptured section of pipe (Source: Acuren)

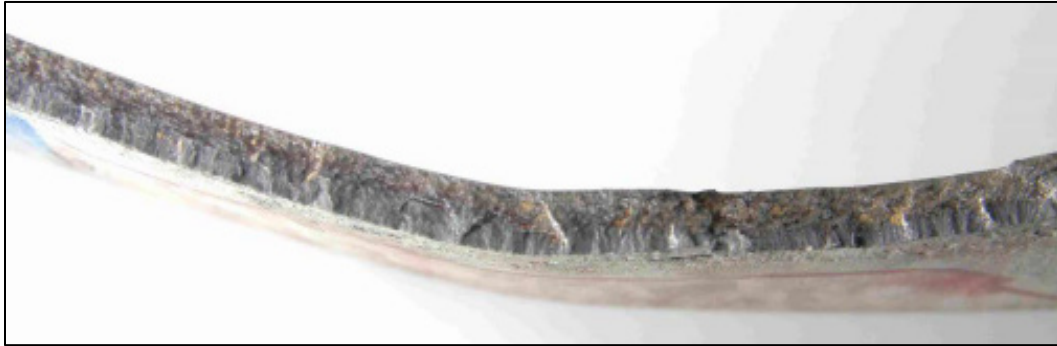
The rupture originated at stress corrosion cracks on the outside surface of the pipe. The cracks grew over time due to a near-neutral pH environment combined with operating stresses and eventually coalesced into a larger single crack. This reduced the load-bearing capacity of the pipeline steel until the critical crack size was exceeded and an instantaneous overstress fracture of the pipe occurred at normal operating pressures. The crack characteristics were consistent with near-neutral pH SCC (Figure 8).

Figure 8. Interacting cracks shown on a portion of section 1 of the ruptured pipe (Source: Acuren)
