RAILWAY INVESTIGATION REPORT

R01D0097

DERAILMENT

CANADIAN NATIONAL TRAIN Q-137-11-28

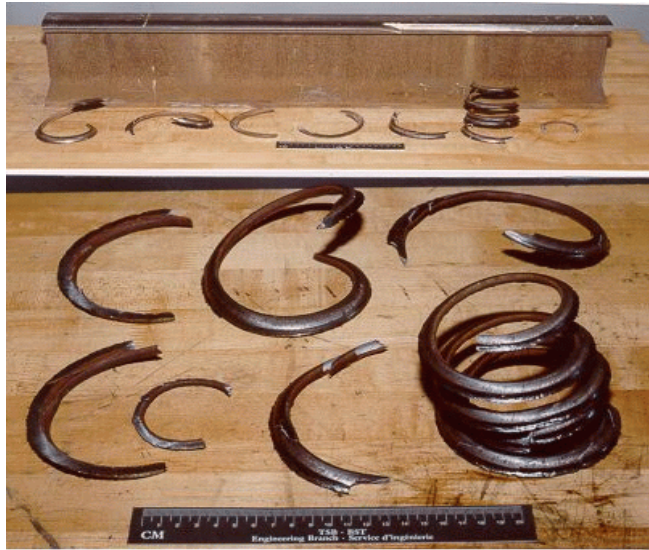
The derailment occurred in a curve that veers 8.29 degrees to the right (relative to the direction in which the train was moving). Examination of the track revealed that between Mile 1.50 and Mile 1.67, the flow lip on the gauge side of the north rail (the low rail in the curve) had been sheared off, forming spiral curls of rail material of various lengths (see Figure 1). At Mile 1.67, the end of the curve, there were witness marks 28 cm (11 inches) in length along the rail surface (see Figure 2) and narrow gashes in the wood ties. The pile-up of cars was located approximately 2000 feet west of the marks on the rail.

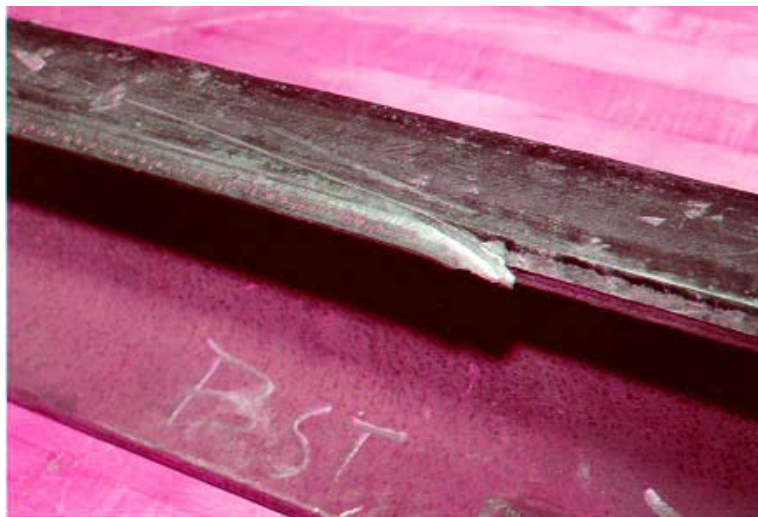
The TSB Engineering Laboratory examination (Report No. LP 71/01) showed that there was a flow lip up to 12 mm thick on the gauge side of the railhead. There was no flow lip on the field side of the rail.

This section of rail consisted of 132-pound continuous welded rail, manufactured by Algoma Steel in 1971. The rails were transposed<sup>2</sup> in 1999, however their installation date is unknown. The sum of the vertical and lateral wear was 27 mm (1 1/16 inches), thus exceeded the 22 mm (7/8 inch) limit specified in Canadian National's (CN's) *Standard Practice Circular* (SPC) 3200.

In the present case, the flow lip was not removed by the traffic, and as a result, the rail had a flow lip measuring up to 12 mm. Consequently, it is likely that this flow lip was already present on the field side of the rail when it was transposed in 1999; however, no corrective grinding was done before or immediately after the transposition to eliminate the flow lip.

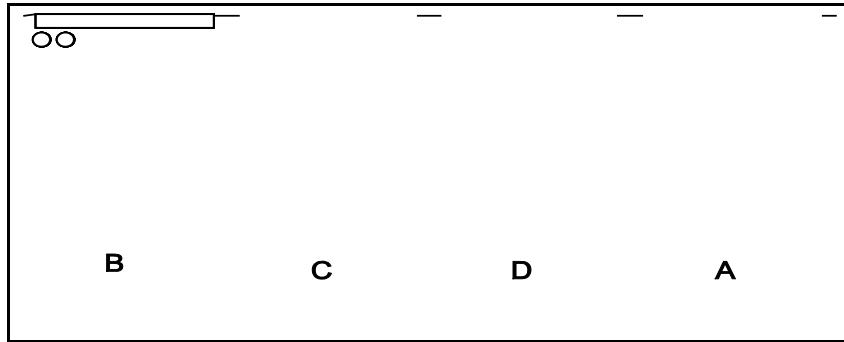
Multi-platform cars consist of up to five permanently coupled platforms, with a conventional coupling system at either end of the group of platforms (see Figure 3). Conventional couplings are designed in such a way as to allow the lateral movement of the different cars when travelling through curves, and to absorb compression and

traction forces between the cars during the train's normal operation. The couplers between platforms on a multi-platform car consist of articulated couplers or bars that remain much more rigid when travelling through curves than do conventional coupler systems.

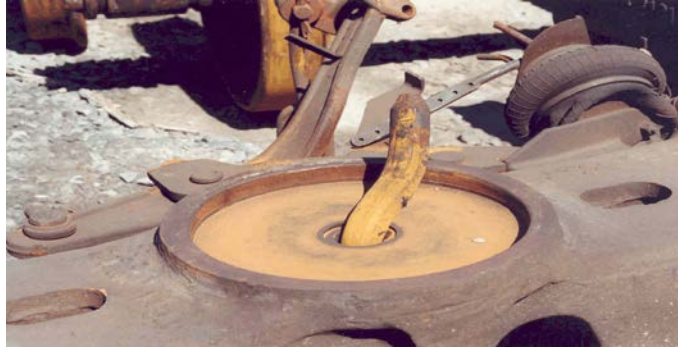
The body (male) centre plate and the truck (female) centre plate of truck D on the platform in question showed signs of abrasion and wear. The centre pin was bent but had remained in place (see Figure 4).

The body centre plate is seated into the truck centre plate, to which it is secured by means of a centre pin measuring approximately 45 mm in diameter, which passes through a hole measuring 54 mm in diameter. The body centre plate is free to move vertically, relative to the truck centre plate, but is held in place horizontally by the truck centre plate crown. The body centre plates may be raised slightly and moved when containers are being unloaded; consequently, if a body centre plate is raised higher than the crown of the truck centre plate (38 mm), the body centre plate and the truck centre plate may become uncoupled, due to the play around the centre pin.

The wear and abrasion noted on the body centre plate and the truck centre plate of truck D of platform C on car DTTX 25335 indicate that, most likely, the platform had been lifted, causing the body centre plate to uncouple from the truck centre plate. They were held together, however, by the centre pin, which remained in place. When the body centre plate is not properly seated in the truck centre plate or when the truck's movement is limited due to insufficient lubrication, the truck can no longer turn freely to negotiate curves, thus causing hard wheel contact against the low rail. Moreover, the flanges of the wheels on the north side of truck D exhibited a vertical wear and a flange height that were close to the upper limits allowed by the AAR *Field Manual*; this further increased hard wheel contact against the rail.

Posters showing cars improperly placed on trucks have been posted in areas frequented by certified car inspectors to encourage them to pay closer attention to the truck's condition and, in particular, to the position of the body centre plate and the truck centre plate.

CN has issued a directive indicating that any car lifted by means of a crane during the unloading process must be inspected before it departs, failing which, it is to be taken out of service. This directive applies even if the car seems to have been properly reseated in the truck centre plate. The inspection must include a check to ensure that the centre pin is still in position. Any irregularity observed by inspectors must be recorded in a log.
