RAILWAY INVESTIGATION REPORT

R02C0022

MAIN-TRACK COLLISION AND DERAILMENT

CANADIAN PACIFIC RAILWAY
TRAIN 671-038 AND TRAIN 177-24
MILE 26.9, MOUNTAIN SUBDIVISION
GLENOGLE, BRITISH COLUMBIA
24 MARCH 2002

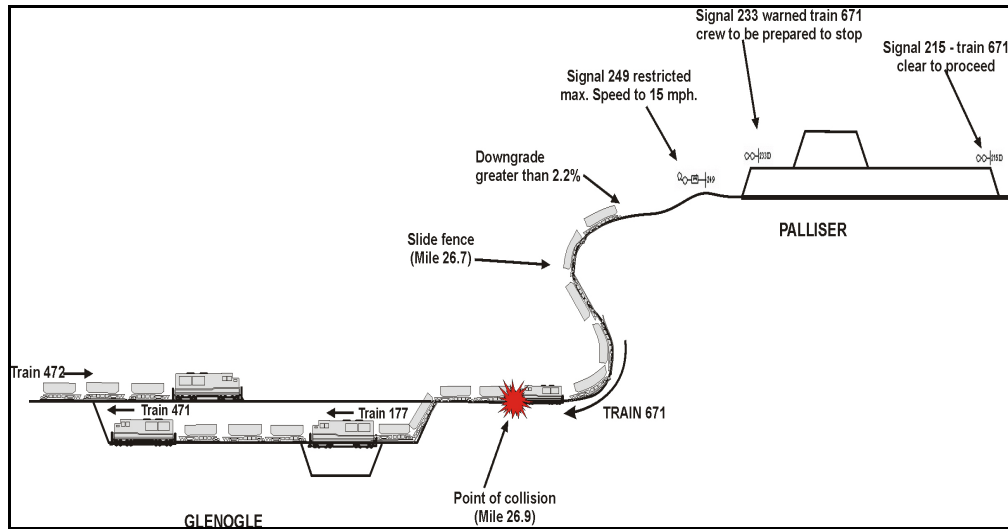
Train 177 consisted of 2 locomotives, 42 loads, weighed 4130 tons and was 6286 feet in length. Train 177 was stationary with its head end portion in the siding at Glenogle and the rear portion extending onto the main track to Mile 26.9.

Train 471 consisted of 2 locomotives, 6 loads, 65 empties, weighed 2250 tons and was 4854 feet in length. Train 471 was stationary with its head end at the west end of the Glenogle siding and the rear portion extending to the middle of the siding.

Figure 1. Sketch showing position of trains and signals
