RAILWAY INVESTIGATION REPORT

R02D0113

MAIN-TRACK DERAILMENT

HIBBARD, QUEBEC

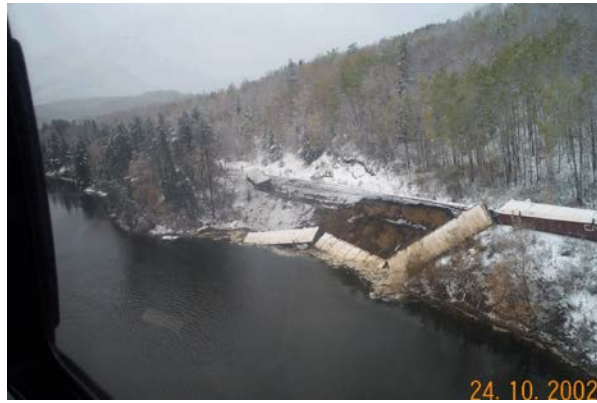
The lead locomotive stopped at Mile 87.58. The first derailed car (102nd car), gondola car CN 137187, remained upright and coupled to the forward portion of the train. The next five cars uncoupled, and three of them descended the track embankment and came to rest at the edge of the lake beside the track (see Photo 1). The derailed cars were damaged and 275 m of track was destroyed. A dike was set up around the derailed cars to recover the ore and clean up the accident site.

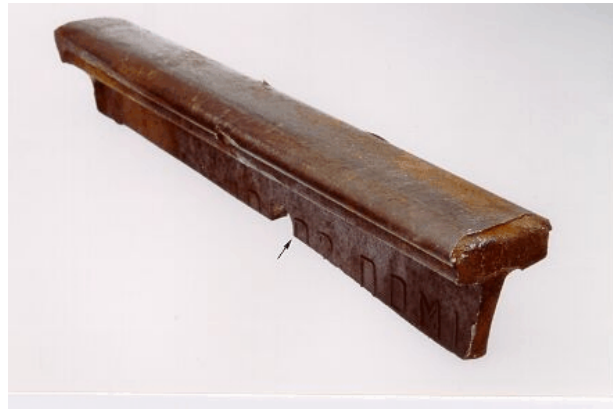
The first piece of rail had a longitudinal fracture in the web running through an old splice bar bolt hole drilled through the rail web and intersecting the **COC** of the rail markings (see Photo 2). The hole showed no abnormal wear or ovalization, and its edges were not chamfered. Metallurgical analysis of one section taken from the edge of the hole revealed decarburization of the metal surface. The fracture surface was relatively flat and uniform. It revealed grain deformation and sub-surface cracking consistent with long-term pounding wear.

Laboratory testing revealed that cracks originated on either side of the splice bar bolt hole and propagated longitudinally through the rail web. Decarburization of the rail around the splice bar bolt hole indicates that heat was applied to the metal during the hole drilling process. Further, the splice bar bolt hole intersected the rail markings, and the edges of the hole were not chamfered. Consequently, the hole presented a site for mechanical and metallurgical stress raisers and contributed to the initiation and propagation of cracks.

1. The south rail failed as the train rolled over it, causing the cars to derail.
2. The longitudinal fracture in the rail was present for some time, and originated at a splice bar bolt hole that acted as a stress raiser, since it intersected rail markings, its edges were not chamfered, and it had been heated in the drilling process.

CN's SPC 1303 recommends that rails with holes be sawn when jointed rail is converted to CWR, because leaving unused bolt holes in CWR is not recommended due to stress raisers and the risk of cracking inherent in this structural detail. The south rail was laid temporarily with splice bar bolt holes present because the risks were not considered immediate since the holes had been present at the Turcot Yard.

In June 2003, Canadian National adopted a new policy requiring that partly worn rail be ultrasonically inspected for internal defects if it is to be laid on Class 3 tracks or higher, including plug rails. If the inspection is not done before the rail is installed, the rail must be degraded to Class 2 until the inspection is completed.
