**RAILWAY INVESTIGATION REPORT**  
**R04W0148**

**NON-MAIN-TRACK TRAIN DERAILMENT**

**CANADIAN PACIFIC RAILWAY**  
**FREIGHT TRAIN 494-05**  
**MILE 0.01, BROMHEAD SUBDIVISION**  
**ESTEVAN, SASKATCHEWAN**  
**08 AUGUST 2004**

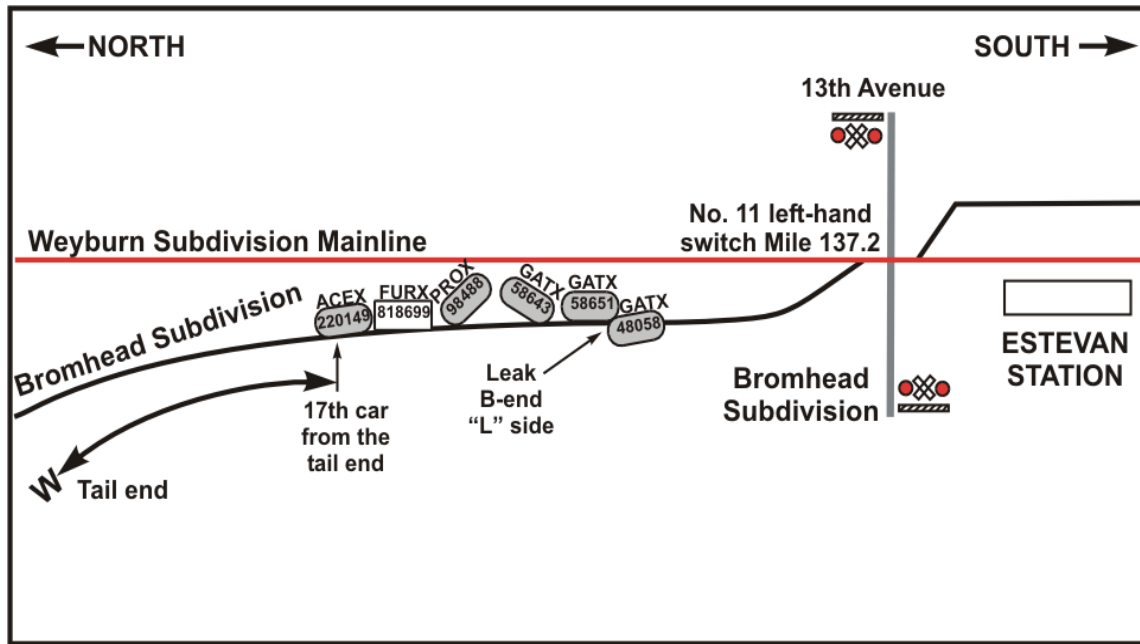
Figure 2. Derailment site diagram

Five of the six derailed cars were pressurized tank cars loaded with anhydrous ammonia; the other car was a covered hopper car loaded with urea. At the west end of the derailment, the first two derailed cars were tank car ACFX 220149 and covered hopper car FURX 818699, respectively. Both cars derailed all wheels, but remained upright. They were sent to Moose Jaw for further examination. The following three derailed tank cars remained coupled together and came to rest on their sides lying to the north side of the track. At the east end of the derailment, the last derailed tank car, GATX 48058, with the B-end leading, came to rest leaning to the south. The car had sustained impact damage to the B-end tank head, and a small amount of product was released to the atmosphere. The remaining product was safely transferred from the car at the site, and the damaged car was sent to Moose Jaw for inspection.

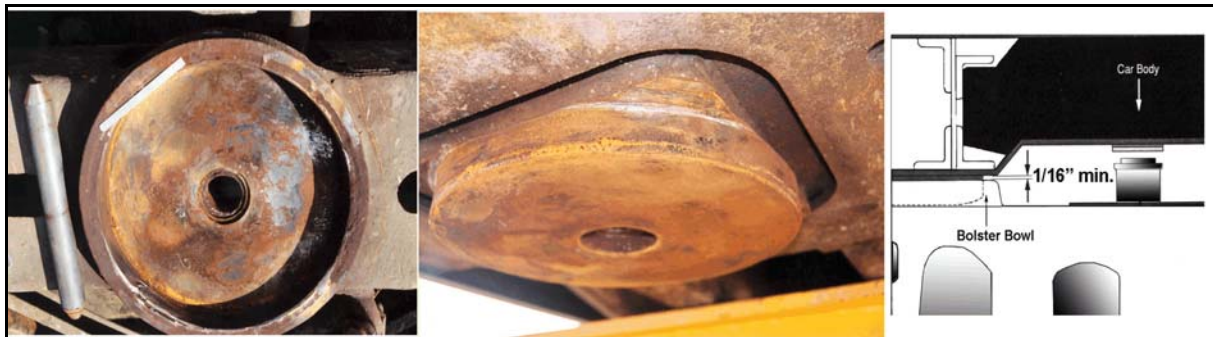
CPR and the TSB conducted a mechanical tear-down inspection of the first two derailed cars, ACFX 220149 and FURX 818699. While no defects were identified in car ACFX 220149, the inspection of car FURX 818699 revealed a number of defective and worn truck components. In particular, the B-end car body centre plate was dry, oxidized, and binding on the truck bolster rim. The contacting surfaces of the body centre plate were smeared and gouged. In addition, both side bearings were tight, and three of four bolster gibs, as well as the L-1 and R-1 bolster friction pockets, were worn to condemning limits (see Appendix A). The TSB identified five train accidents in the previous 18 years in which binding car body centre plates were contributory factors.

**Photo 2.** The truck bolster rim on car FURX 818699 was worn at four locations. The wear on the corners of the matching car body centre plate corresponded to the bolster rim wear. The sketch indicates the clearance between the two.

While negotiating a curve, lateral forces generated by a properly performing truck will not exceed the lateral restraint capacity of adequately secured rail. However, when freight car and truck defects that restrict truck rotation and facilitate truck warp are present, the wheel flange angle of attack is increased, and higher-than-usual truck-side lateral forces are generated in curves. Binding centre plates, tight side bearings, and truck components worn to condemning limits are defects that increase truck rotational resistance and warp. Since these defects were present on car FURX 818699, it can be concluded that the B-end truck induced higher-than-usual lateral forces on the south rail as the car negotiated the turnout curve.

The binding centre plate on the B-end of car FURX 818699 was a defect that had existed for some time. Although this condition required immediate attention, it remained undetected despite a number of inspections that had been performed on the car prior to the derailment. Such defects are supposed to be captured during safety inspections; however, as demonstrated by this occurrence, they are not always identified. The quality and thoroughness of the inspections may be hindered by a number of factors such as car configuration, work environment, and awareness of the inspector.

Acknowledging the human limitations on performing visual inspections, the rail industry is implementing automated inspection technologies. Canadian Pacific Railway (CPR) is currently reviewing options for installing up to two truck performance detectors on its network in the next few years. These detectors are designed to identify defects in freight car trucks similar to those that were present in car FURX 818699.

CPR developed and distributed a "Tech Tip" poster across its system to illustrate what to look for when inspecting freight car centre plates and side bearings. CPR instructed all certified car inspectors to review the poster.

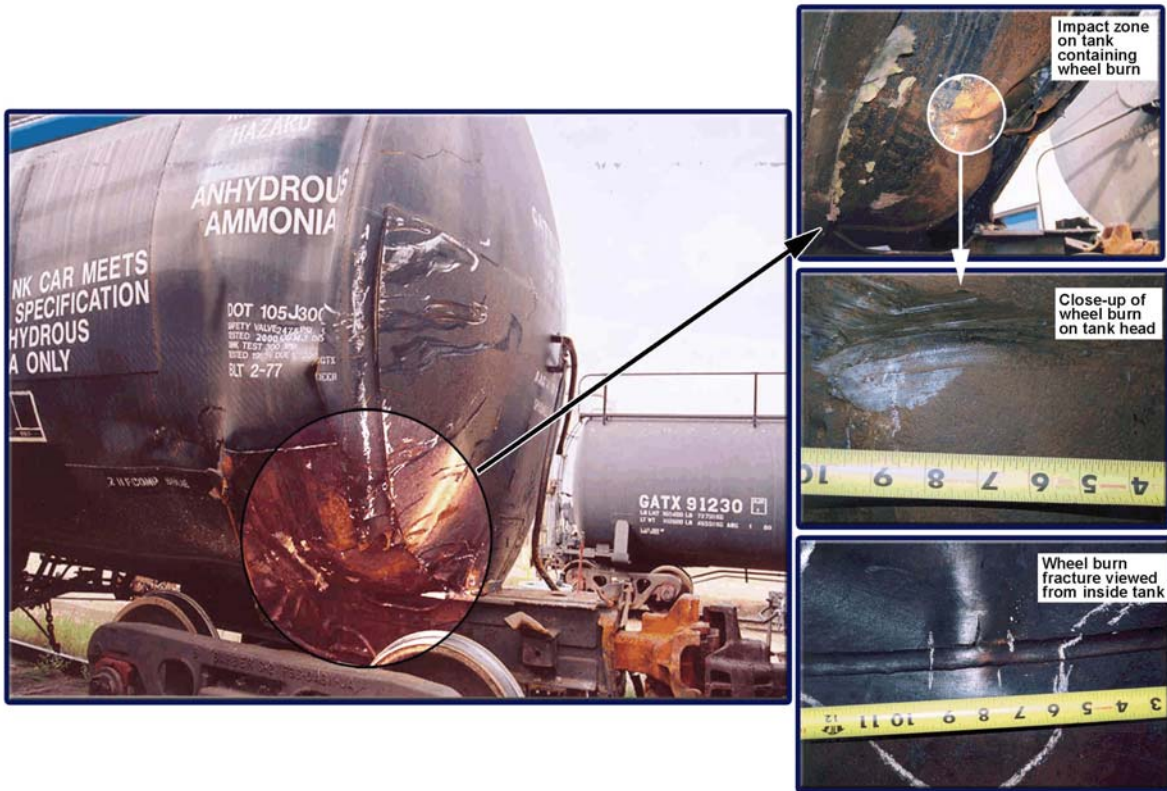
On 15 September 2004, car GATX 48058 was examined at the GATX facility in Moose Jaw. A two-foot diameter dent was observed in the B-end tank head. The lower portion of the dent contained a wheel flange burn that extended into the weld securing the tank head to the body of the tank. The burn measured about five inches long, two inches wide and one inch deep. At the root of the flange burn, a two-inch-long crack extended into the tank head weld area. On the inside of the tank, a one-inch longitudinal crack was visible extending up to the tank head weld. A second crack, perpendicular to the longitudinal crack, had propagated 2 ½ inches along the toe of the weld. The damaged area of the tank car was removed and sent to the TSB Engineering Laboratory for further analysis.

**Photo 3.** Zone affected by impact on B-end of tank car GATX 48058. Note wheel flange burn on tank exterior and a through crack on tank interior.

- The B-end of the tank car sustained a small through fracture as a result of an impact with the flange of a wheel during the derailment. No pre-existing primary or secondary fractures were observed.
- No metallurgical anomalies were observed in the tank head, weld, or shell material. The chemical and tensile properties of the tank car met or exceeded the minimum AAR specifications for TC 128 Grade B steel.
- The tank car head and shell were constructed with a very fine-grained steel (ASTM 10), which provides superior toughness and resists crack propagation.
- The Charpy impact value of the tank car head material was measured at 66.8 foot-pounds at -45.6°C. Testing in previous TSB investigations (R94D0033 and R96M0011) revealed Charpy impact values of 3 to 5 foot-pounds at temperatures between -30°C and -45.6°C, for tank cars constructed prior to 1989.

Tank car GATX 48058 sustained a relatively small fracture and released a minimal amount of product. However, analysis determined that the car was constructed from material that had properties superior to current AAR specifications. The high Charpy impact values and fine-grained microstructure of the tank car steel were characteristic of a material with high impact resistance and toughness. These properties likely played a role in the survival of tank car GATX 48058 and reduced the risk of a more serious tank breach.
