RAILWAY INVESTIGATION REPORT

R05W0014

DERAILMENT

Canadian National
Train L53241 12
Mile 4.55, Letellier Subdivision
Winnipeg, Manitoba
12 January 2005

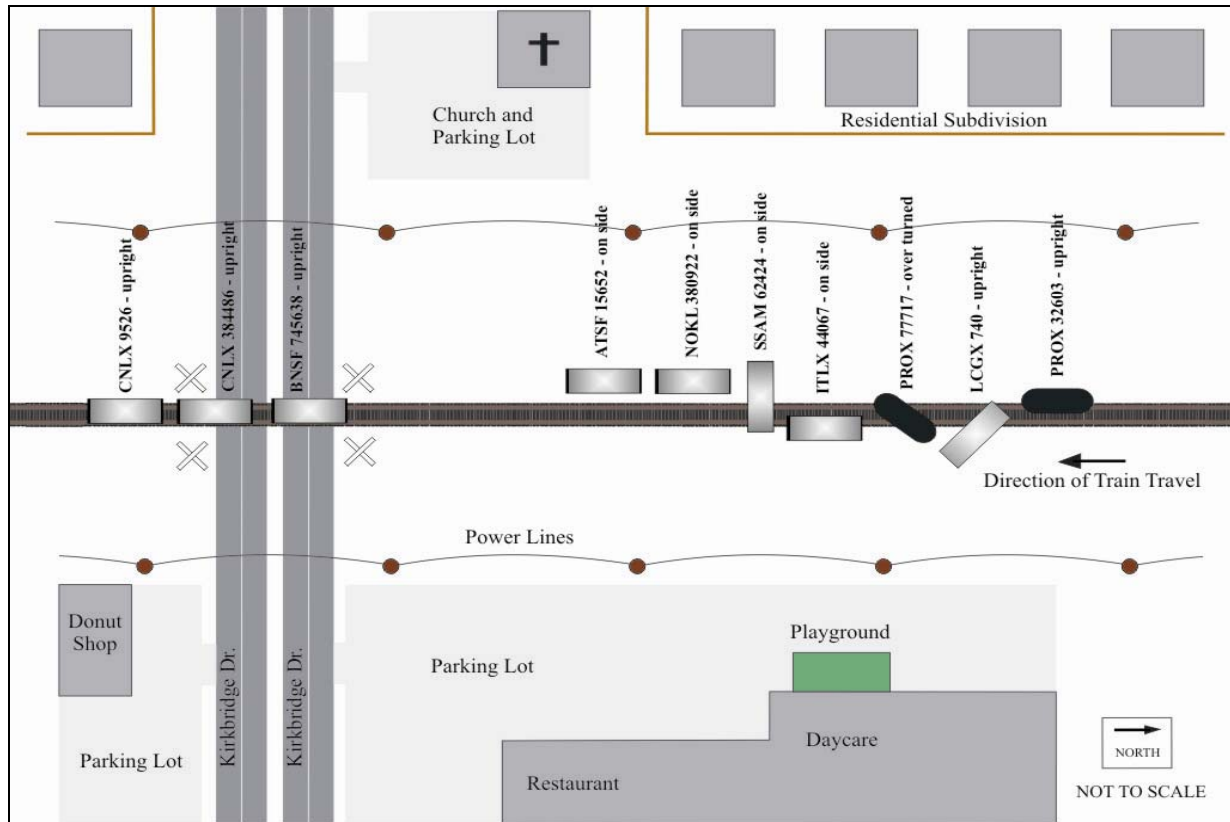
Figure 1. Schematic of the Derailment Site

The locomotive came to rest at Mile 4.64, with the derailed cars in various positions along the right-of-way. Figure 1 shows a schematic of the derailment. The 16th car (CNLX 9526), a loaded covered hopper car, remained upright with the L4 and R4 wheels derailed. Examination of the car determined that pieces of the L3 and R3 roller bearing adaptors had broken away and were missing. The missing pieces were not recovered.

The 17th and 18th cars, both loaded covered hopper cars, were blocking the public crossing at Kirkbridge Drive, Mile 4.45. The 23rd car (PROX 77717), a tank car containing liquid calcium chloride, a non-regulated product, had overturned. A minimal amount of product was lost. The 25th car (PROX 32603) a tank car containing liquefied petroleum gas (UN1075), remained upright with no product loss.

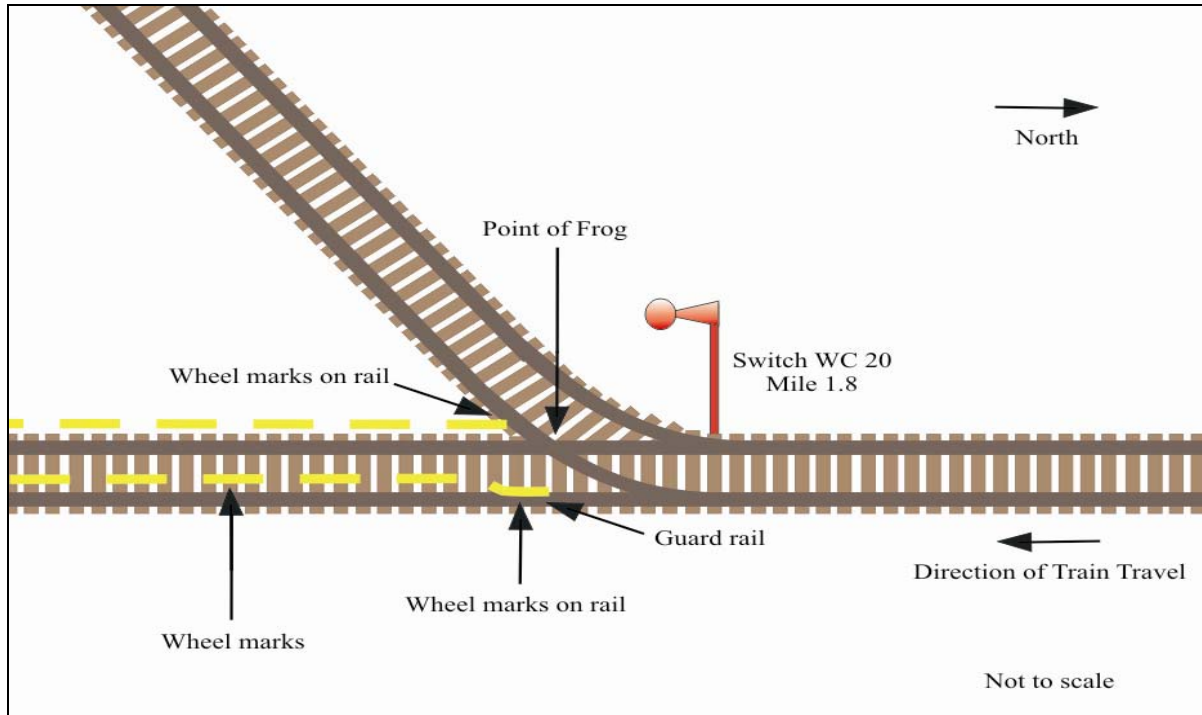
Figure 2. Location of Wheel Marks near Turnout WC20

Marks were observed on top of the ties leading north from the derailed cars to turnout WC20 at Mile 1.8 (see Figure 2). On the east side of the turnout, marks were observed on top of the guard rail, 12 3/8 inches north of the point of frog. At the end of the guard rail, marks were also observed on the ties between the rails. On the west side of the turnout, there were marks on the ties and on the tie plates starting at the heel of the frog. These marks continued between the rails on the industrial lead track, over a joint bar and along the west side of the main track.

The wheel marks on top of the east guard rail at turnout WC20 were the first signs of the derailment. The position of these marks indicated that wheel lift had occurred before the wheels reached the point of frog. CNLX 9526 was the first derailed car. The wheel marks indicated that CNLX 9526 had travelled in a derailed state for approximately 2.75 miles before the train UDE occurred.

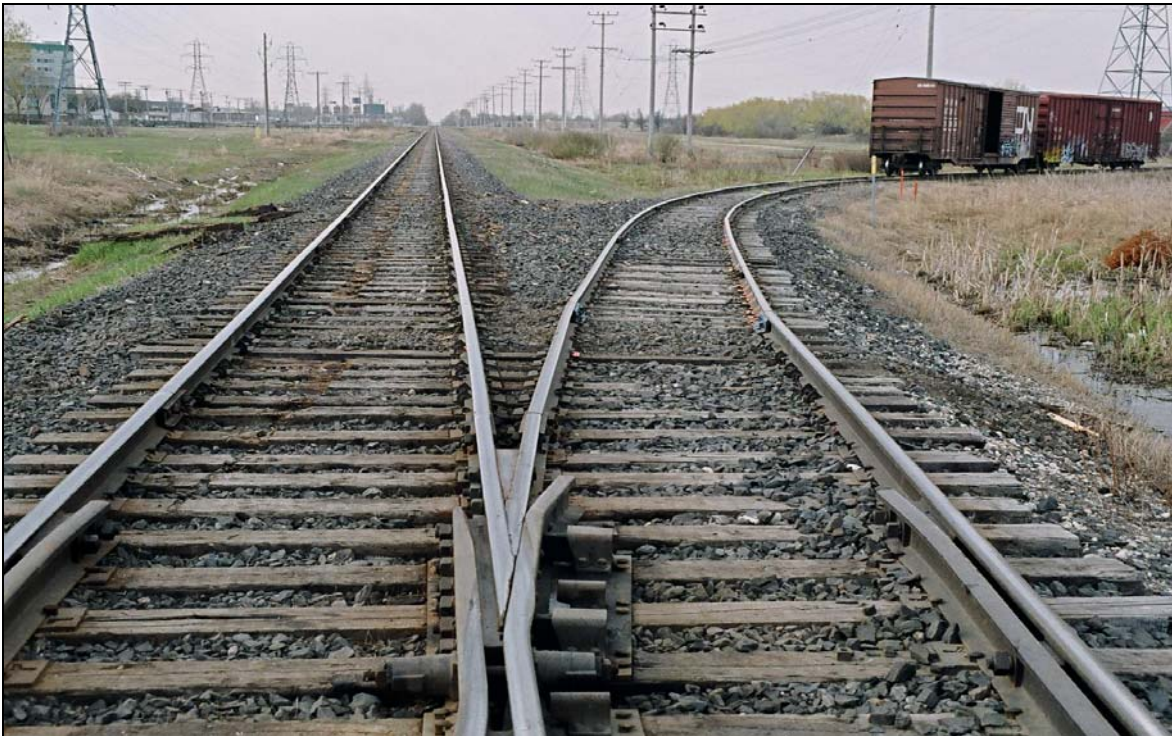
Photo 1. Turnout WC20 at Mile 1.8

The turnout at Mile 1.8 was a number 8 right-hand 100-pound turnout, with a spring frog and a standard height guard rail conforming to AREMA³ specifications (see Photo 1). The spring frog was supported by a base plate fastened to the ties with standard spikes. The guard rail was bolted to the running rail and rested on plates fastened to the ties with standard spikes. A spring frog has a hinged wing on the diverging route that is held in place by a spring. This wing provides solid support for the wheel during a main track movement, but opens under lateral pressure for a diverging route movement.

rail. This lateral force was sufficient to open the spring wing in the turnout, resulting in the west wheels following the diverging route at the point of frog, and subsequently resulting in the derailment.

- The warp defect was immediately corrected by shimming.
- The track was machine surfaced and lined as soon as the ground was thawed.
- Due to the relative instability of the ground in the vicinity of the WC20 switch, the frog was changed to a standard non-spring frog.
- An education blitz was undertaken to teach track inspectors the importance of warp defects, and how best to locate them.
- A revised schedule has been put in place to make better and more frequent use of the Track Geometry hi-rail truck on branch lines.

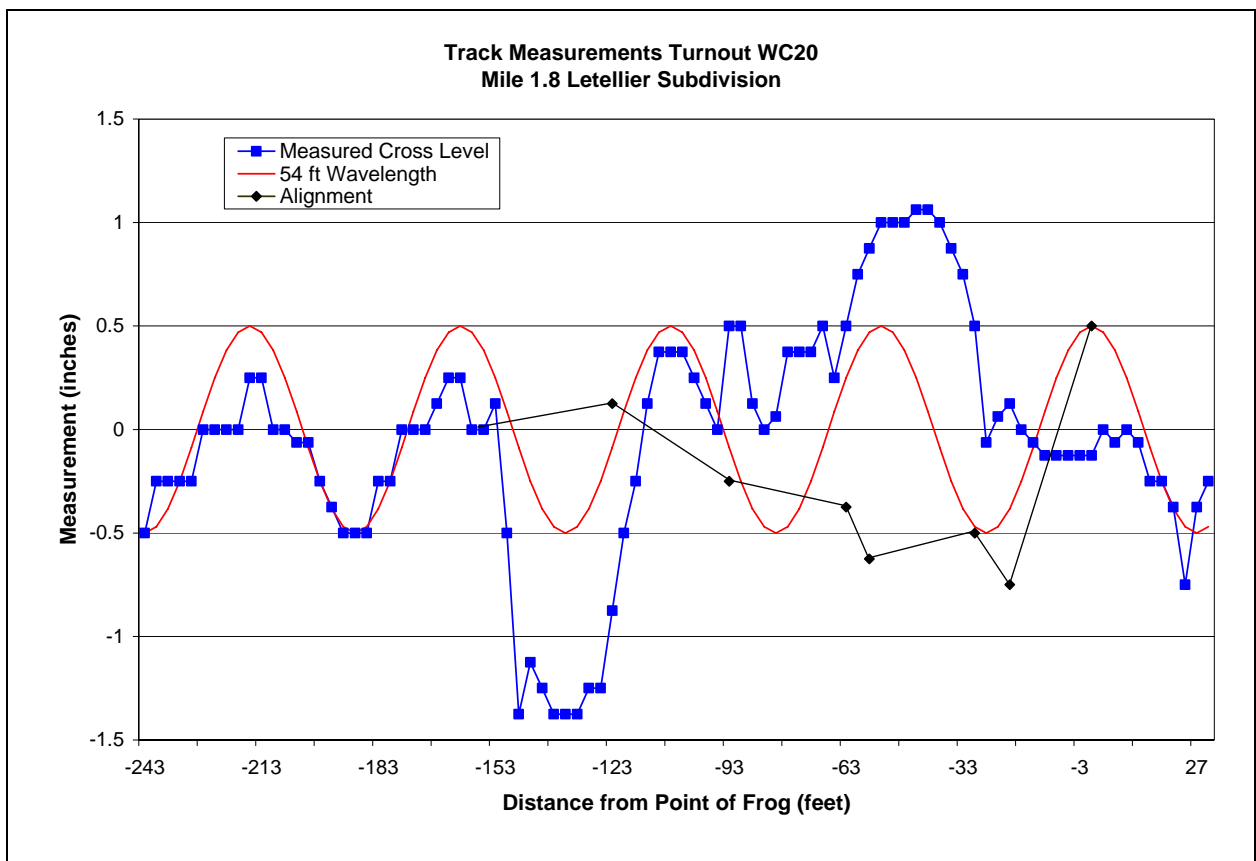
Figure 3. Alignment and Cross-level Measurements in the vicinity of Turnout WC20

After the derailment on 12 January 2005, the gauge and guard check at the turnout were inspected and were found to be within standard. Track alignment measurements were also taken. Alignment was within prescribed standards. However, in the 21 feet prior to the point of frog, there was an alignment shift in the track from $-\frac{3}{4}$ inch to $+\frac{1}{2}$ inch (i.e., track had shifted eastward).

Cross-level measurements were also taken starting from approximately 240 feet north of the turnout. Approximately 150 feet north of the point of frog, there was a near-urgent defect (warp 62). The cross-level deviations are plotted in Figure 3 and the values range from approximately $+1$ inch to $-1\frac{3}{8}$ inches. In the plot, positive cross-level measurements identify locations where the west rail was high, while negative values identify locations where the west rail was low.

In Figure 3, a sine wave with a wavelength of 54 feet (i.e., the approximate spacing of track deviations) has been overlaid on the plot with the track measurements. The sine wave has been plotted to align as closely as possible to the maximum cross-level deviations.

In the 240 feet north of turnout WC20, there were a number of cross-level deviations. Two of these cross-level deviations exceeded the priority level threshold, and there was one near urgent warp 62 defect. The spacing of these cross-level defects had a wavelength of approximately 54 feet. The train was traveling at 21 mph as it approached the turnout. The combination of train speed (i.e., within critical speed range of 15 to 25 mph) and the spacing of the cross-level deviations (i.e., wavelength of 54 feet) would have excited the covered hopper car CNLX 9526 of roughly 0.6 cps, which is within the $\frac{1}{2}$ to $\frac{2}{3}$ cps range of the natural frequency for this type of car. With the car operating in this critical frequency range, the resulting car body oscillation was sufficient to initiate wheel lift of the east wheels on the trailing truck. With this wheel lift, the guard rail could not perform its function of steering the west wheels past the point of frog. In addition, in the 21 feet just prior to the point of frog, there was a slight alignment shift eastward in the track. Therefore, as the trailing truck of CNLX 9526 approached the point of frog, the car would have resisted the small change in alignment, creating a lateral force on the
