RAILWAY INVESTIGATION REPORT
R06T0153

MAIN-TRACK DERAILMENT

CANADIAN NATIONAL
FREIGHT TRAIN A-435-31-14
MILE 6.0, OAKVILLE SUBDIVISION
MIMICO, ONTARIO
14 JULY 2006

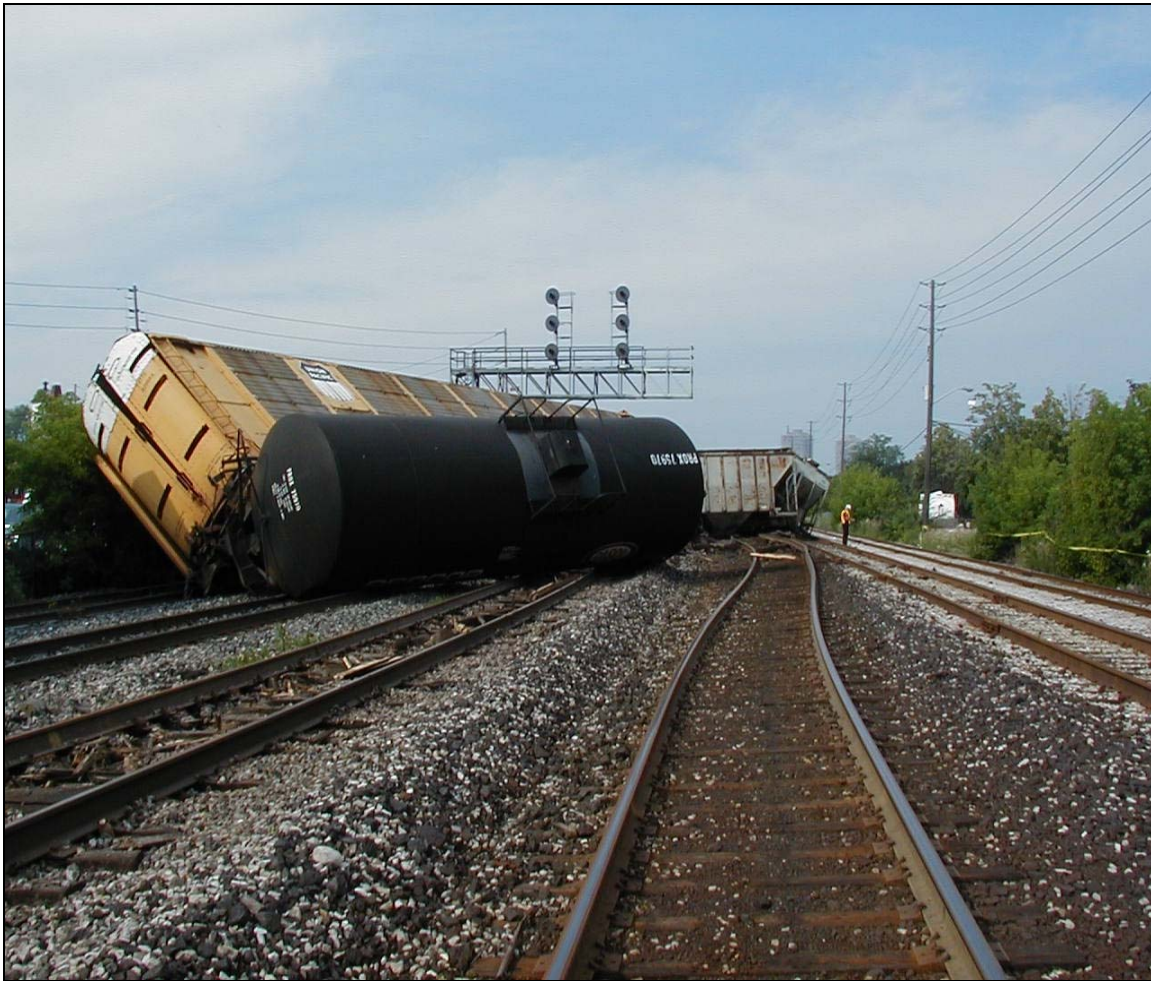
At approximately 1348, at Mile 6.0 of the CN Oakville Subdivision, near Mimico, Ontario, the train passed over a recently installed turnout. As the train travelled over the switch at a speed of 27 mph, an in-train emergency brake application occurred. The crew detected no abnormalities as their locomotive passed over the switch. After coming to a stop and conducting the required emergency procedures, the crew inspected the train and discovered that 7 non-regulated cars had derailed (72nd car to 78th car) from their 129-car train. The derailed cars were fouling all main tracks adjacent to the GO Transit passenger loading platform at Mimico Station (see Photo 1).

Photo 1. Derailed cars blocking main-line tracks

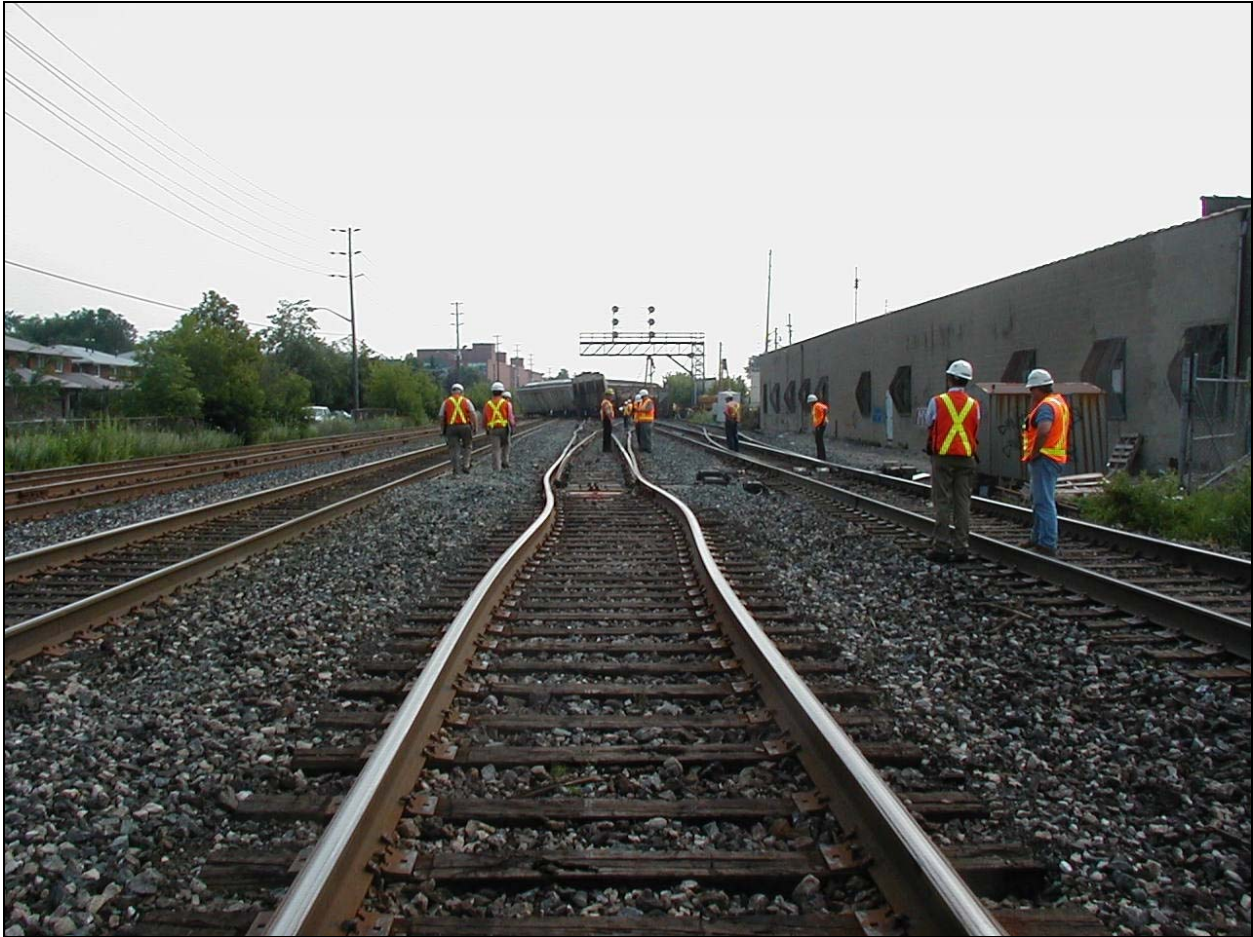
East of the switch, the track structure had shifted laterally (approximately 12 inches), forming an “S” shape (see Photo 2). In addition to the buckled track and damaged turnout, approximately 650 feet of the three main-line tracks was damaged during the derailment.

Photo 2. Track buckle at turnout (Mile 6.0)

With unrestrained, high thermal expansion forces in the rail, the track buckled east of the turnout (Mile 6.0) resulting in the derailment. Specifically, the track buckled under the load of the train as a result of increased longitudinal rail forces, insufficient rail anchoring, and a destabilized track structure.

1. The train derailed due to a track buckle in the vicinity of a recently installed turnout.
2. The track buckle occurred as a result of increased longitudinal rail forces, insufficient rail anchoring in the vicinity of the turnout, and a destabilized track structure that was unable to restrain the thermal expansion forces.
3. Multiple turnout inspections in the six months before the derailment failed to identify the unfinished box-anchoring.

- All turnouts were inspected to ensure that anchors have been properly installed as per the regulations and SPCs.
- A procedure was modified to ensure that no turnouts would be resurfaced unless the rail anchor pattern complies with the SPCs.

- A joint inspection process was implemented for CN Track Services personnel to ensure that all aspects of a maintenance or construction project are completed according to the SPCs and Transport Canada regulations. This process requires communication and sign-off between the Track Supervisor and the Program Supervisor.
