**RAILWAY INVESTIGATION REPORT**  
**R06V0119**

**TRAIN DERAILMENT**

**ROCKY MOUNTAINEER VACATIONS INC.**  
**PASSENGER TRAIN RMV 1-28**  
**MILE 68.3, CANADIAN PACIFIC RAILWAY**  
**MOUNTAIN SUBDIVISION**  
**FRAINE, BRITISH COLUMBIA**  
**28 MAY 2006**

Report Number R06V0119

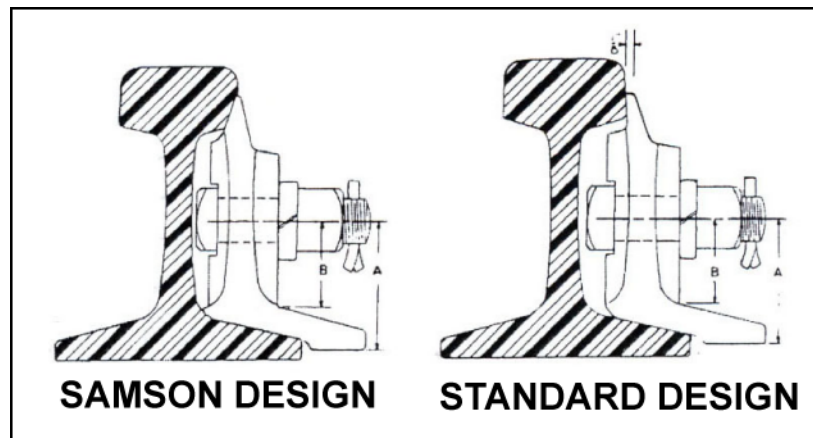
In a Samson switch point, the lower corner of the head on the gauge side of the stock rail is machined at an angle to house the point on the stock rail. This machining on the stock rail is referred to as an undercut. The undercut protects the switch point from direct impact with oncoming wheel flanges, and the angled fit resists scissor action between the switch point and stock rails under traffic. Samson switch point stock rails are supplied from the manufacturer with an undercut in either end for installation on either side of the track. Figure 2 compares cross sections of the Samson and standard switch point designs.

Figure 2. Samson and standard switch points

Samson switch points are designed for heavy traffic switches. Their design “shelters” the switch point under the stock rail, protecting the point from excessive wear and wheel impacts as they traverse from the stock rail to the switch point while taking the diverging route. The crossover at Fraine was not heavily used and CPR has only recently made Samson points standard on mainline installations. While AREMA standard knife-point switches are widely used in the industry, Samson switch points reduce the risk of overstress impact from wheels with flat, vertical flanges.

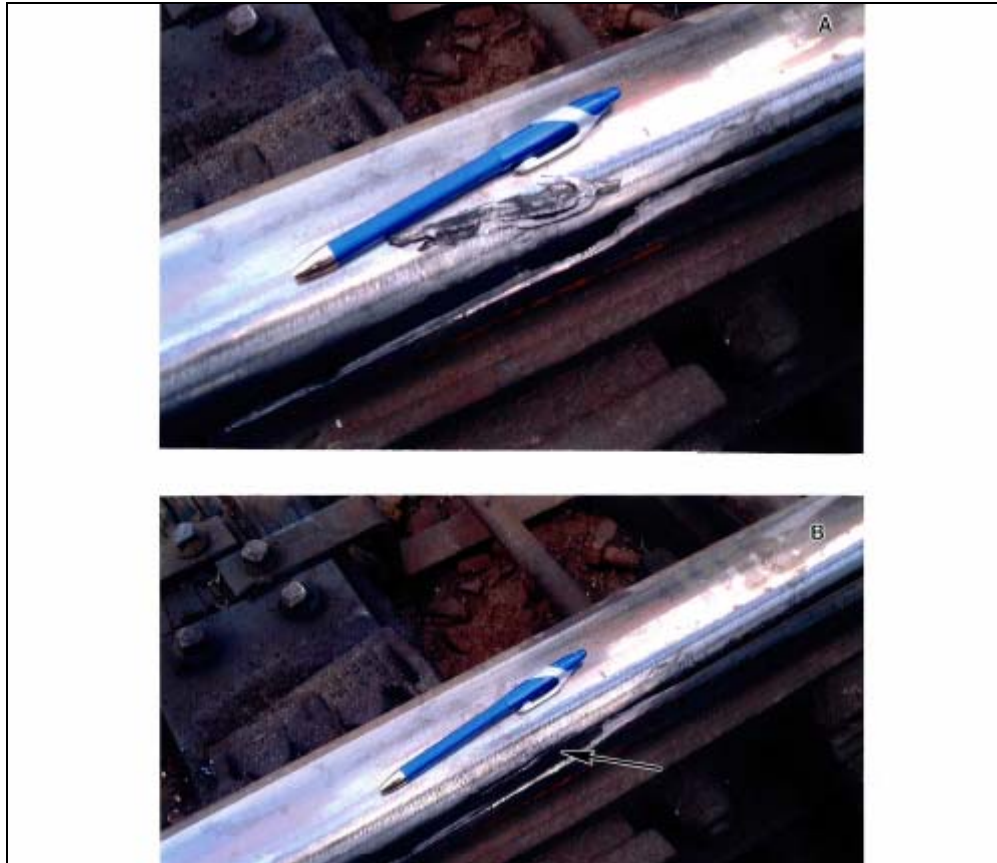
A small piece of the Macdonald track left-hand switch point was found lodged between the switch point and stock rail (see Photos 1a and 1b). The fragment measured 9.4 cm long with a maximum width of 1.5 cm. The piece had chipped out a distance of approximately 11.5 cm to 21.5 cm from the point end. Wheel marks on the switch point indicated that a wheel travelled about 18½ feet along the top of the switch point before dropping in between the stock rail and switch point. Although a piece of the switch point had broken out, the actual tip of the switch point was not hit.

**Photo 1a.** Separated piece of switch point

**Photo 1b.** Original position of the fragment between the switch point and stock rail (arrow)

- The piece separated from the point rail as a result of an applied overstress. The remaining surfaces of the separated piece were too badly damaged to identify the presence or nature of any prior progressive failure.

- The material properties appear consistent with a lightly alloyed high carbon steel in a pearlitic heat treatment condition. No material deficiency is indicated.

After the occurrence, the chipped switch point was ground to restore profile and the switch rods were adjusted. The switch point remained in service until both switch points and frog were replaced on the Macdonald track crossover switch, along with the switch point area of the No. 13, 136-pound, Connaught track crossover switch. Track damage through and east of the crossover was minimal, but 400 feet of track panel, 1400 feet of new rail, and four cars of ballast were required to repair the track west of the crossover.

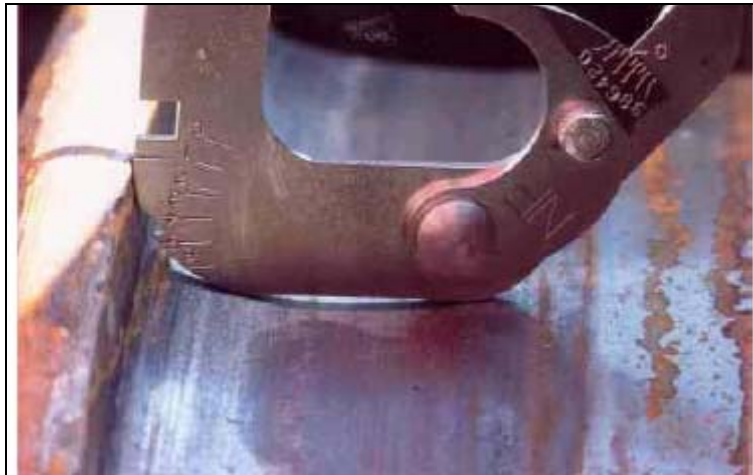
Wheel R1 had a flange height of 1 9/64 inch. Flange height of 1½ inch is cause for removal according to “Why Made Code 64 Rule 41 of the AAR Field Manual.” Part II of the RPCISR, Safety Defects, 9.1 (g) prohibits wheels from continuing in service when the height of the wheel flange from the tread to the top of the flange is more than 1½ inch. The diagonally opposite L2 wheel had a flange height of 1 5/16 inch. The flange on wheel R1 was 13/16 inch vertical, as shown in Photo 2. “Why Made Code 62 Rule 41 of the AAR Field Manual” specifies that a flange with a flat vertical surface extending 1 inch or more from the tread is cause for renewal. The RPCISR has no provisions concerning wheels with vertical flanges.

**Photo 2.** R1 wheel with vertical flange gauge applied

Field evidence, wheel measurement data, and laboratory examination of the broken piece of switch point indicate that the B-end of car RMR 3237 derailed first. Wheel measurements and wear profiles of the four R wheels on the leading trucks of the first two derailed cars indicate that wheel R1 on car RMR 3237 was the wheel most likely to exert excessive lateral force on the switch point. The circumferential band of surface cracking on the tread of wheel R1 suggests possible steering issues with the B-end of the car. This condition likely contributed to the vertical flange wear pattern on the leading R1 wheel, indicating that the flange had been crowding the rail gauge face.

Although the condition of the R1 wheel was not cause for removal according to the AAR interchange rules or condemnable under the RPCISR, the vertical flange of wheel R1, unlike the flange of a new wheel profile, was in full contact with the switch point, resulting in overstress, causing a piece to break out. The broken piece of the switch point became wedged between the switch point and stock rail, and wheel R1 rode up on the switch point and fell between the switch point and the stock rail, derailing itself and the car ahead, RMR 5558. The five cars following car RMR 3237 “split the switch” and also derailed.
