**RAILWAY INVESTIGATION REPORT
R07T0270**

COLLISION AND TRAIN DERAILMENT

**CANADIAN NATIONAL YARD ASSIGNMENT YWCS60-17
AND
CANADIAN NATIONAL FREIGHT TRAIN M33931-17
MILE 0.00, HALTON SUBDIVISION
MACMILLAN YARD, TORONTO, ONTARIO
17 SEPTEMBER 2007**

Report Number R07T0270

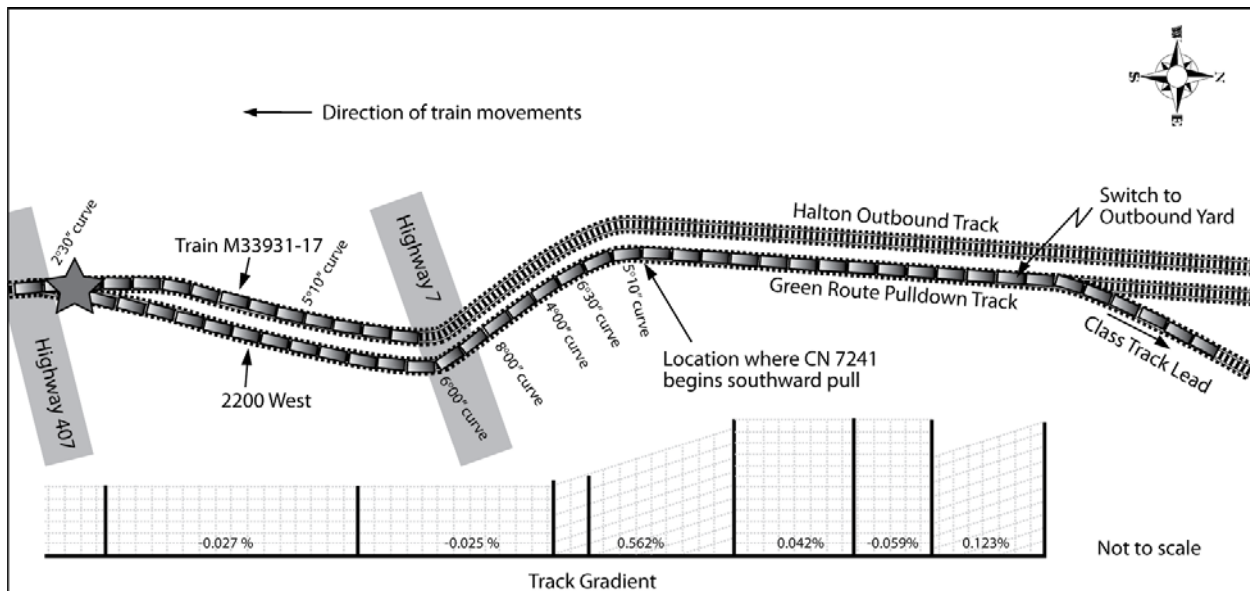
Figure 2. Diagram of location at time of collision

At approximately 0249 eastern daylight time (EDT),² the foreman completed assembling a block of 97 cars in track C24. The head end was 5840 feet to the south on the pullback track (Green Route). The Halton outbound track runs parallel to the Green Route, and then joins the Green Route south of the Highway 7 overpass (see Figure 2).

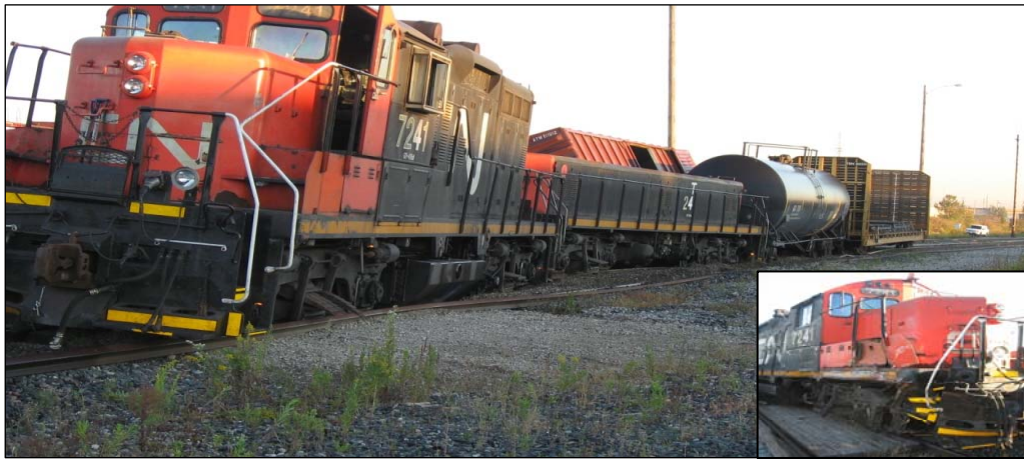
Photo 1. The 2200 West post-derailment. Inset: Damage to CN7241 at point of collision.

The locomotive and booster unit (CN7241 and CN241) as well as the following two head-end cars derailed and remained upright. The derailed cars included a tank car loaded with bunker "C" oil (GATX71793, non-placarded) and a bulkhead flat car loaded with steel plate (TTPX805536). All the derailed cars showed substantial surface, truck, and appliance damage on the side where they contacted train 339. CN7241 came to rest with the lead truck on a wood plank crossing south of the switch, approximately 50 metres (165 feet) past the fouling point of the Halton outbound route (see Photo 1). The east rail was rolled and the fuel tank on locomotive CN7241 was punctured. The switch and approximately 200 feet of track were damaged or destroyed.

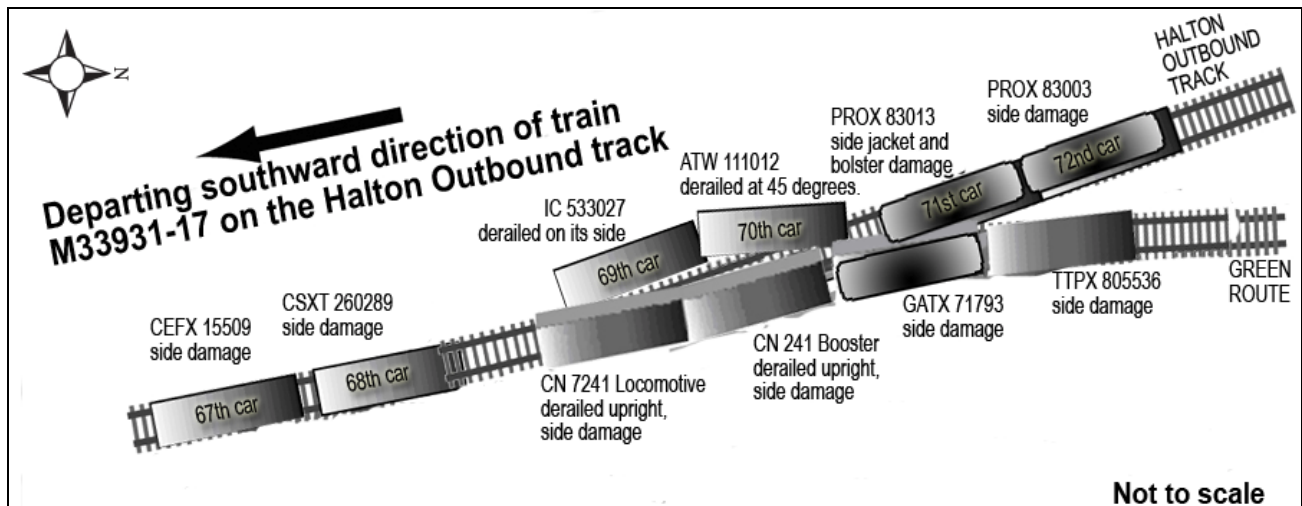
Figure 3. Accident site diagram

On train 339, the 67th to the 72nd cars were damaged or derailed (see Figure 3). The first car contacted was the 67th car, a covered hopper car (CEFX15509) that sustained minor scrapes. It was followed by a second hopper car (CSXT260289) that remained upright on the rails. The car body had become unseated from its trucks and was leaning to the west. There was a train separation between the 68th and 69th car, a loaded box car (IC533027) on its side. A second loaded box car (ATW111012) was also derailed and leaning to the west.

The 71st and 72nd cars (PROX83013 and PROX83003) were loaded special dangerous commodity cars containing chlorine gas (Class 2.3, UN1017). These cars, both 105J tank cars, sustained significant damage to their jackets, handrails, and structure. The cars derailed, but remained upright and tank integrity was not breached. The damage on the chlorine tank cars occurred from contact with the bulkhead flat car TTPX805536.

CN undertook temporary repairs to the wheel, truck brake, and end sill to make PROX83013 and PROX83003 safe to travel for offloading. On 19 September 2007, Transport Canada (TC) issued an estoppel⁴ for CN's plan to move the two loaded chlorine tank cars as a dedicated movement to a trans-loader for offloading on September 21. The movement was accompanied by trained mechanical personnel and restricted to 15 mph. Once unloaded, the cars were loaded on a flat car for shipment to the owner.

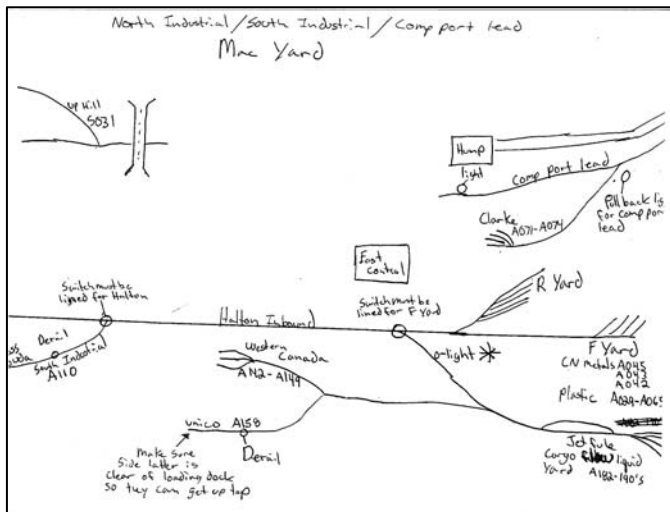
Figure 5a. Helper’s sketch of MacMillan Yard

MacMillan Yard knowledge was not tested during training and qualification. There were no maps included in the training material. There were no maps of the yard in the yard manual. Conductors were given little direction and were left to learn the layout of the yard as they worked on the job. Some conductors adapted by making their own hand-drawn sketches (see Figure 5a) or by making copies of other employees’ sketches. This is in contrast to mainline operations, where crews are provided with timetables, illustrated train-handling guides and track diagrams (see Figure 5b).
