RAILWAY INVESTIGATION REPORT
R09T0092

MAIN-TRACK TRAIN DERAILMENT

CANADIAN NATIONAL
TRAIN NUMBER M36231-20
MILE 247.20, KINGSTON SUBDIVISION
BRIGHTON, ONTARIO
21 MARCH 2009

Report Number R09T0092

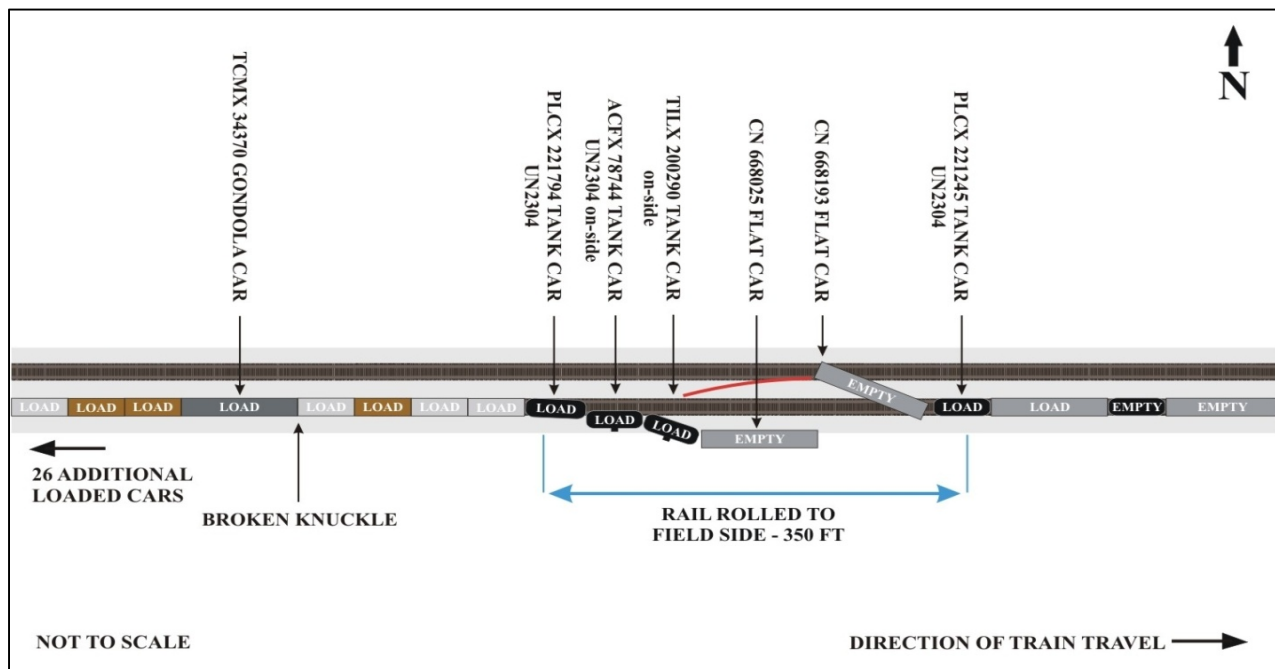
Figure 2. Accident site diagram

The derailed cars came to rest at the bottom of a sag³ in undulating territory.⁴ The first derailed car was PLCX 221245 (the 98th car), which had the two south wheels on the leading truck and all wheels on the trailing truck derailed. The 99th and 100th cars were long, empty flat cars. They remained upright and jackknifed to the north and south side of the track respectively. The 101st car came to rest on its side with its lead truck pushed south of the track. The 102nd and 103rd cars remained parallel to the track with the 102nd car on its side and the lead truck of the 103rd car derailed to the south (see Figure 2). The draft gears on cars that did not derail were compressed. On some cars, the coupler horn was contacting the centre sill striker face. There were no pre-existing defects observed on the derailed cars.

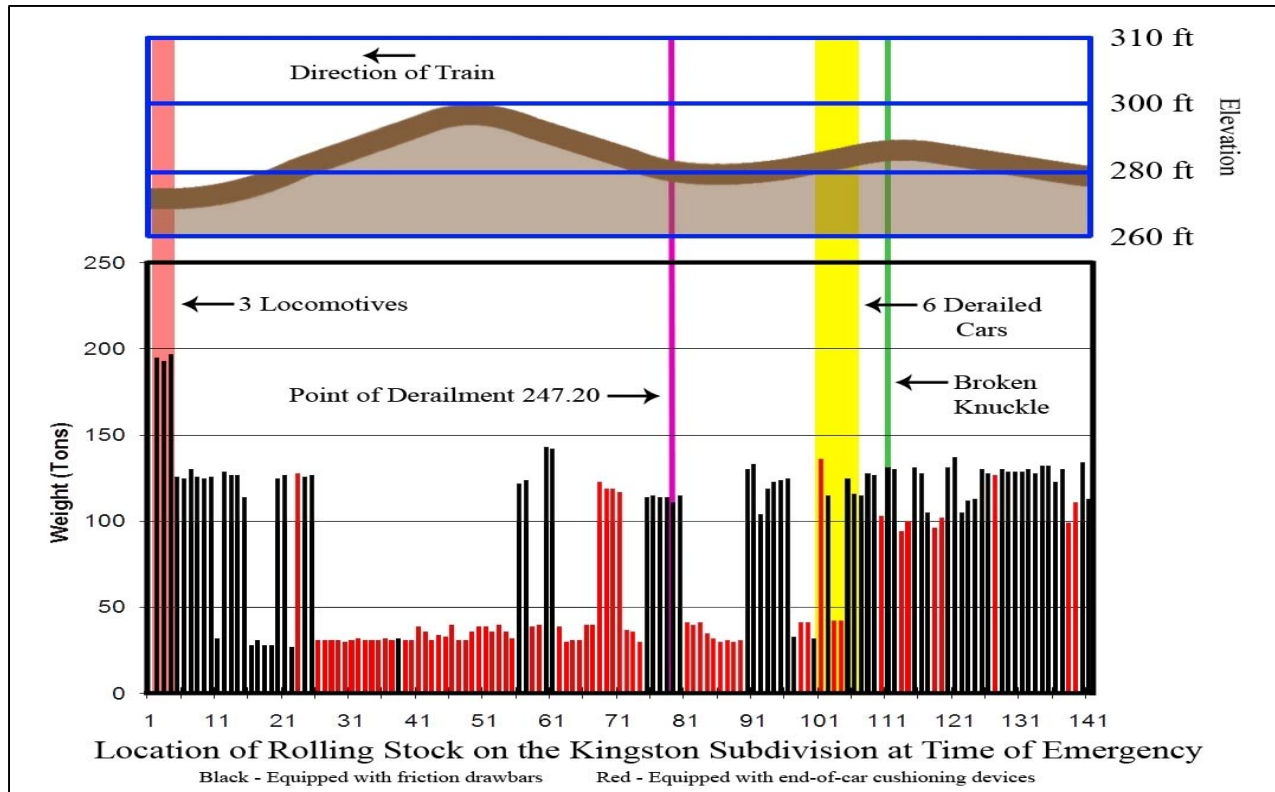
Figure 3. Train tonnage profile in relation to track elevation and point of derailment

A tonnage profile of the occurrence train in relation to the track elevation and point of derailment is contained in Figure 3.
