**RAILWAY INVESTIGATION REPORT**  
**R09T0151**

**MAIN-TRACK DERAILMENT**

**CANADIAN PACIFIC RAILWAY**  
**FREIGHT TRAIN NUMBER 235-04**  
**MILE 174.41, BELLEVILLE SUBDIVISION**  
**OSHAWA, ONTARIO**  
**05 JUNE 2009**

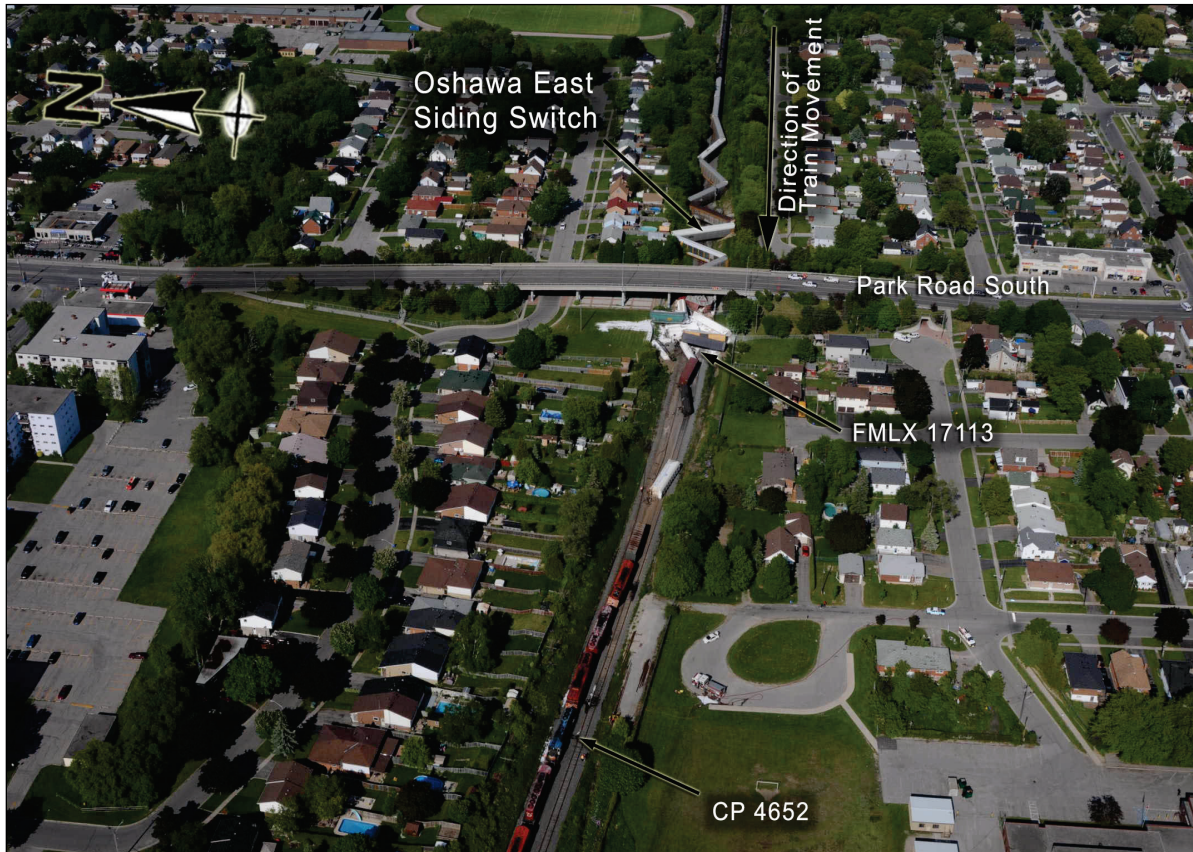
**Photo 1.** Aerial view of derailment

It was determined that the last 4 locomotives and the following 27 cars had derailed. The derailed cars included 7 box cars (3 loaded), 5 covered hopper cars (3 loaded), 7 tank cars (6 loaded) and 8 empty multi-level, flat cars (see Photo 1). One of the derailed cars, dangerous goods (DG) tank car FMLX 17113, was loaded with hydrogen peroxide (UN 2015). The car remained intact and no product was released; however, about 3000 gallons of diesel fuel spilled from damaged locomotive fuel tanks into adjacent ditches and ignited. Emergency responders were dispatched, extinguished the fires and contained the spilled diesel fuel. As a precaution, 105 nearby homes were evacuated. The evacuation order remained in effect until noon the next day, when FMLX 17113 was secured and removed. There were no injuries.

The 4 derailed locomotives and the first derailed car remained upright along the right-of-way. The fourth and fifth locomotives had sustained fire damage. The fourth locomotive, CP 4652, was identified as the first to derail. Initial inspection revealed that traction motor (TM) combos (TM and wheel set assembly) Nos. 1 and 3 on CP 4652 exhibited discoloration consistent with heat and fire exposure. The leading No. 1 TM combo on CP 4652 had severely overheated and the axle had broken in the area of the bull gear side suspension bearing (see Photo 2). The fibreglass bull gear cover was burned and the pinion gear teeth were damaged and worn away. There were skid flats and burn marks on the wheels consistent with canting and sliding on the gauge corner of the rail. All 4 TM combos from CP 4652 were shipped to the TSB Laboratory for further examination.

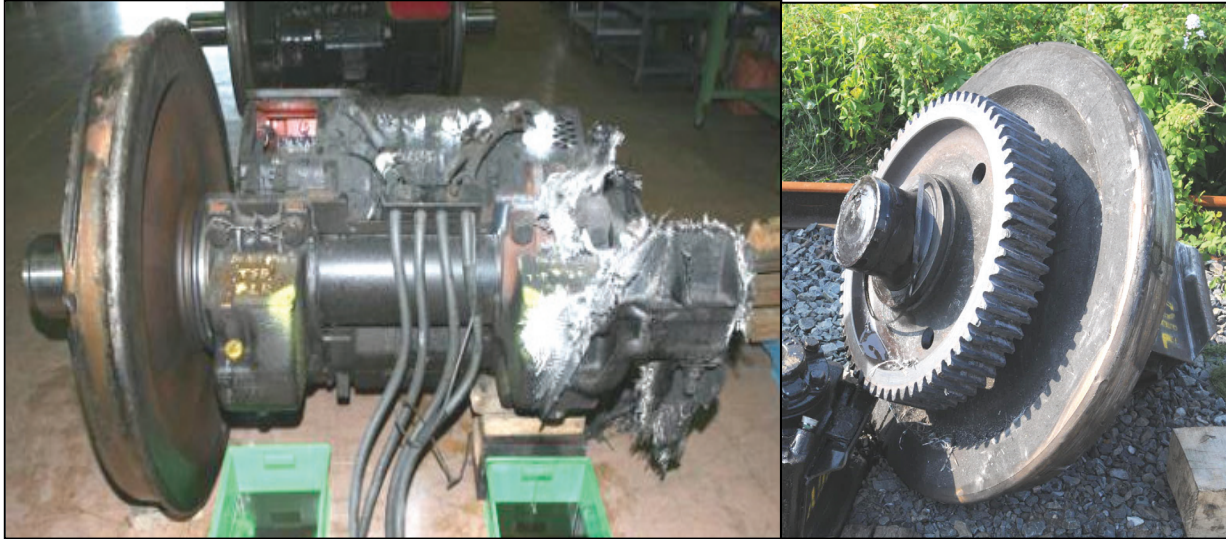
**Photo 2.** Left: CP 4652 No. 1 TM combo

Right: Broken axle with bull gear

The axle from TM combo No. 1 fractured near the midpoint of the gear side suspension bearing area. The pinion gear had been stripped of its teeth and the mate bull gear was void of lubricant and exhibited minor teeth damage. The fractured stub end of the failed axle (bull gear side) showed extensive smearing damage consistent with continued operation after failure. Due to overheating, oil levels were lower on the gear side and the wick had completely disintegrated. However, the operation and alignment of the wick relative to the suspension bearing window appeared normal. On the side opposite the bull gear (commutator side), the wick was properly aligned and in good operating condition.

1. The No. 1 axle on locomotive CP 4652 likely broke near Mile 163.0. The train continued on until Canadian Pacific Railway 4652's No. 1 wheel set displaced and came into contact with the east Oshawa siding switch at Mile 174.41 causing the derailment of 4 locomotives and 27 cars.
2. Due to non-conforming asperities on axle surfaces, the lubrication system broke down and the resulting friction produced heat sufficient to cause bearing breakdown and meltdown.
3. Once the babbitt and bearing material melted, liquid metal penetrated the axle suspension bearing journal surface, which initiated liquid metal embrittlement cracking in the axles Nos. 1 and 3, and resulted in the catastrophic failure of axle No. 1.

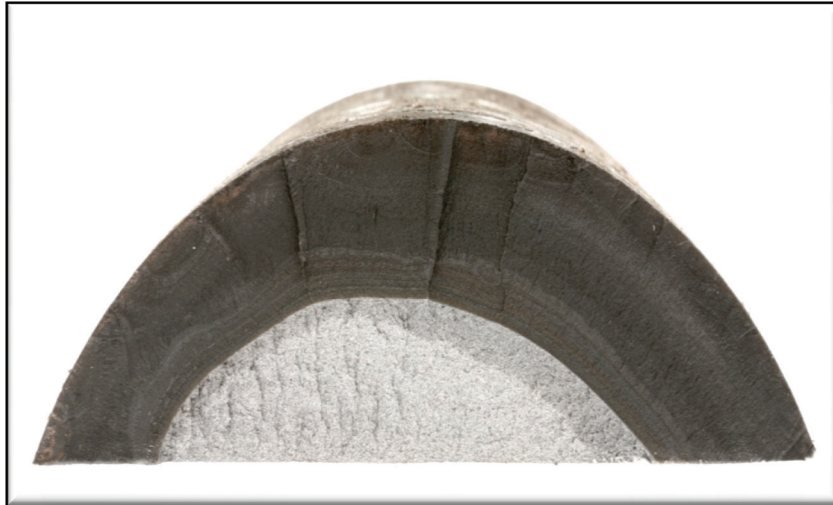
**Photo 4.** Close-up of secondary crack in axle No. 3

The axle from TM combo No. 3 was not fractured through. The bull gear cover was damaged and the bull gear teeth were shiny and dry. The gear-side bearing components were heat discoloured. The bull gear was devoid of lubricant and the gear case was damaged. The wicks appeared to be properly aligned.

Ultrasonic inspection revealed 3 secondary cracks inboard of and parallel to the primary fracture on the axle of combo No. 1. The axle from combo No. 3 had 1.5 inch deep radial cracks around its entire circumference at the approximate center of the gear side suspension bearing area (Photo 4).

The cracks in both axles showed dark colour and beach marks consistent with progressive cracking. There were no metallurgical anomalies in samples taken from the core of the axle. Brass and lead material was observed on the crack face. The lead and brass material was present to a finite depth, suggesting that subsequent crack growth was caused by the fatigue extension of the crack.

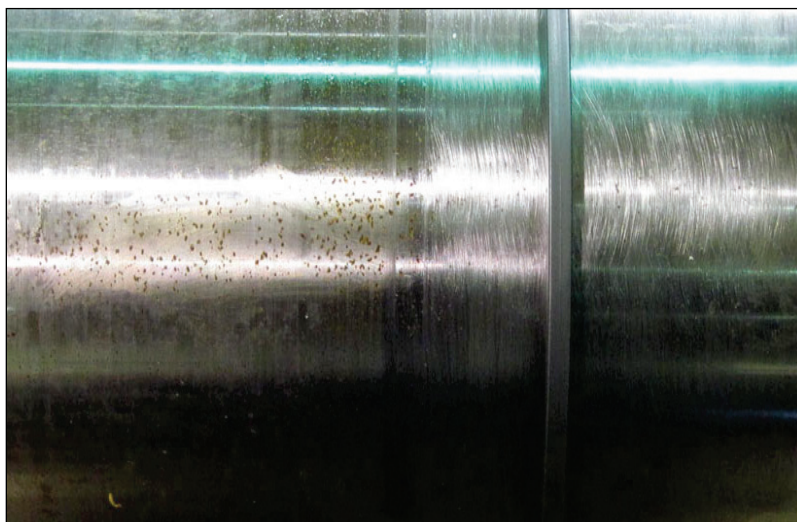
**Photo 5.** Axle 2 from CP 4652

Surface roughness in the axle suspension bearing journal area on axles 1, 2 and 3 from CP 4652 ranged from 14 to 22 micro-inches. Each axle journal exhibited corrosion pits and a significant number of multi-directional scratches consistent with mechanical damage from the use of abrasive paper. The scratches varied in orientation and depth (see Photo 5). The axle from CP 3024 had similar surface features and roughness.

Detailed scanning electron microscope (SEM) examination and energy dispersive spectroscopy (EDS) analysis were performed on samples from the bearing journals of axles 2 and 4. Flattening of the edges of the scratches was observed on axle 2. Steel corrosion products as well as bearing material were observed in the corrosion pits and in many of the deeper scratches.

The examination of the 2 randomly chosen wheel sets revealed that corrosion pitting had developed on 3 of the 4 axle suspension bearing journal surfaces beneath the protective coating during storage. The pitting significantly increased the surface roughness. After removing the protective coating, the average recorded surface roughness of the pitted axle surfaces ranged from 37 micro-inches to 144 micro-inches.
