**RAILWAY INVESTIGATION REPORT
R11C0118**

MAIN TRACK DERAILMENT

**CANADIAN NATIONAL RAILWAY
FREIGHT TRAIN Q11531-18
MILE 13.20 THREE HILLS SUBDIVISION
ALIX JUNCTION, ALBERTA
21 OCTOBER 2011**

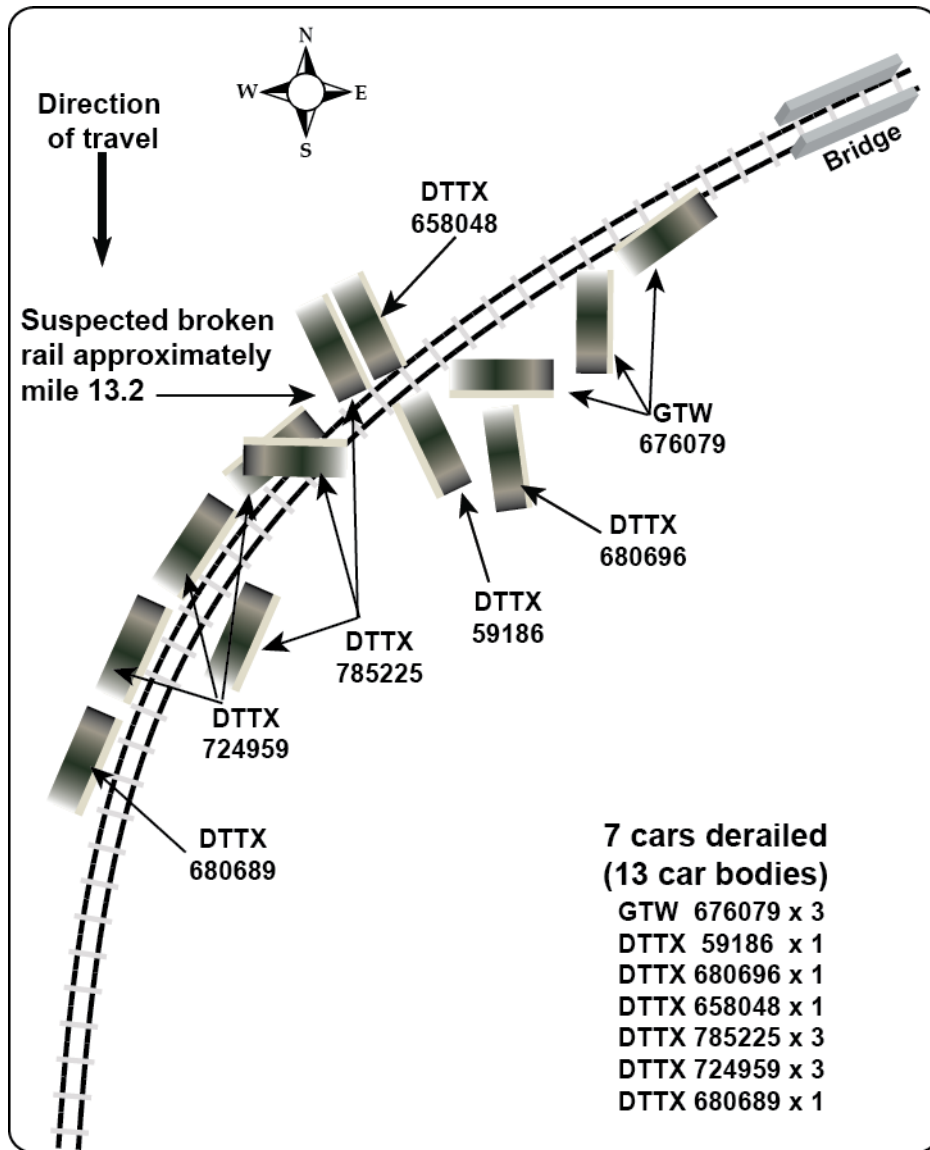
The first 2 cars (4 platforms) had derailed to the high side of the curve and had rolled down the bank and were upside down. The third car was on top of the last platform on the second car. The remaining cars and platforms had derailed to both sides of the track (Figure 2). Each platform had been loaded with 2 containers transporting a variety of products.

Figure 2. Site Sketch

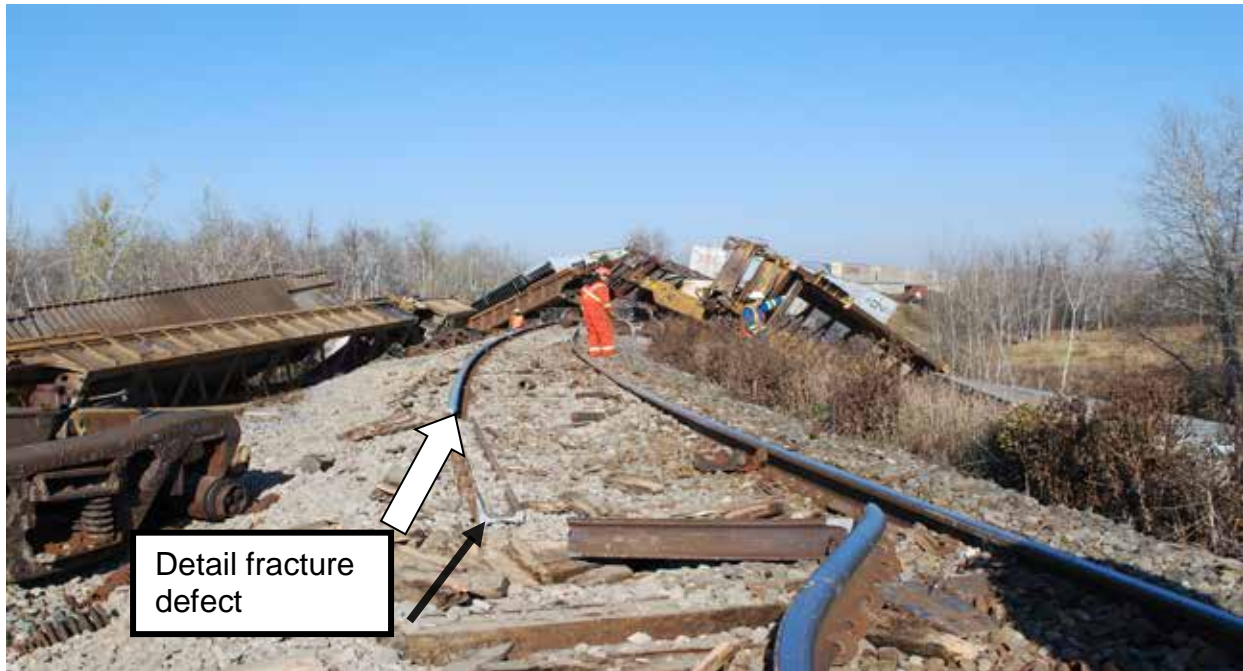
The derailed cars were situated in 2 groups, approximately 80 feet apart. Within this 80 foot section of undamaged track, the track contained 3 joints in the high rail. There were no wheel marks on the intact track. At the south end of this section, there was a 14' broken piece of 1959 Dominion rail with a definitive transverse defect on the gauge corner at both ends of the piece (photos 1 and 2). At the north location, there were marks on the base of the high rail, indicating that the rail had been pushed through the rail anchors in a southward direction. Another piece of the high rail found at the north location had a battered north end at a broken joint. A number

of broken rail sections showed head checking² and shelling³ in the central region of the running surface.

Photo 1. Derailed site looking north. (Note: Detail fracture defect in rail end)

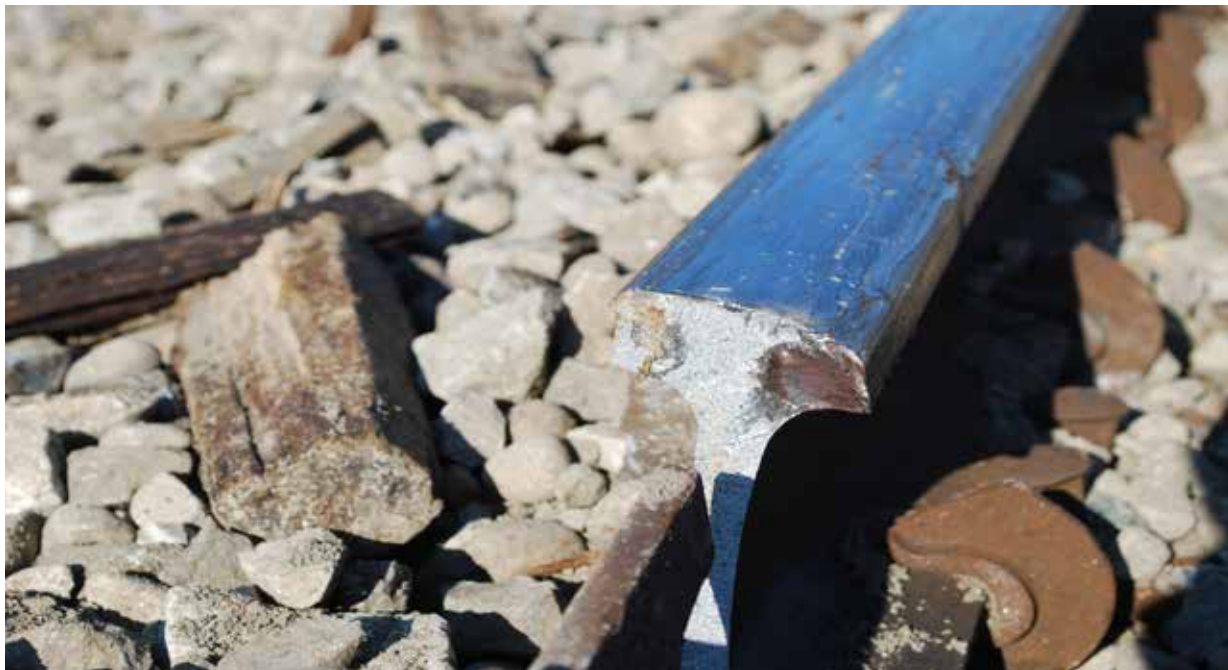
Photo 2. Broken rail with 2 transverse defects

During the derailment event, a second group of cars derailed just south of the first rail break location. At this second location, the high rail had been pushed southward, resulting in the rail being forced out of alignment and breaking into several short sections (up to 14 feet in length) due to a number of existing transverse defects in the rail.

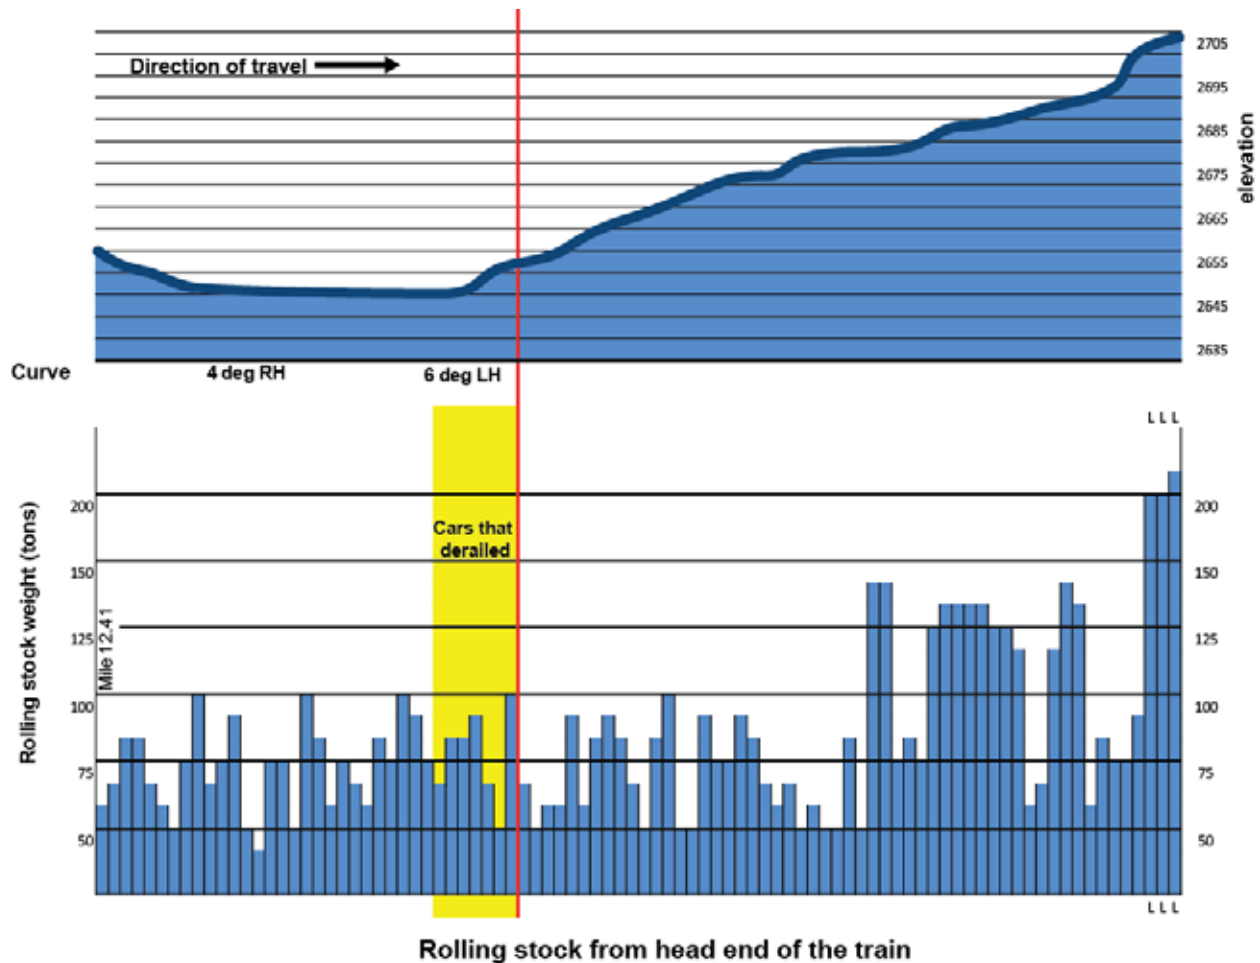
Train Q115 departed Toronto, Ontario, each day destined for Calgary, Alberta. Between Edmonton and Calgary, the train operated on the Camrose and Three Hills subdivisions. This train and its northbound counterpart, Q114, had been operating over these subdivisions since 2008. The occurrence train had been marshalled according to CN's train marshalling standards (Figure 3).

Figure 3. Overlay of train marshalling and track profile (Note: Red line identifies the POD location)

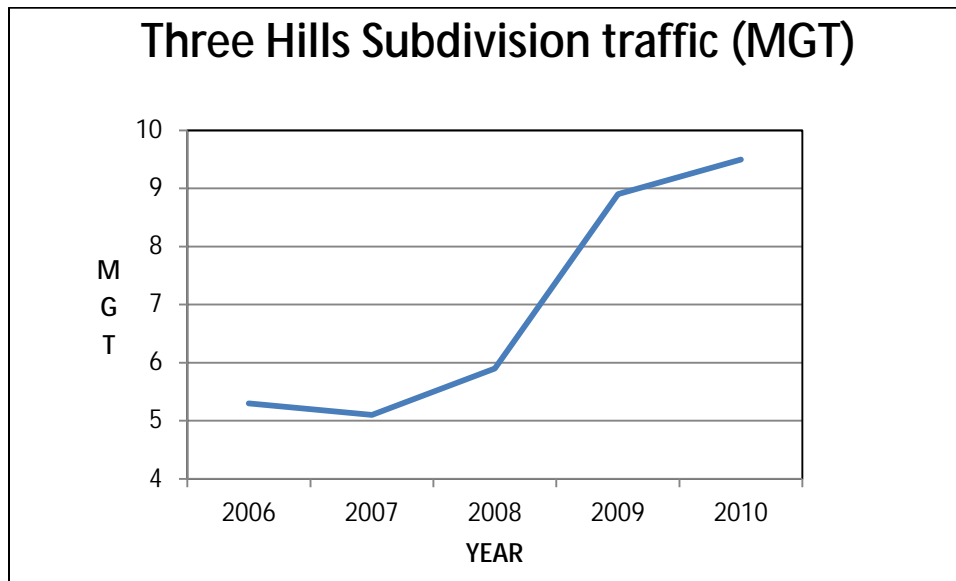
From 2007 to 2010, the rail traffic, as measured in million gross tons (MGT), had increased by approximately 86% from 5.1 to 9.5 MGT (Figure 4).

Figure 4. Rail traffic (MGT) from 2006–2010
