**RAILWAY INVESTIGATION REPORT  
R11T0162**

**MAIN-TRACK DERAILMENT**

**CANADIAN NATIONAL  
TRAIN Q10251-10  
MILE 243.1 BALA SUBDIVISION  
WATERFALL, ONTARIO  
14 JULY 2011**

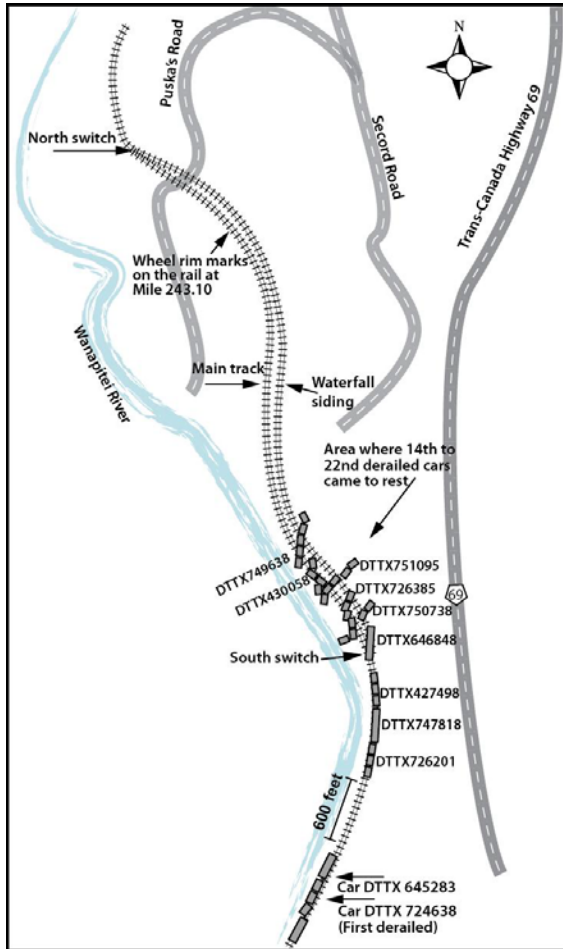
Figure 2. Derailment site diagram (not to scale)

The derailed cars came to rest in a 3° right-hand curve south of the switch, in the short tangent section containing the switch, and in the 3° left-hand curve approaching the south siding switch (Figure 2).

In the vicinity of the south switch, the 14th to 19th cars and the leading 2 platforms of the 20th car had jackknifed and piled up. The 20th to 22nd cars derailed along the main track in various orientations.

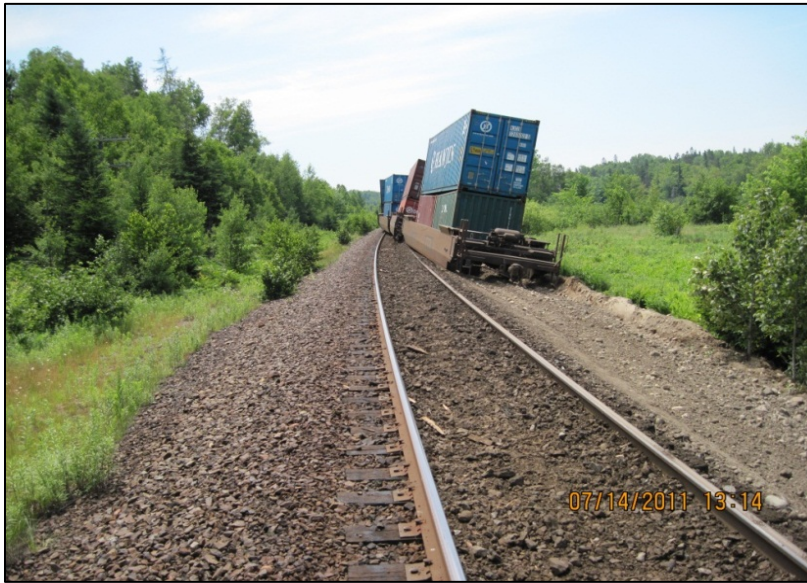
South of the south switch, cars DTTX 724638 (the 12th car) and DTTX 645283 (the 13th car) came to rest still coupled to the head end of the train, approximately 600 feet from the other derailed cars. DTTX 645283 was derailed completely to the inside of the curve (Photo 1a).

**Photo 1a.** View of cars DTTX 724638 and DTTX 645283 looking south

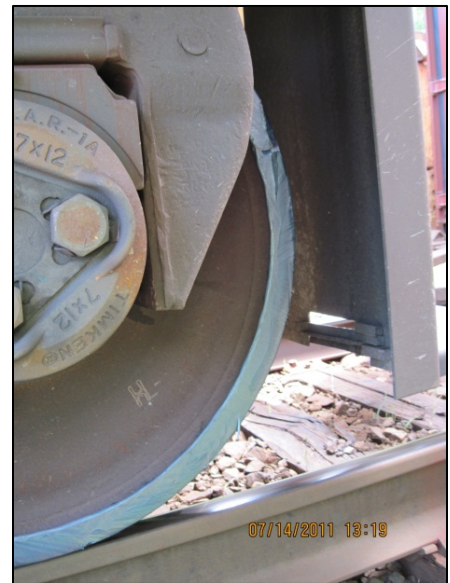
**Photo 1b.** Close-up of the L3 wheel on DTTX 724638 showing bluing and abrasion on the rim face

Car DTTX 724638, a 3-platform intermodal well car travelling with the B-end leading (Figure 3), derailed the trailing platform upright with the 5/6 and 7/8 wheel sets straddling the west rail. The leading truck was undamaged. The L3 and L4 wheels on the articulated C truck (Figure 3 and Photo 1b) came to rest damaged but not derailed. There were impact marks on the tread and severe abrasion and bluing on the face of the wheel rims. Freshly broken rail anchor fragments were present in the lead-end well of the C platform. The tread on the 5/6 and 7/8 wheels showed some surface roughness from the derailment, but not the severe damage observed on the L3/L4 wheels.

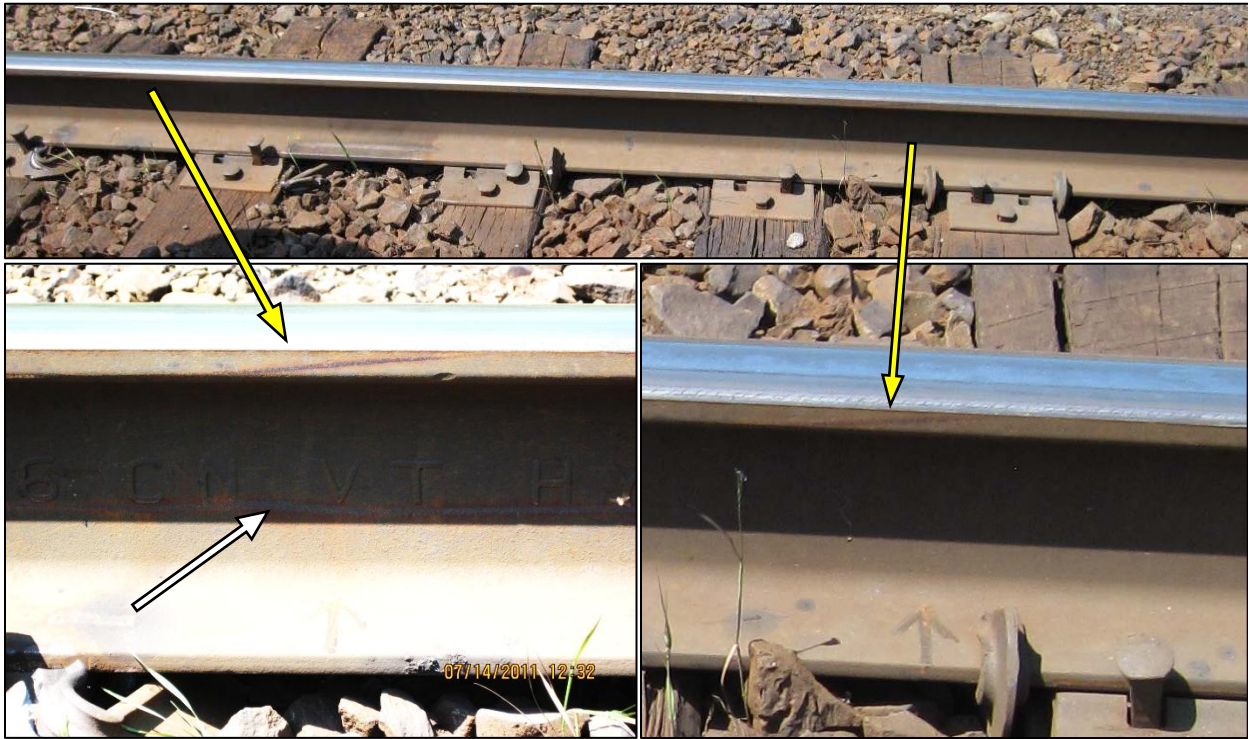
The first signs of derailment were located at Mile 243.10, south of the Puska's Road crossing in the body of a 3° right-hand curve with 4 inches of elevation. The balanced speed<sup>4</sup> for freight trains was 45 mph. Two 4 inch-long abrasion marks on the gauge face of the west (low) rail in the body of the curve marked the location where two wheels left the head of the rail. There was also a fresh wheel rim mark on the web of the low rail below the second abrasion mark (Photo 2).

**Photo 2.** Photo of low rail gauge side at POD. Yellow arrows point to rim marks where the L4 wheels (left close-up photo) and L3 (right close-up photo) dropped into gauge. Note the wheel rim mark (white arrow) in the rail web just inside the margin of the rail head shadow.

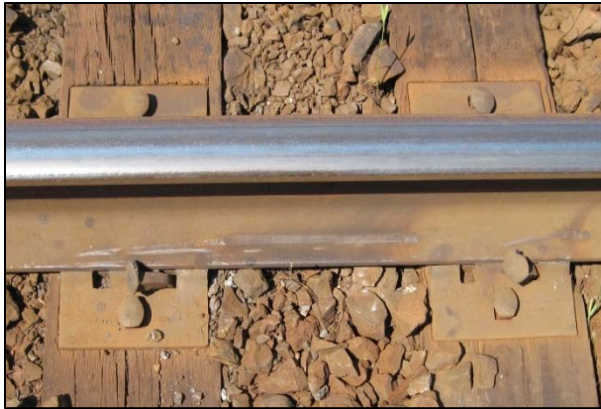
There were signs of ongoing low-rail movement and canting, including shiny tie-plate rail seats, anchor wear against the tie and spike lift (Photo 3). There was also tie-plate movement and anchor cut of the tie plates. The matching high rail showed some gauge-side spike lift ( $\leq 1$  inch), and had been gauged recently. A number of gauge measurements and cross level readings were taken in the vicinity north of the POD. A 1-inch urgent tight gauge condition was identified 46.5 feet north of the POD.

**Photo 3a.** Bent and lifted gauge-side low rail spikes at the point of derailment

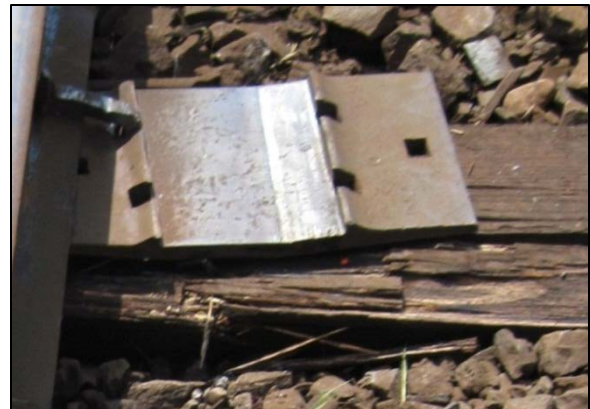
**Photo 3b.** View of tie plate showing rotation and polish from rail cant and base rotation

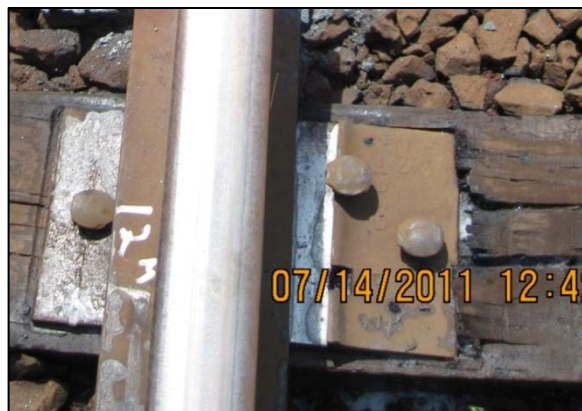
**Photo 3c.** Close-up showing old anchor cut on tie and tie plate plus more recent vertical/horizontal polishing on the anchor face

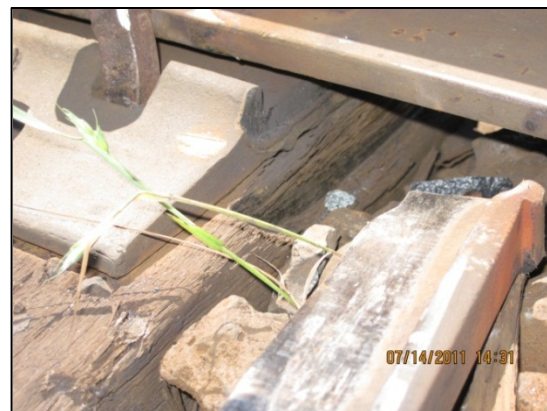
**Photo 3d.** View of tie and plate showing low rail field side plate cut, rail seat polishing and tie splitting

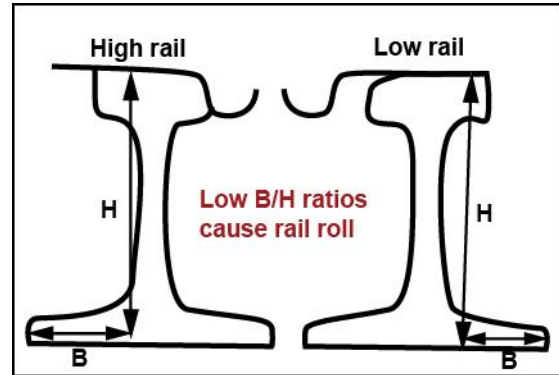
Figure 4. L/V Ratio  
(Source: TTCI/NS Report TD-11-052)

- The existing negative low-rail cant was likely increased by the non-conforming wheel-rail contact <sup>23</sup> towards the field side top of the low rail. As the rail cants, the downward vector of the vertical load tends to shift toward the field side effectively reducing the L/V (or B/H) ratio <sup>24</sup> required to produce rail rollover or a gauge-widening type derailment, increasing the potential for the rail to roll (Figure 4).
