**RAILWAY INVESTIGATION REPORT  
R12D0063**

**UNPROTECTED OVERLAP OF AUTHORITY**

**AGENCE MÉTROPOLITAINE DE TRANSPORT  
TRAINS AMT 94 AND AMT 93  
MILE 40.8, ADIRONDACK SUBDIVISION  
ADIRONDACK JUNCTION  
MONTRÉAL, QUEBEC  
13 SEPTEMBER 2012**

Report Number R12D0063

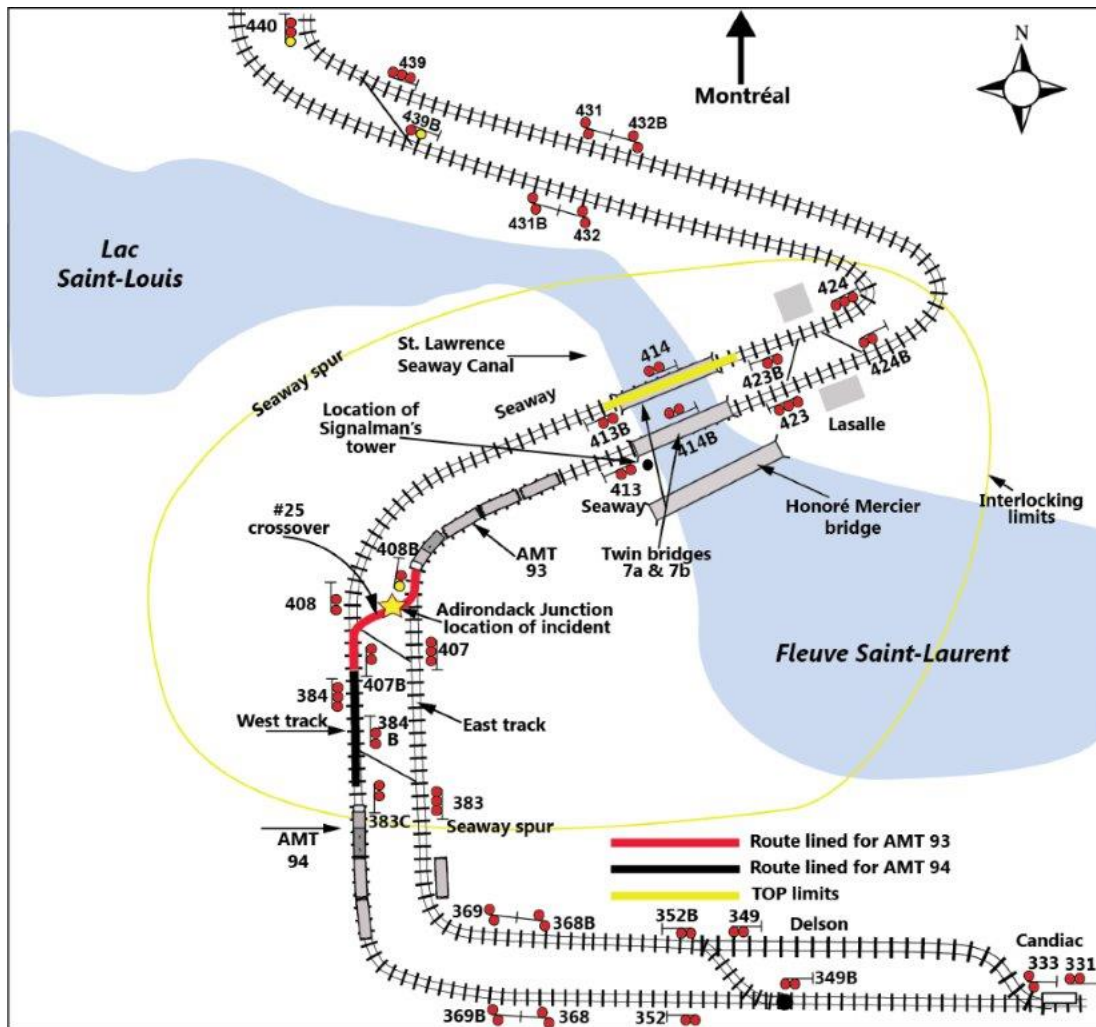
Figure 2. Location of occurrence

On 13 September 2012, at 1715, <sup>1</sup> southbound Agence métropolitaine de transport (AMT) commuter train No. 93 (AMT 93) departed Montréal, Quebec, on the east track of Canadian Pacific's (CP) Adirondack Subdivision, destined for Candiac, Quebec (Figure 1). This regularly scheduled train comprised 1 locomotive and 4 coaches, and was operating with approximately 350 passengers. AMT 93 entered CP's Seaway Interlocking at LaSalle, Mile 42.4, and received a permissive signal at Adirondack Junction, Mile 40.8.

At 1735, northbound AMT commuter train No. 94 (AMT 94) departed Candiac on the west track, destined for Montréal. This regularly scheduled train consisted of 1 locomotive and 4 coaches, and was operating with no passengers. At approximately 1736, AMT 94 was issued a written authority <sup>2</sup> to pass stop signal 383C, located at Seaway Spur, Mile 38.3, within the interlocking, and to continue on the west track.

AMT 93's crew, which was monitoring the standby channel stipulated in the timetable, overheard the Seaway Interlocking signalman's <sup>3</sup> broadcast of the pass-stop authority to AMT 94. Seconds later, AMT 93 passed the permissive medium to stop <sup>4</sup> indication on signal 408B at Mile 40.8 at a speed of 30 mph, and diverged to the west track (Figure 2). The AMT 93 crew members brought their train to a stop. They then contacted AMT 94 and the signalman, and determined that both trains were operating toward each other on the same track. The situation was protected. The 2 trains stopped approximately 2 miles apart.

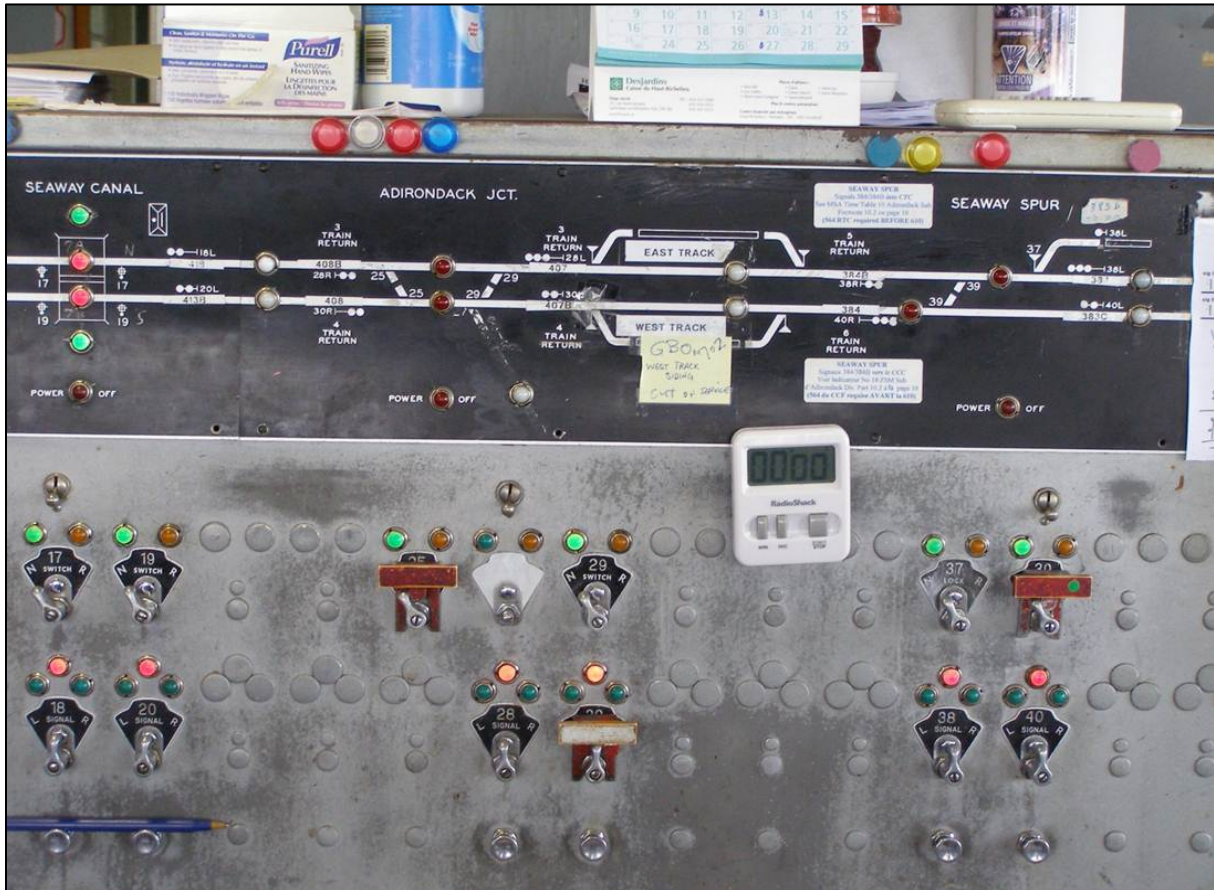
Photo 1. Traffic control board for Seaway Interlocking

The traffic control board in the Seaway tower is manually operated. It is separated into 3 distinct sections (Photo 1):

Unlike more modern rail traffic control systems that provide additional defence barriers, the Seaway Interlocking control system in use at the time of the incident has no associated software logic to trigger automatic blocking or to provide a text-based prompt when there are conflicting movements. The interlocking control system at Seaway depends on the signalman remembering each rule and manually applying adequate blocking (wooden blocks placed over toggle switches) to protect authorities. In addition, the yellow light below the track display indicating that the crossover is in the reverse position may not always be sufficiently compelling to remind the signalman that the switch is not lined correctly. Without a visual display in which track occupancy, signal blocking, and text-based prompts are presented graphically when the limits of a proposed authority are selected, signalmen at Seaway Interlocking who depend on manual signal blocking may not immediately become aware of potential conflicting train movements, increasing the risk of an overlap in authority and the possibility of a collision.

1. Without a visual display in which track occupancy, signal blocking, and text-based prompts are presented graphically when the limits of a proposed authority are selected, signalmen at Seaway Interlocking who depend on manual signal blocking may not immediately become aware of potential conflicting train movements, increasing the risk of an overlap in authority and the possibility of a collision.
2. When proficiency testing cannot adequately verify the operational functions of manual signal blocking, inadvertent actions and decisions by the signalman can remain undetected and uncorrected, increasing the risk of signal blocking errors.

An Agence métropolitaine de transport upgrade project was started that includes the replacement of the old code system (i.e., Seaway Interlocking control system). This project is scheduled for 2015.

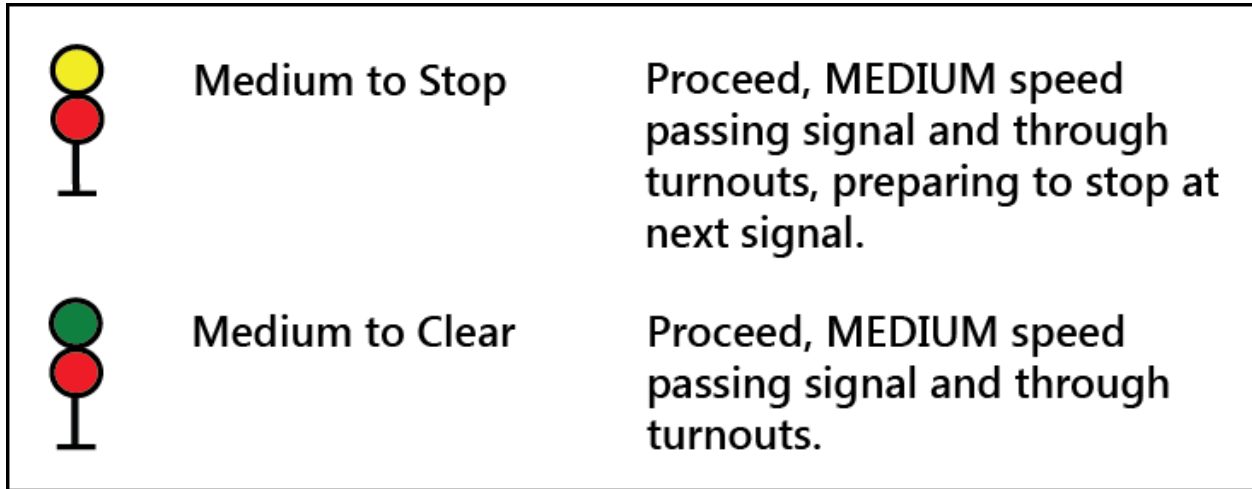
Figure 3. Dwarf signal indications

Within the Seaway Interlocking, all of the station platforms for commuter rail passengers are accessed from the east track. When southbound commuter trains are operating on the east track, to facilitate a station stop and then remain on that track, the most permissive signal indication provided is a medium to stop (yellow/red). However, if a southbound train crosses over on to the west track (i.e., back into normal directional operation), a more permissive signal indication, medium to clear (G/R), can be displayed (Figure 3).

In this occurrence, AMT 93 had a medium to stop indication at signal 408B. The next signal on the west track (signal 384) had not yet been requested by the signalman. This signal indication (medium to stop) was the same indication that a crew would see when lined to continue southward on the east track.

The crew on AMT 93 expected to remain on the east track, given that all passenger platforms are accessed from the east track. Furthermore, the medium to stop signal indication that they received at Adirondack Junction was the same indication that they would expect to see when continuing southward on the east track. Given the signal indication encountered and the expectation that they would be continuing on the east track, it was not until AMT 93 crew members overheard the issuance of the pass-stop authority and saw the switch points that they realized they were lined toward the opposing train.
