**RAILWAY INVESTIGATION REPORT
R12T0038**

**MAIN-TRACK DERAILMENT
VIA RAIL CANADA INC.
PASSENGER TRAIN NO. 92
MILE 33.23, CANADIAN NATIONAL OAKVILLE SUBDIVISION
ALDRSHOT, ONTARIO
26 FEBRUARY 2012**

Report Number R12T0038

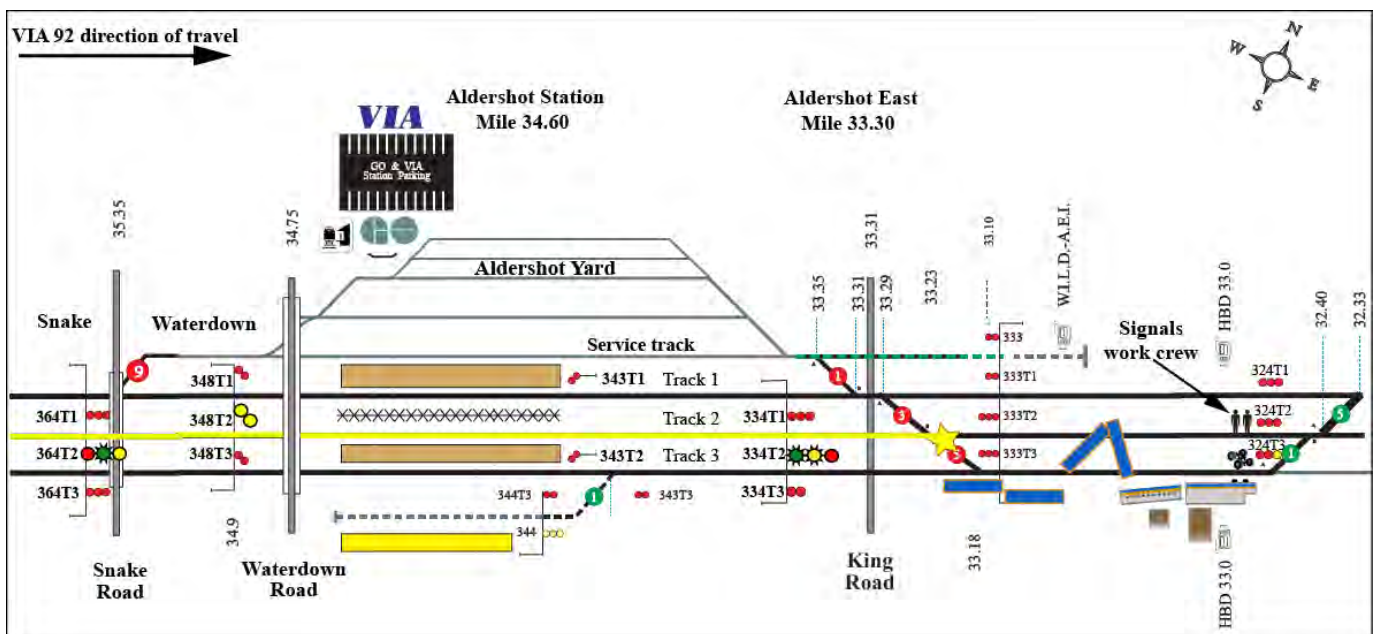
At 1525:43, VIA 92 entered crossover No. 5 while travelling at about 67 mph. The locomotive (VIA 6444) leaned northward briefly, then derailed and rolled to the south. The locomotive slid down the embankment and struck the concrete foundation of a building adjacent to the right-of-way. The entire rear truck of VIA 6444, including the traction motors, separated from the locomotive, derailed and came to rest approximately 1000 feet east of the locomotive. It was straddling track 3 near the location where the signals work crew was working moments earlier. The signals work crew immediately contacted the RTC and reported the accident. The RTC cancelled all nearby permissive signals to protect the site against other train movements and initiated emergency response protocols.

Figure 3. Track schematic and site diagram (not to scale)

At the east end of the No. 5 crossover, there were wheel flange impact marks observed on the guard rail and the frog of turnout 5B, indicating that the locomotive wheels had left the north rail near the frog.

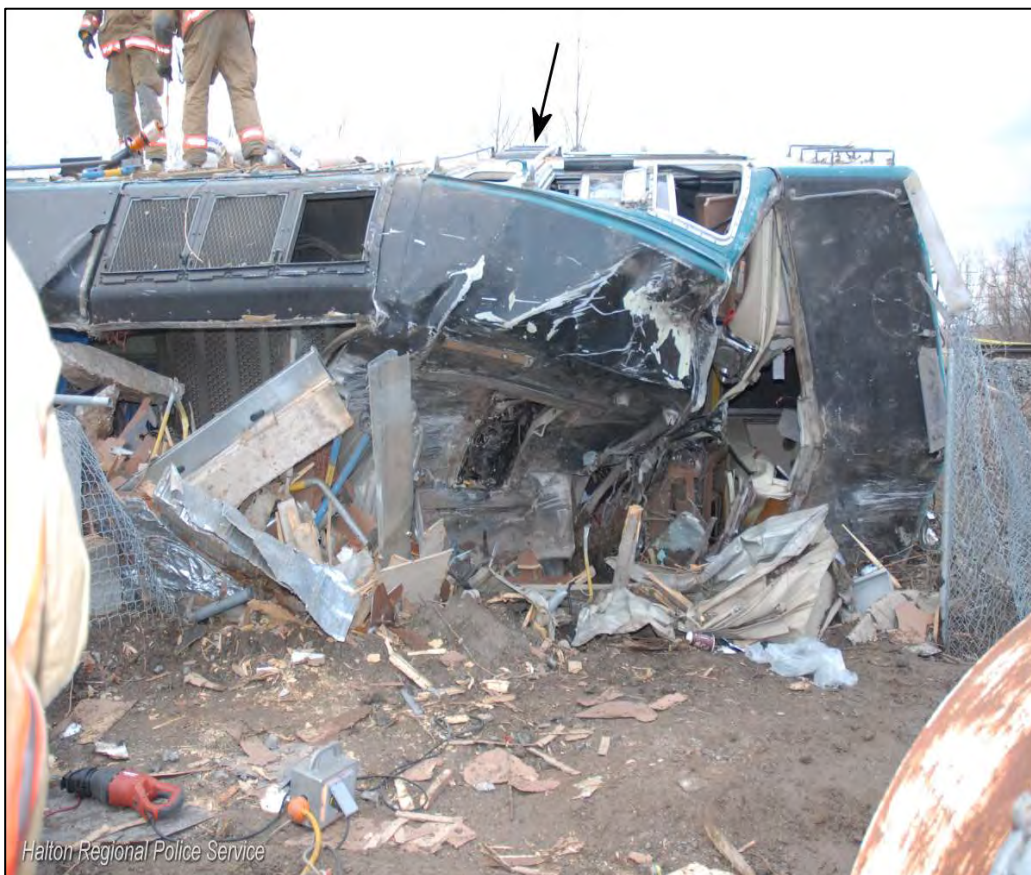
The locomotive and all 5 coaches derailed. In the vicinity of the accident, the tracks are situated at a slightly higher elevation than the surrounding terrain. During the accident, locomotive VIA 6444 and the 1st coach (VIA 3454) slid down the embankment, rolled and came to rest on their sides. The train and its air brake line remained connected and intact. The front locomotive truck was on the side of the embankment, partially attached to the locomotive by cables. The locomotive cab area just above the front nose had struck the foundation of a building adjacent to the track. The building foundation was heavily damaged, while the cab roof had completely collapsed, resulting in extensive damage to the cab interior (see Photo 1).

Photo 1. VIA 6444 on its side with collapsed cab roof. ICLE door on top (source: Halton Regional Police).

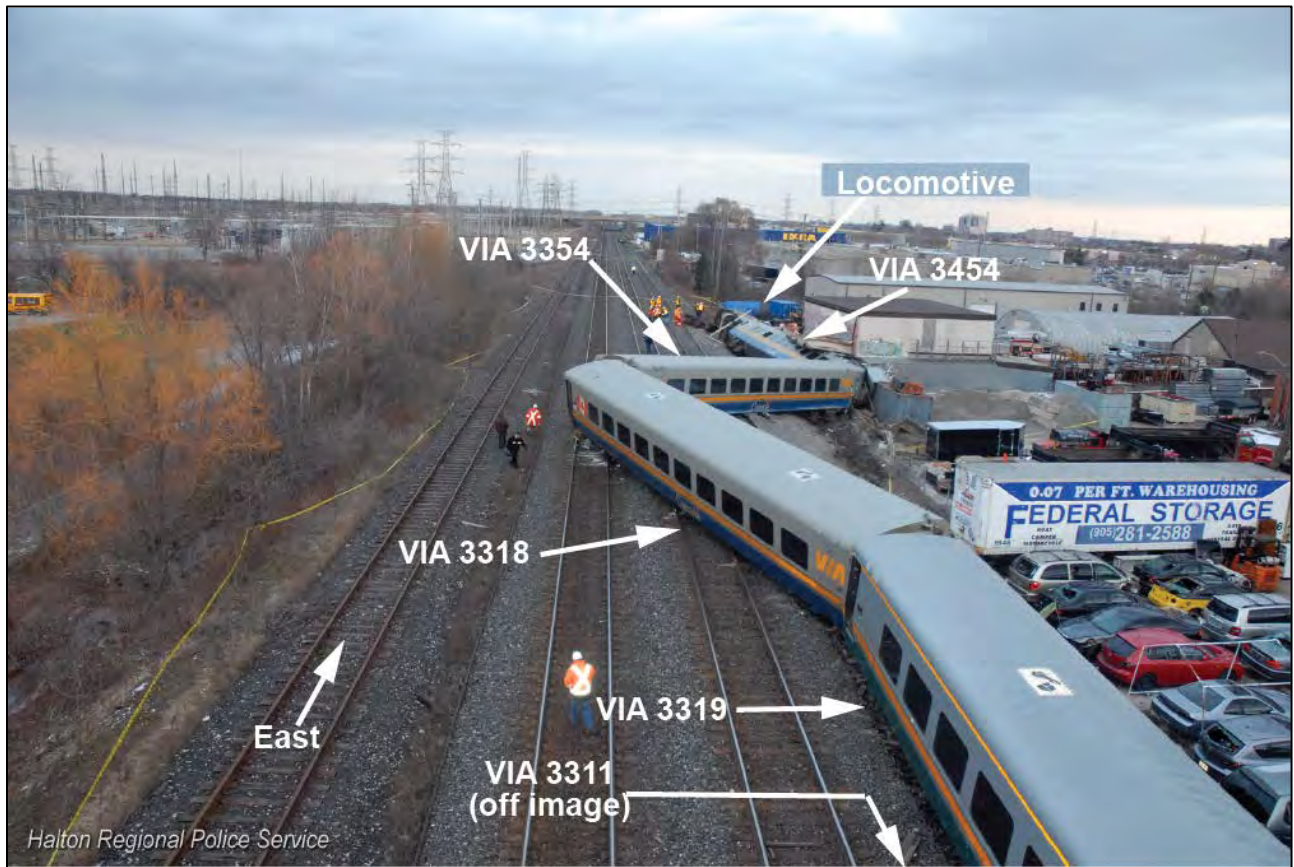
The majority of the passengers were travelling in the first 2 coaches, both of which were heavily damaged. The 2nd coach (VIA 3354) and the 3rd coach (VIA 3318) had jackknifed. The front portion of the 2nd coach had slid down the embankment. The 2nd and 3rd coaches had come to rest foul of track 2. The 4th coach (VIA 3319) and the 5th coach (VIA 3311) remained upright on the right-of-way just south of track 3 and sustained minor impact damage (see Photo 2).

Photo 2. Accident site looking eastward (source: Halton Regional Police)

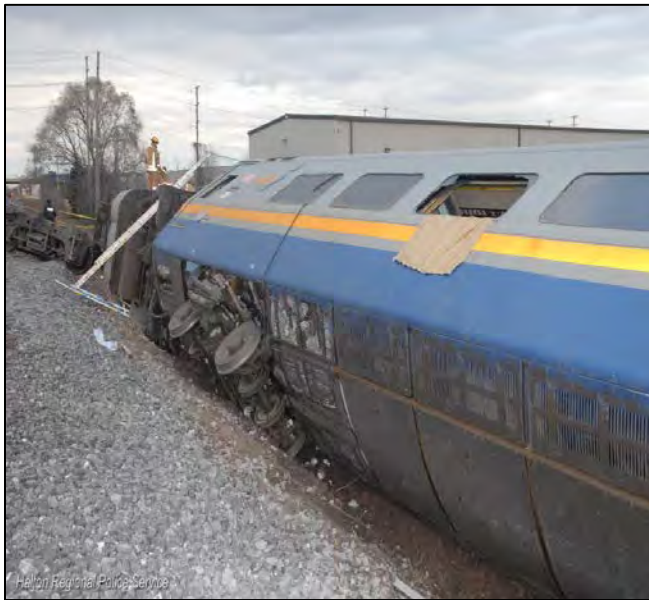
Photo 3. Emergency window exit used on VIA 3454 (source: Halton Regional Police)

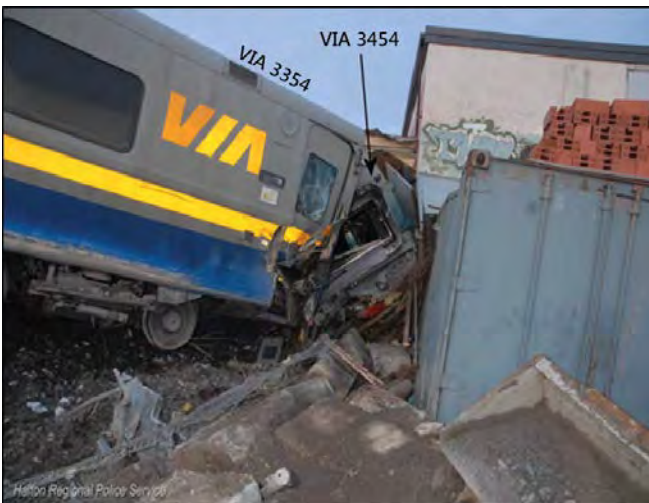
Photo 4. The trailing end door of the 1st coach was cut open while both side doors of the 2nd coach (VIA 3354) were jammed (source: Halton Regional Police)

While the west end door of the 1st coach was partially open, it was bent during the accident and could not fully open (see Photo 4). Subsequently, the door was cut away to aid with the evacuation. Additional ladders were provided to allow emergency responders to gain access to the coach and to allow passengers to evacuate from the coach. It was difficult for many of the passengers and emergency responders to make their way over the seats of the overturned coach to the available exits.

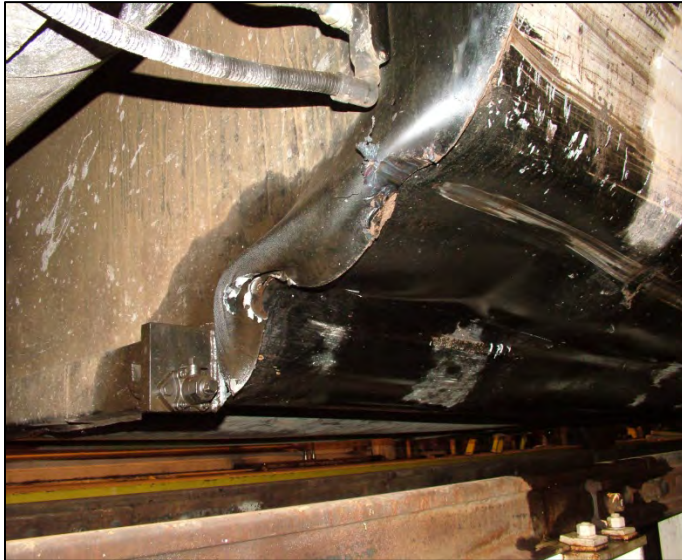
Photo 5. Dented fuel tank on VIA 6444 (source: TSB)

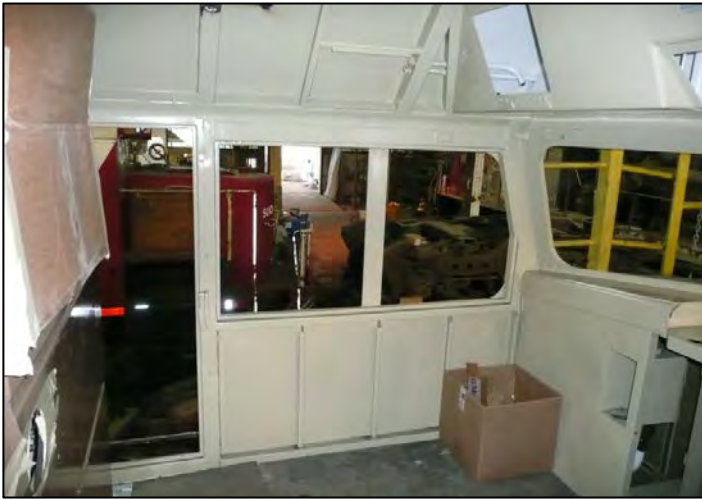
The front nose section of the GM F40PH-2D locomotive contains 2 substantial collision posts to protect against frontal collision. In comparison, the roof structure and cab sides were constructed with various configurations of light gauge steel (see Photo 9). The roof frame structure consisted of a number of steel U-channels that were fabricated into a 2½-inch square tube (see Photo 10). The wall thickness of the tube was 0.120 inch (just under 1/8 inch) while the roof sheeting was 0.135 inch thick (just over 1/8 inch). There was no significant corner post structure and no roof reinforcement.

Photo 9. Exposed cab interior structure, conductor side (source: TSB)

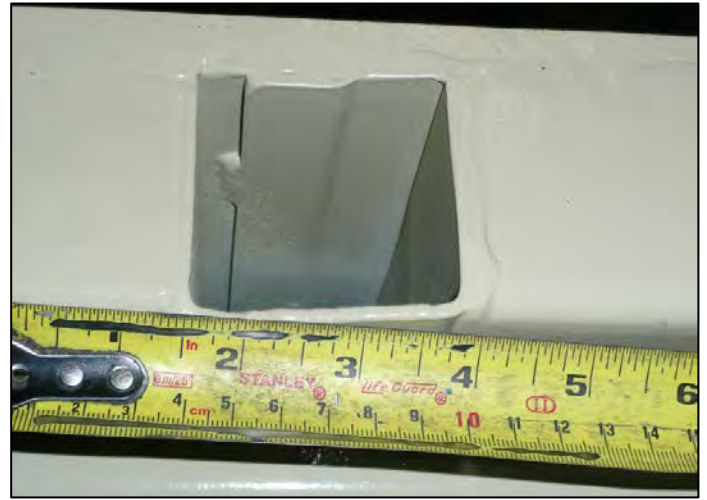
Photo 10. Tubing used for roof framing structure. Roof sheeting at top of photo (source: TSB).

During the rebuild, there was no structural upgrade in the area of the cab to protect against rollover or impact. This rebuild did not include the structural requirements outlined in Part II of the *Locomotive Safety Rules* and nor was it required. Once rebuilt, the service life of these locomotives can extend up to 40 years or longer if rebuilt again in the future. Such rebuild programs are not uncommon in the rail industry.

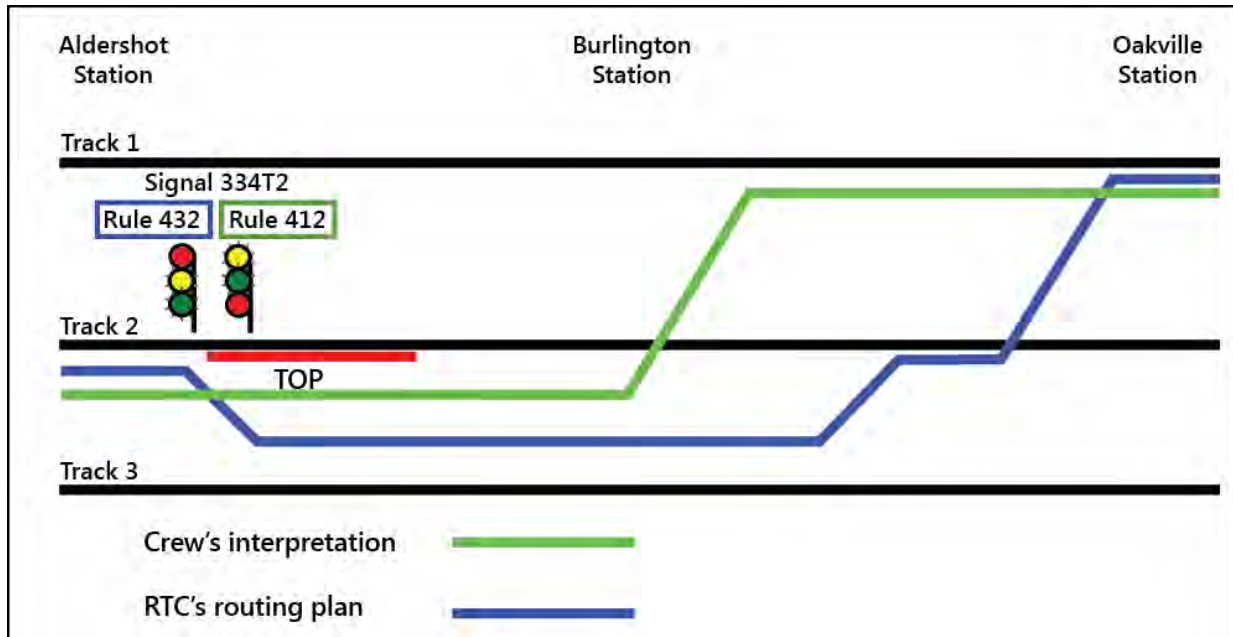
are usually routed through the 45 mph crossovers near Burlington, crossing from track 2 to track 3 using a 15 mph crossover in order to get to track 1, while in accordance with operating practice, would have been an unusual routing that is rarely used (see Figure 6).

Figure 6. RTC routing versus likely expectation of VIA 92's crew

The crew's advance knowledge of an upcoming wheelchair passenger disembarkment at Oakville may have created an expectation that they would remain on track 2 and cross over from track 2 to track 1 near Oakville, which reinforced the perception bias towards a permissive signal indication.
