**RAILWAY INVESTIGATION REPORT  
R13C0069**

**BRIDGE FAILURE AND DERAILMENT**

**CANADIAN PACIFIC RAILWAY  
FREIGHT TRAIN 292-26  
MILE 172.5, BROOKS SUBDIVISION  
CALGARY, ALBERTA  
27 JUNE 2013**

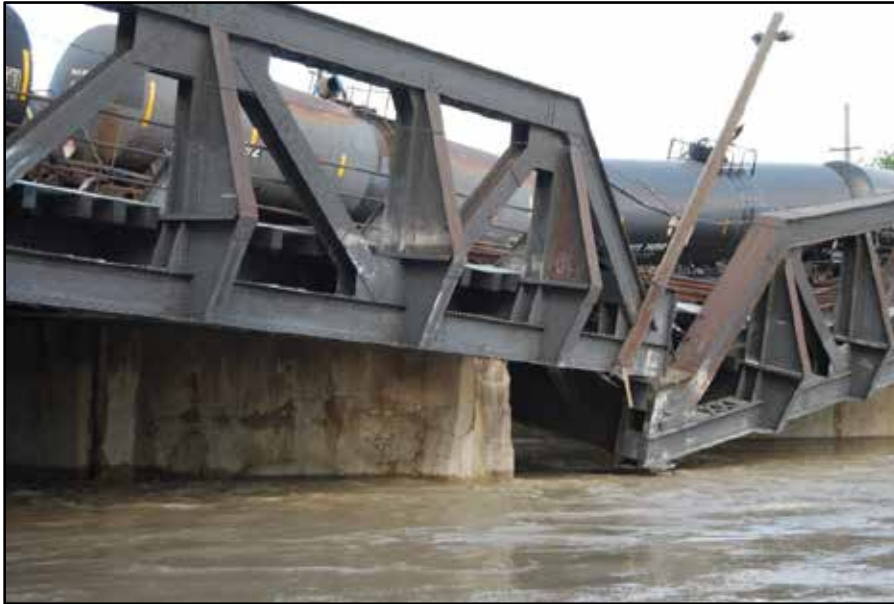
At 0314, with the train travelling at 9 mph, a train-initiated emergency brake application occurred. The train stopped 22 seconds later. After making the necessary emergency broadcast and notifying the rail traffic controller (RTC), the conductor performed an inspection and determined that 6 tank cars (the 63<sup>rd</sup> car to the 68<sup>th</sup> car) situated on the Bonnybrook Bridge had derailed in an upright position. The bridge failed at the Pier no. 2 location, under the 67<sup>th</sup> and 68<sup>th</sup> cars (Photo 1). There were no injuries, and there was no loss of product.

Photo 1. The bridge failure and derailment (with river flow left to right)

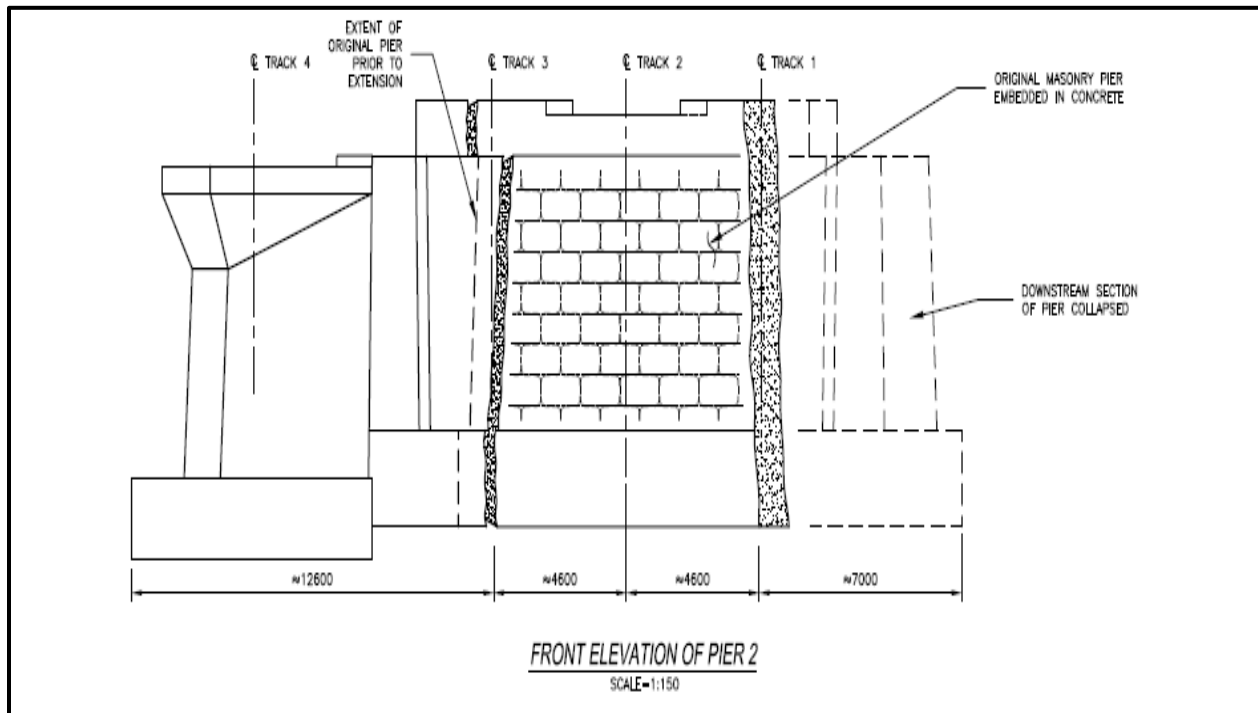
Figure 1. Diagram of Pier no. 2, showing the locations of fractures (shaded areas) (Source: Canadian Pacific Railway [CP])

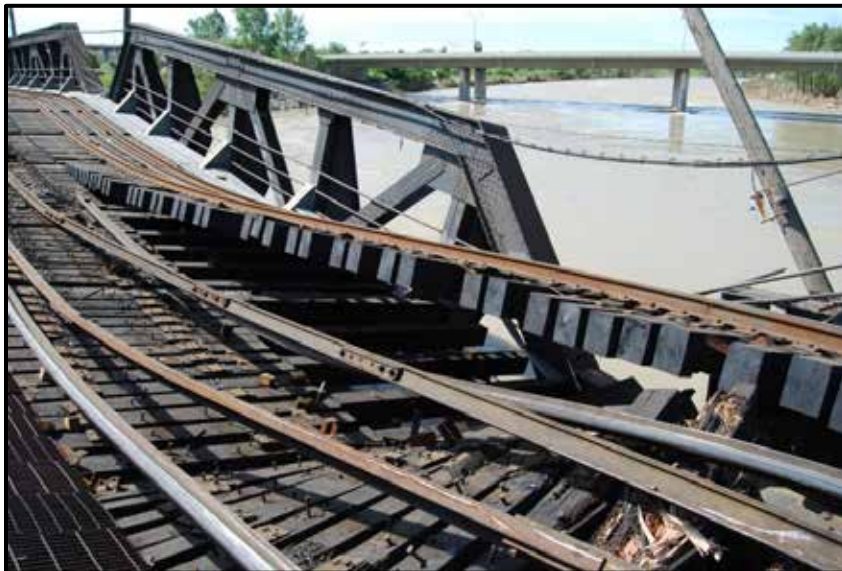
- The west end of TTP span no. 2 and east end of TTP span no. 3 were unsupported and extensively damaged.
- The north side bottom chord of TTP span no. 2 was bent.

- Stringers, floor beams, connections, and floor system bracing on TTP spans no. 2 and no. 3 were bent and torn, and had failed in many locations.
- Span bearing components and anchor bolts under the south truss at Pier no. 2 were missing.

Photo 4. Bridge deck at Pier no. 2, showing tracks P1 and P2 after removal of the tank cars, with Ogden Road Bridge in the background

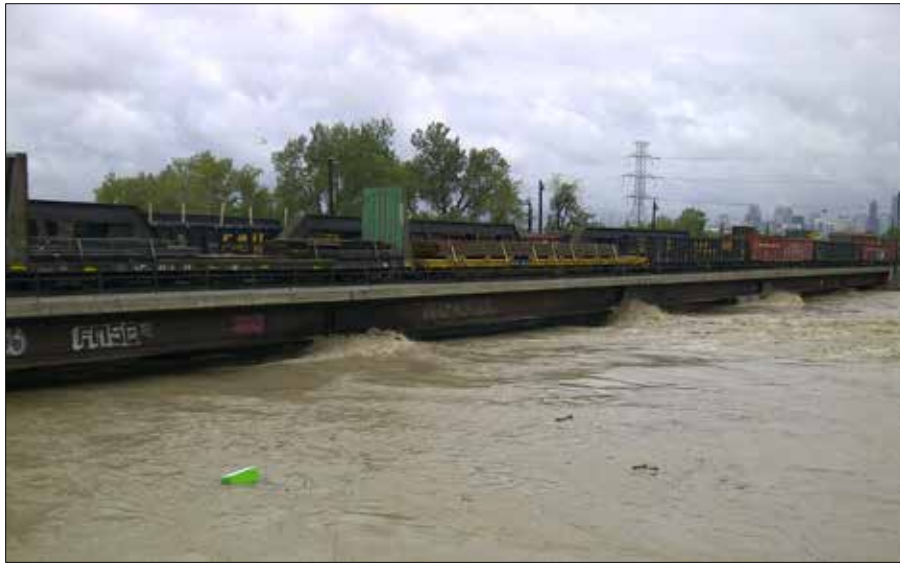
Between 20 June and 24 June, there were 18 bridge inspections (including measurement of water elevation) by CP engineering supervisors. During the height of the flood (21 June), the water level had risen to about 8 inches below the bridge girders (Photo 5 and Photo 6).

Photo 5. Bonnybrook Bridge (from upstream) on 21 June, at the height of the flood (Source: CP)

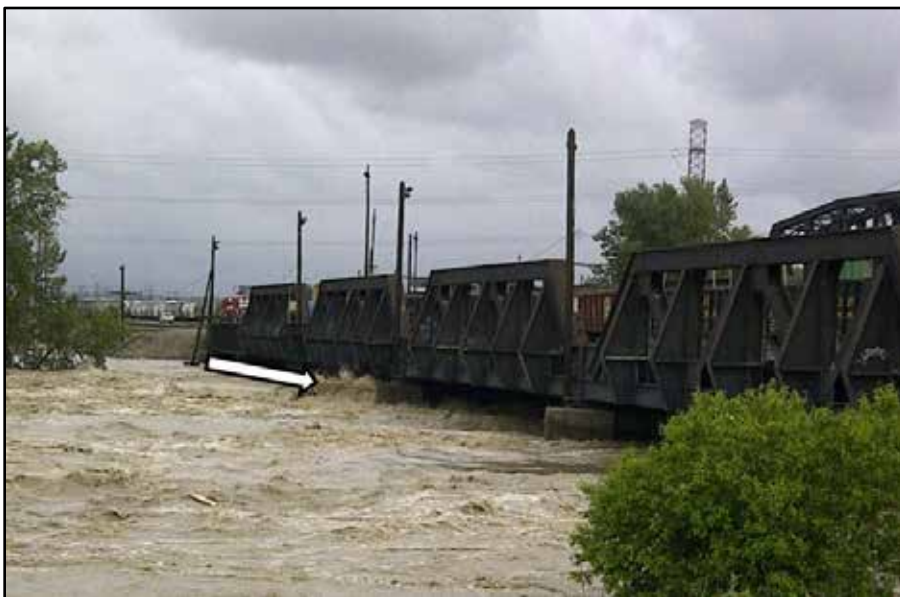
Photo 6. Bonnybrook Bridge (from downstream) on 21 June

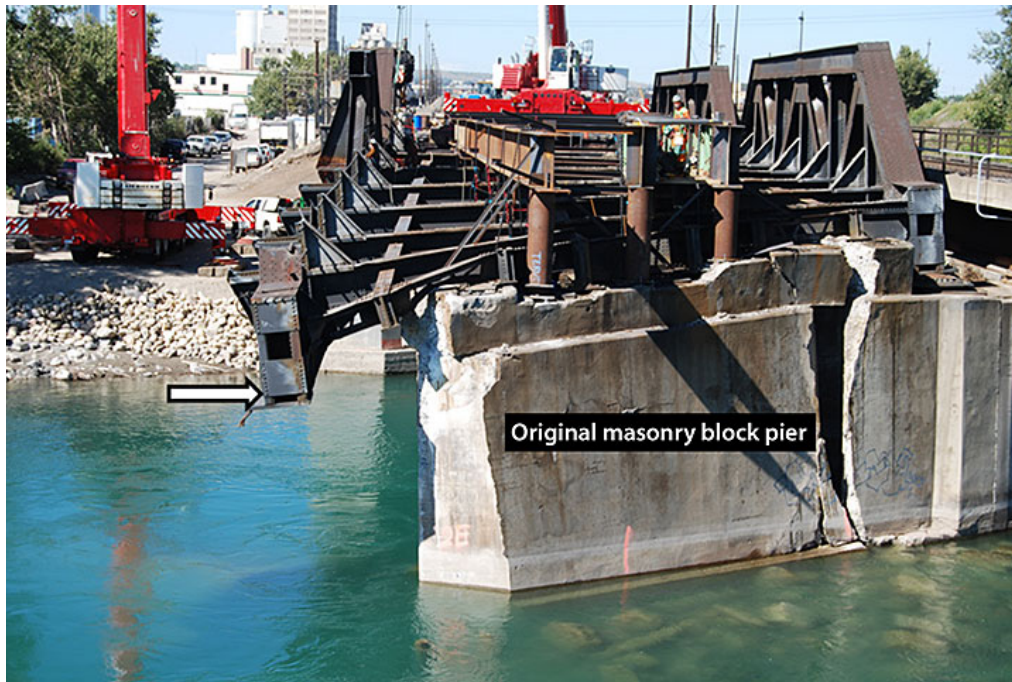
Post-accident photographs taken 04 September 2013, when the river level had subsided, show that the upstream 1912 extension had separated from the original masonry block pier (Photo 7 and Photo 8). The river bottom can also be seen in these photographs. During some of the dry months (e.g., September), the foundation of Pier no. 2 can be completely out of the water.

Photo 7. An arrow indicates the unsupported span bearing. (River flow is right to left.)

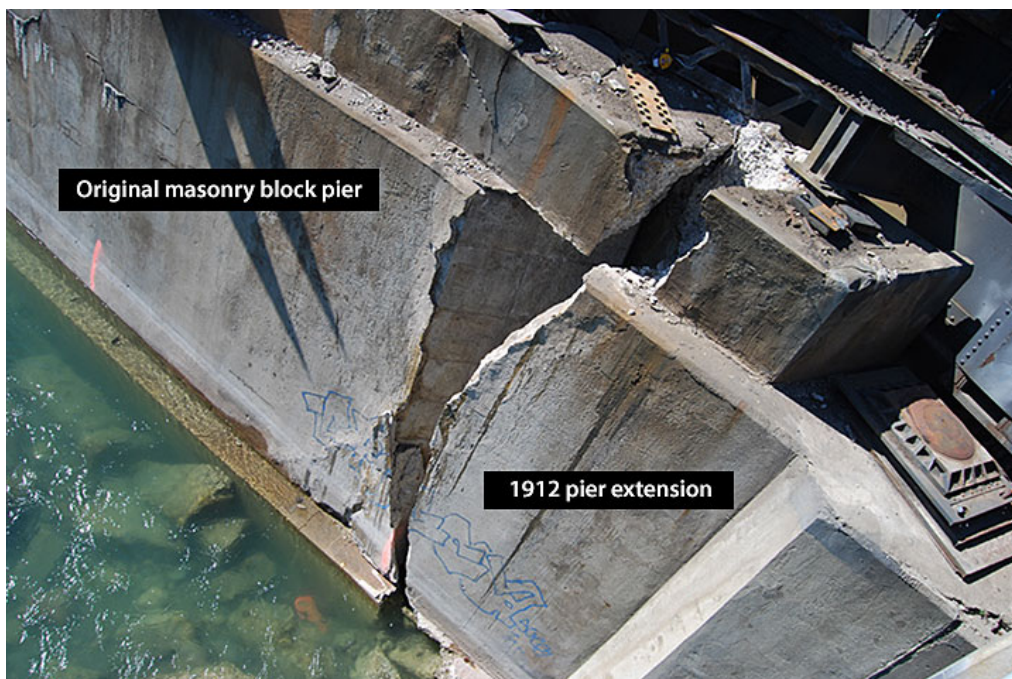
Photo 8. Separation of the 1912 pier extension from the original masonry block pier

As train 292 travelled eastward over the Bonnybrook Bridge, the bridge failed under the train, resulting in the derailment of 6 cars. The bridge failed due to scour, which caused the loss of foundation at Pier no. 2. The foundation failure resulted in the clean separation of the 1912 downstream concrete extension from the original masonry block pier.

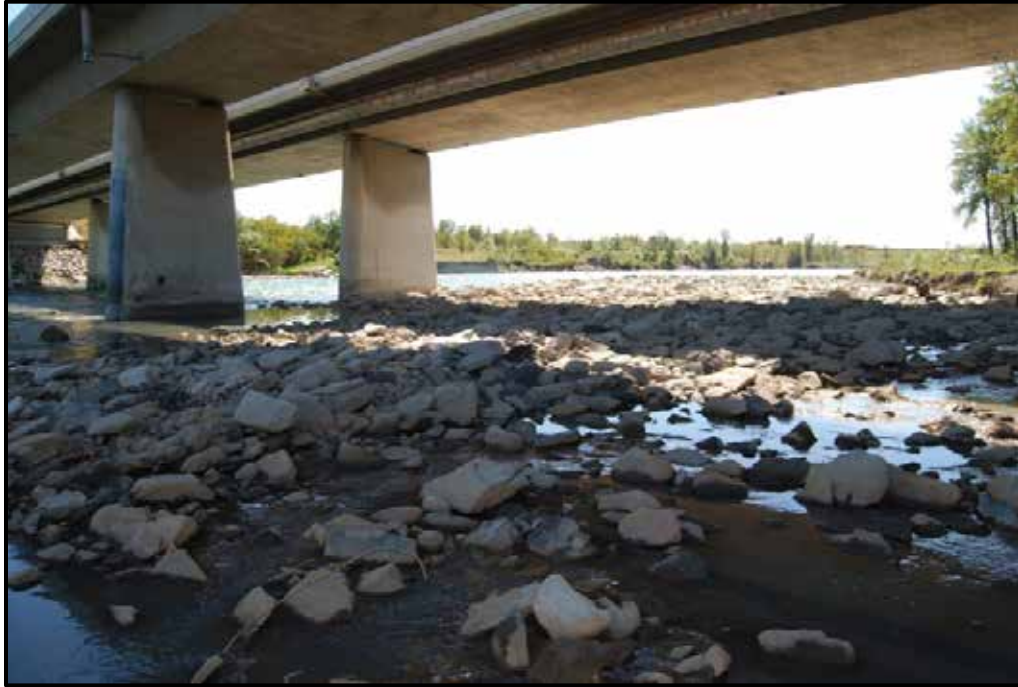
Photo 9 (taken in September 2013) shows a rock bar deposited downstream under the Ogden Road Bridge. Some of the broken-up bedrock deposited at this location had likely originated from under and around Pier no. 2 of the Bonnybrook Bridge.

Photo 9. Broken up bedrock and rubble deposited under Ogden Road Bridge, downstream of Bonnybrook Bridge

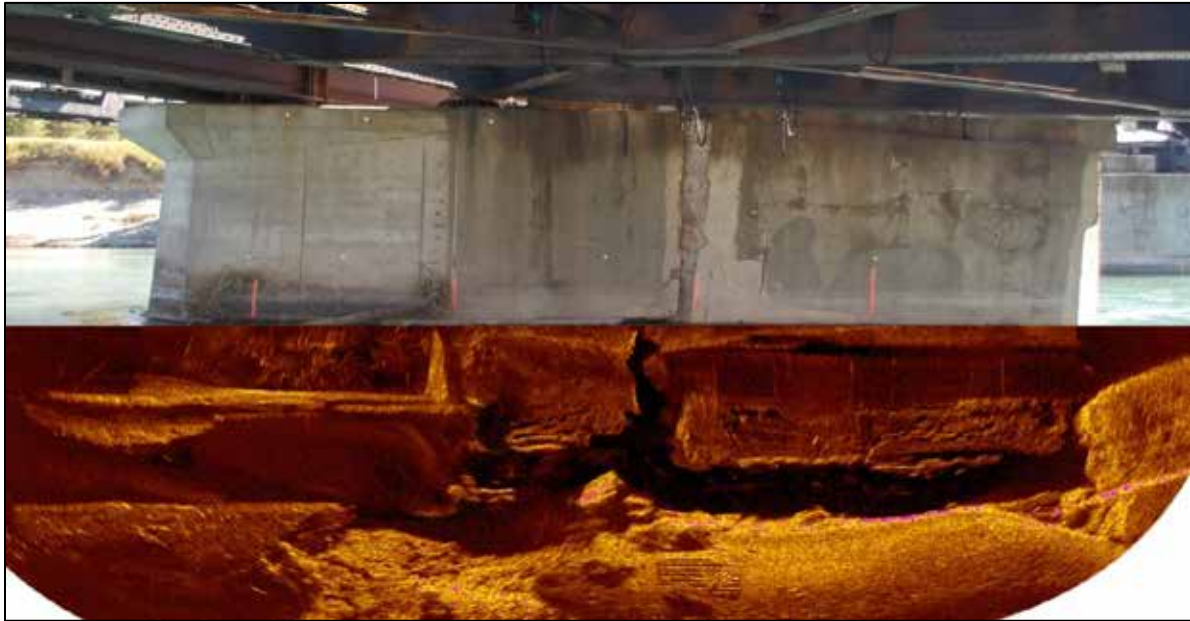
Underwater inspection of Pier no. 2 of the Bonnybrook Bridge was not possible during the flood, due to the high volume and high flow rate of the silty flood water. However, on 28 June 2013 (after the accident), a bathymetric survey<sup>13</sup> was conducted. This survey identified a scour hole on the downstream side of Pier no. 2. The survey images indicated that scour of more than 1 m was present downstream of Pier no. 2, and that much less scour was present around the other piers.

Photo 10. Sonar image of the west side of Pier no. 2, showing the extent of scour

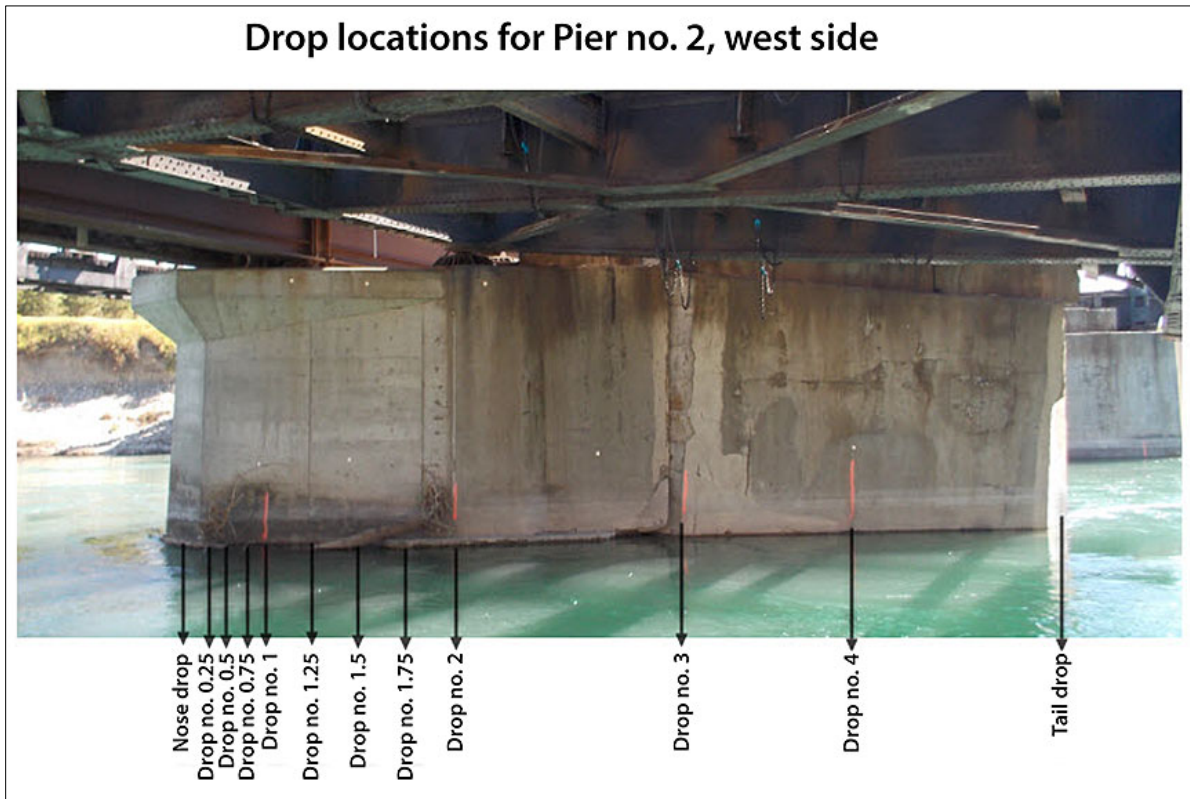
Photo 11. Drop locations for sonar cross-sections of the west side of Pier no. 2

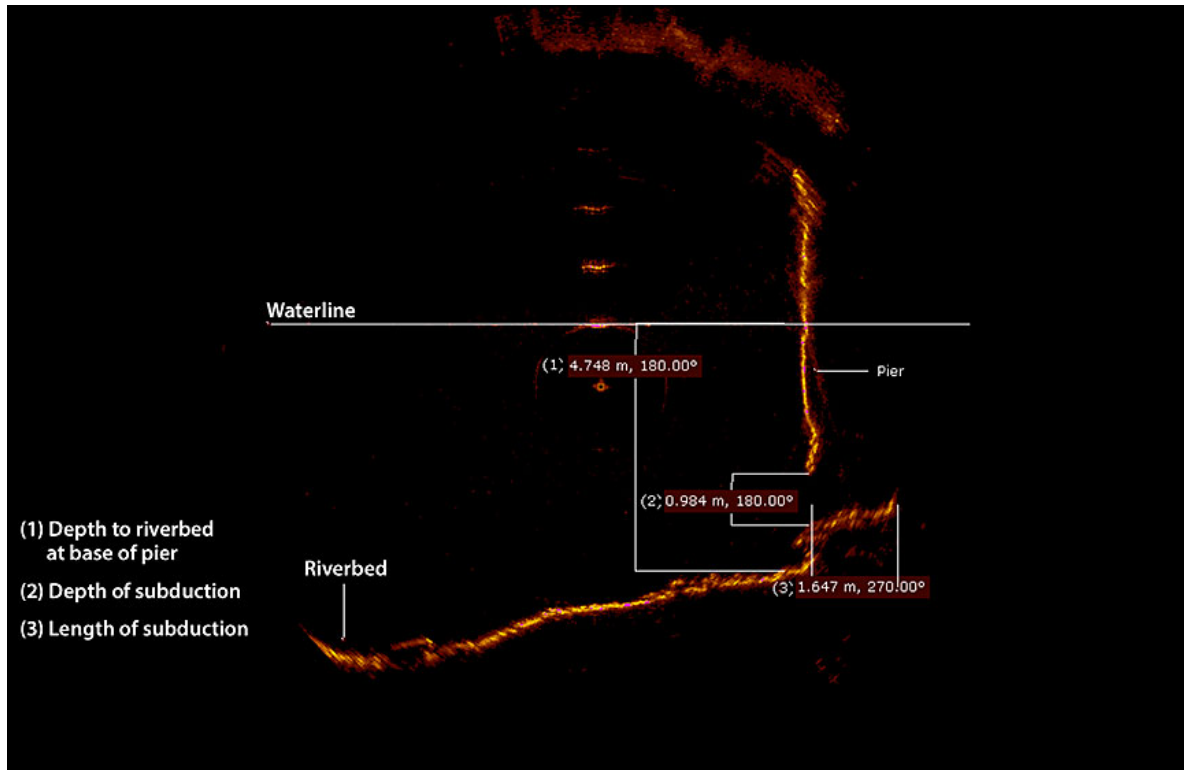
Figure 5. Sonar image of drop no. 2

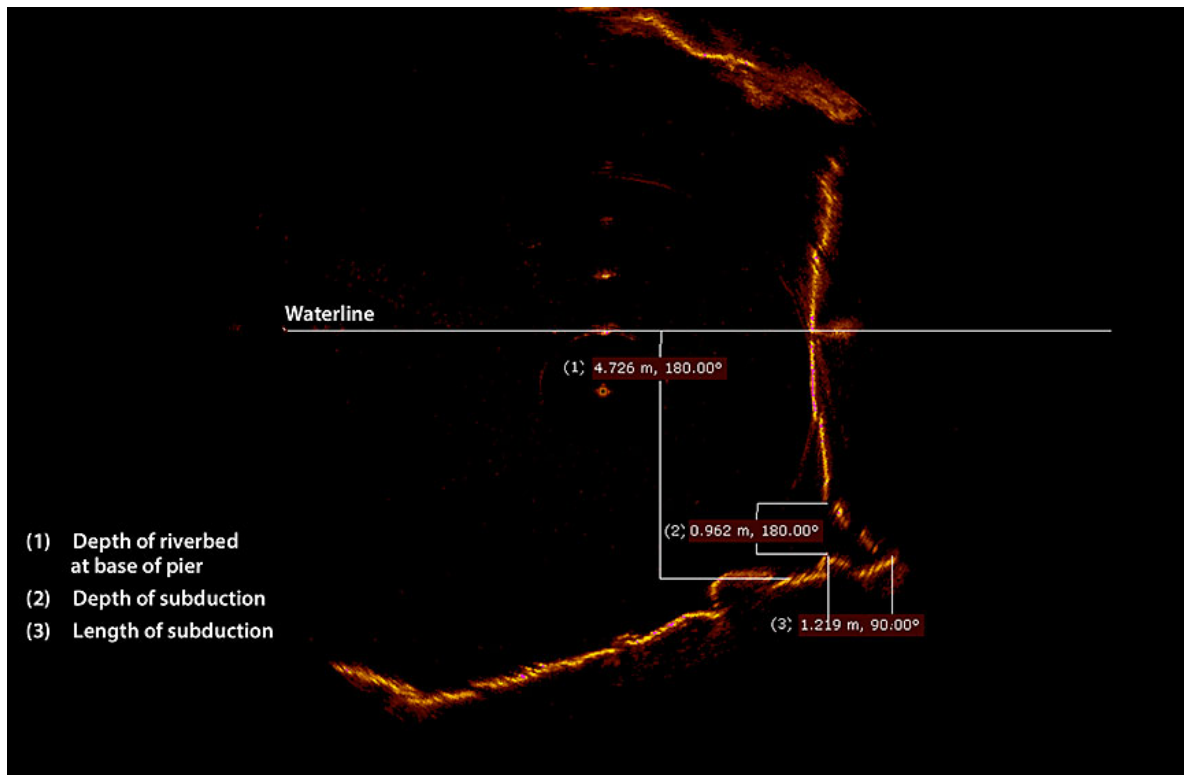
Figure 6. Sonar image of drop no. 3

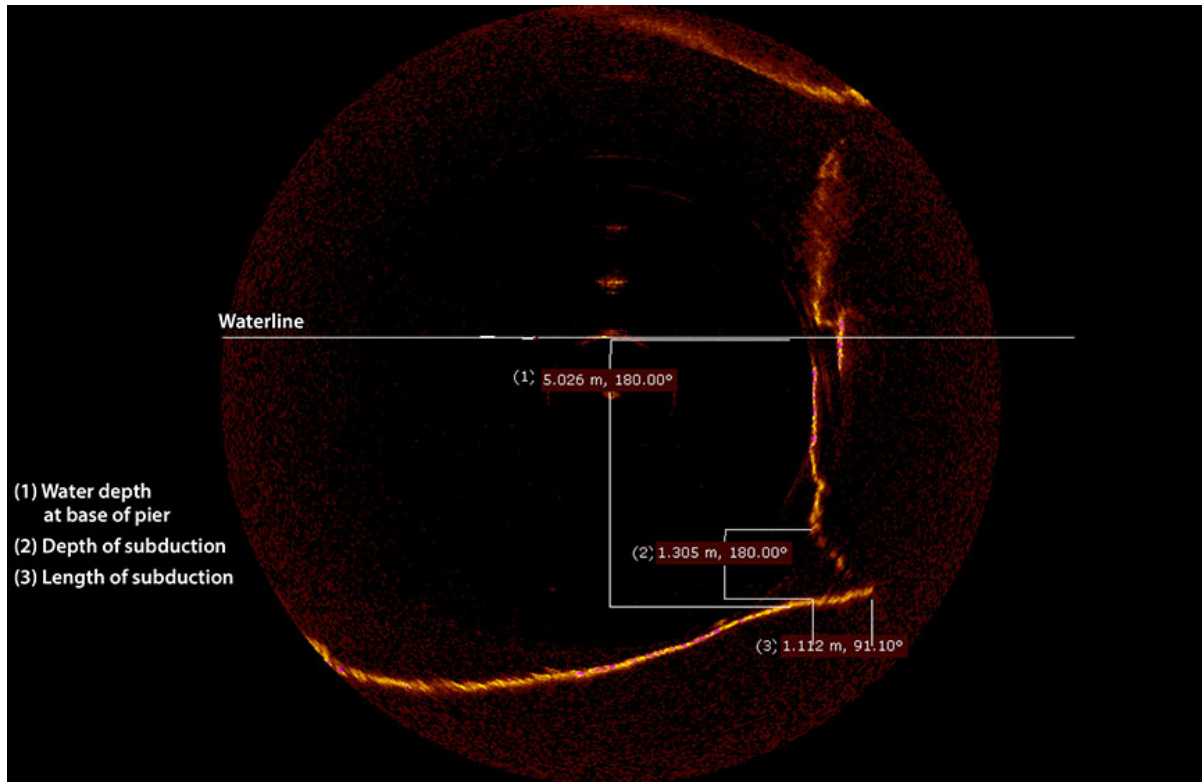
Figure 7. Sonar image of drop no. 4
