**RAILWAY INVESTIGATION REPORT  
R14W0256**

**MAIN-TRACK DERAILMENT  
CANADIAN NATIONAL RAILWAY  
FREIGHT TRAIN A40541-05  
MILE 74.58, MARGO SUBDIVISION  
CLAIR, SASKATCHEWAN  
07 OCTOBER 2014**

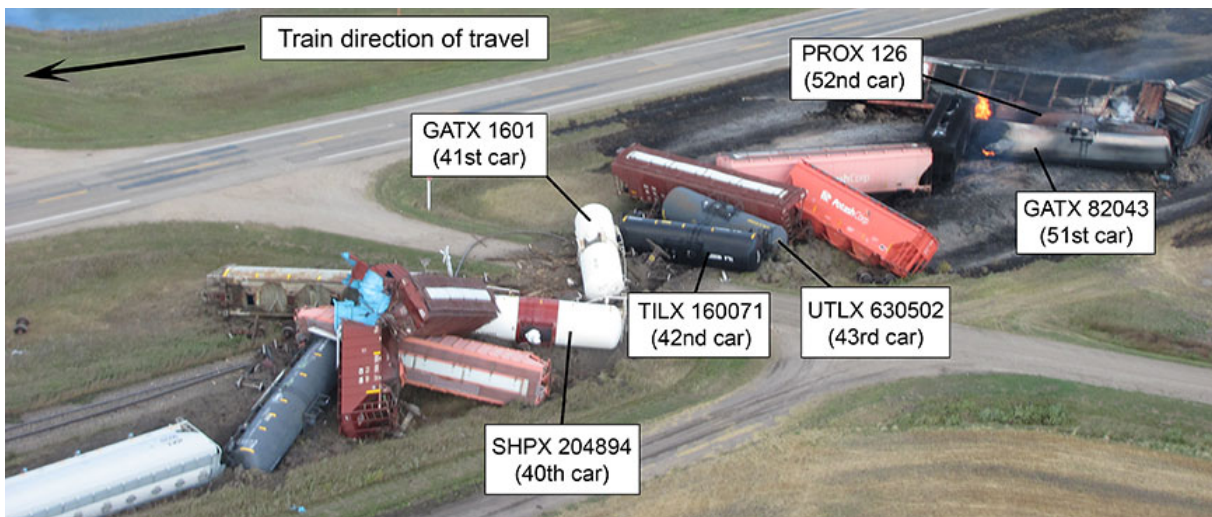
Tank car GATX 82043 sustained impact damage to its shell and A-end head which resulted in a release of product. The released product ignited and fed the post-derailment pool fire. Tank car PROX 126, which remained in the pool fire, sustained 2 thermal tears. Nearly all of the contents of these 2 cars were consumed in the fire.

Photo 1. Derailment site looking northeast (Source: Saskatchewan Ministry of the Environment)

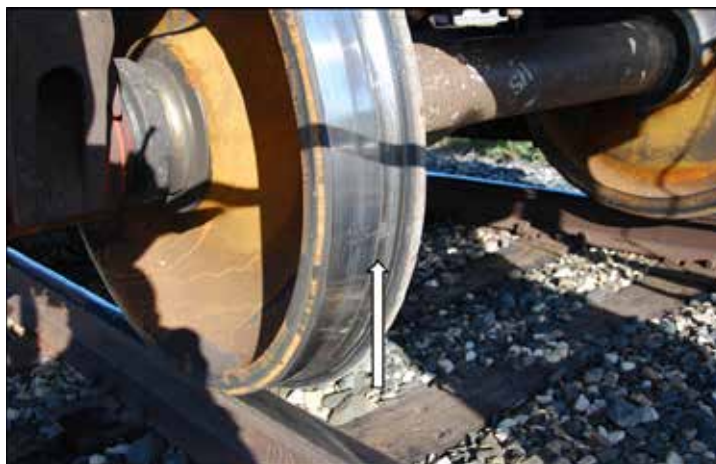
During the site examination, the wheels of the head end cars that did not derail were examined. The wheels of the 31st car, DOWX 3282, a DG tank car loaded with ethanolamine (UN 2491), exhibited impact marks on the wheel tread (Photo 2).

Photo 2. Impact mark on the wheel tread of the trailing wheel of the 31st car (DOWX 3282)

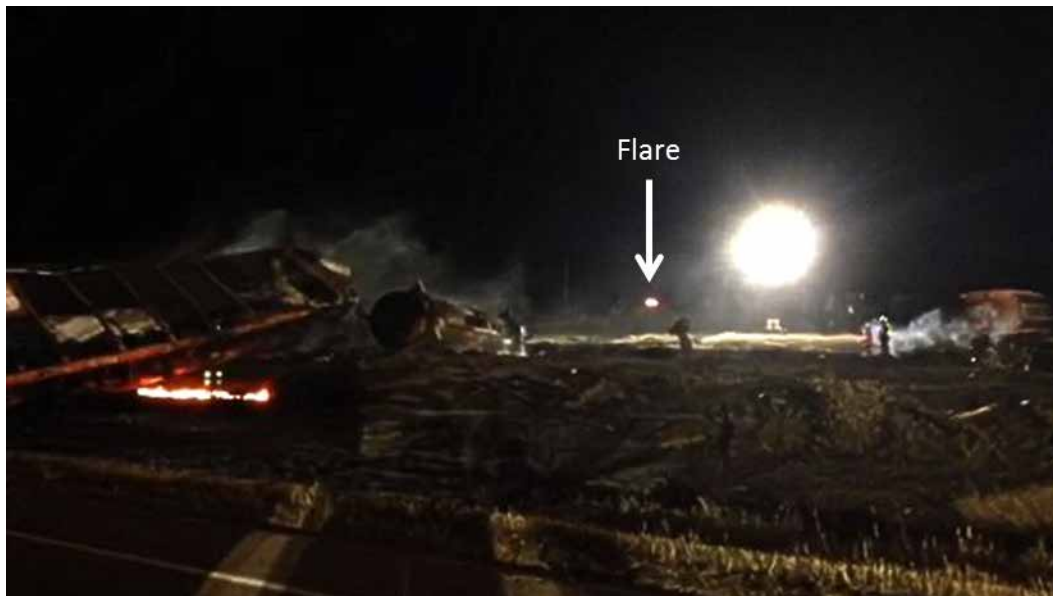
The flare was thrown into the pool near the base of the tank (Photo 3).

Photo 3. Flare thrown into pool of product (Source: Assistant fire chief, Wadena Fire Department)

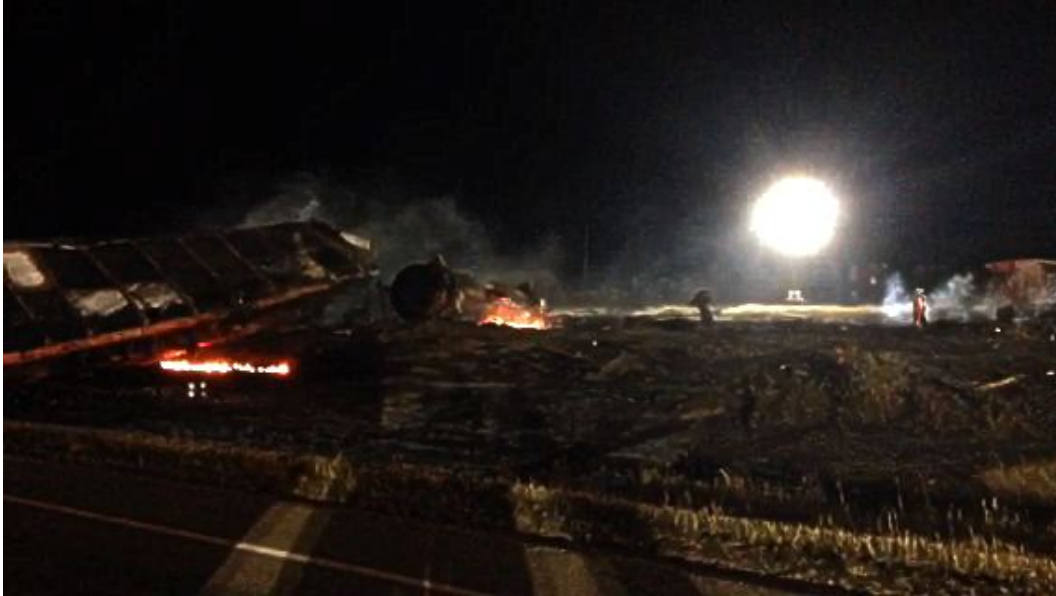
The product pool ignited and began to burn at the base of the tank car (Photo 4) when an unexpected flash fire occurred as the vapors inside the breached tank car ignited, sending a large fire ball toward the CN SDGO and AVP (Photo 5).

Photo 4. Ignition of product pool (Source: Assistant fire chief, Wadena Fire Department)

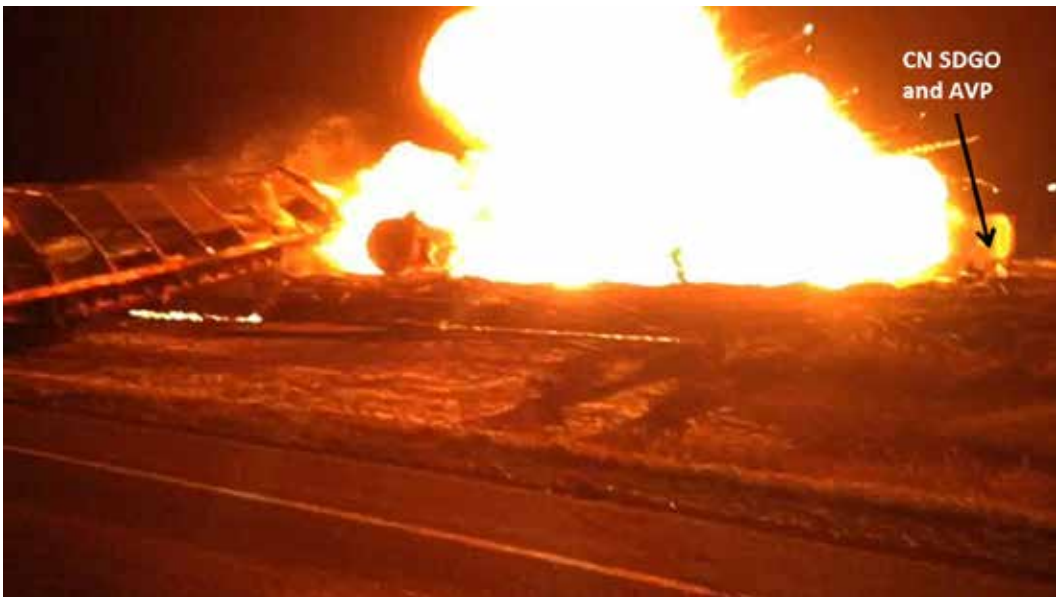
Photo 5. Flash fire (Source: Assistant fire chief, Wadena Fire Department)

Both took immediate evasive action as the fire ball blew over them and then quickly extinguished itself. The SVPW and VPSS, who were on site at the time, immediately approached the CN SDGO and AVP. There were no injuries. Subsequently, wrecking activities continued.

Subsequent to the close-call during the flaring activity, an incident debriefing occurred during a CN DG Team conference call about 3 weeks after the derailment. After a discussion, it was decided to draft a controlled burn procedure that references the importance of openings in the car where a similar pressure event could take place and, if possible, ensure the ignition source is introduced at a 90-degree angle to the opening. The first draft DG Team Standard Operating Guideline (SOG) 200.16, entitled *Controlled Burn*, was prepared by September 2015. The SOG was issued on 07 January 2016, 15 months after the close-call.

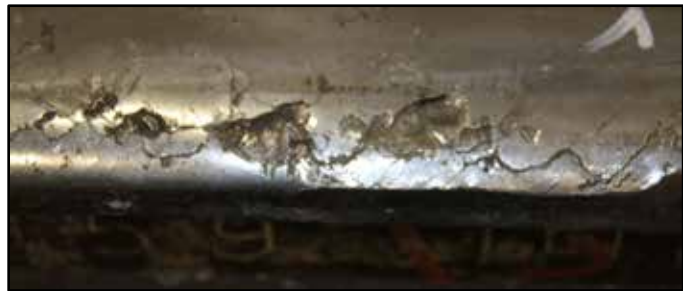
Photo 6. Shelling on the gauge face of the rail

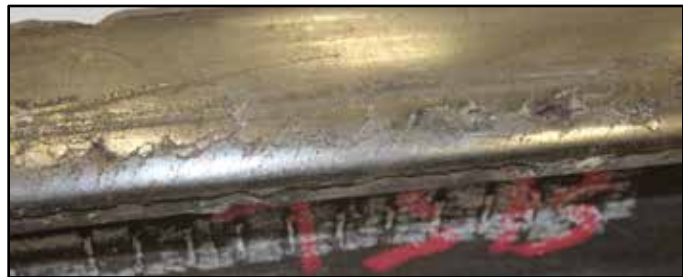
Photo 7. Head checking on the gauge face of the rail

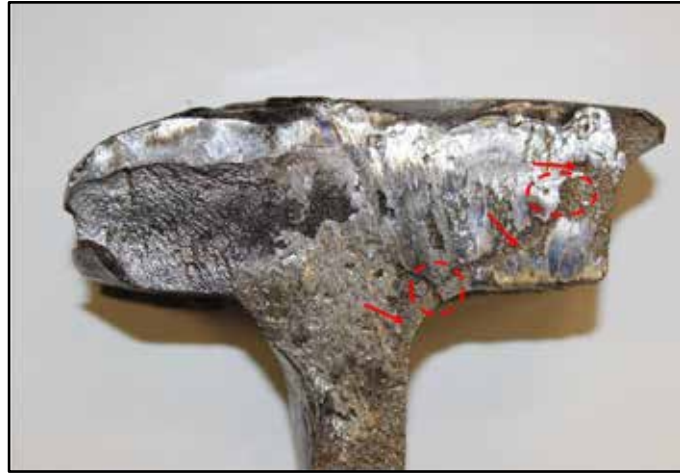
the head. The crack experienced recent growth to approximately 85% of the cross-sectional area of the rail head. The remaining rail section then failed in overstress (Photo 8).

5. Examination results indicate that the detail fracture occurred at the location where a 3.5 mm deep LSC had been detected on 18 July 2014, some 12 weeks before the occurrence.
6. Rail pieces No. 2, No. 3 and No. 4 had each fractured in overstress. These fractures likely occurred during the derailment, resulting in post-separation impact damage.
7. The gauge and field side head wear measurements showed that the rail head had been slightly deformed by compressive loading from passing rail cars.

Photo 8. West fracture face of rail piece No. 1 – (Note: Red arrows show the boundary of the detail fracture. Gauge is to the left, field to the right. Red circles indicate areas where fatigue striations were observed.)

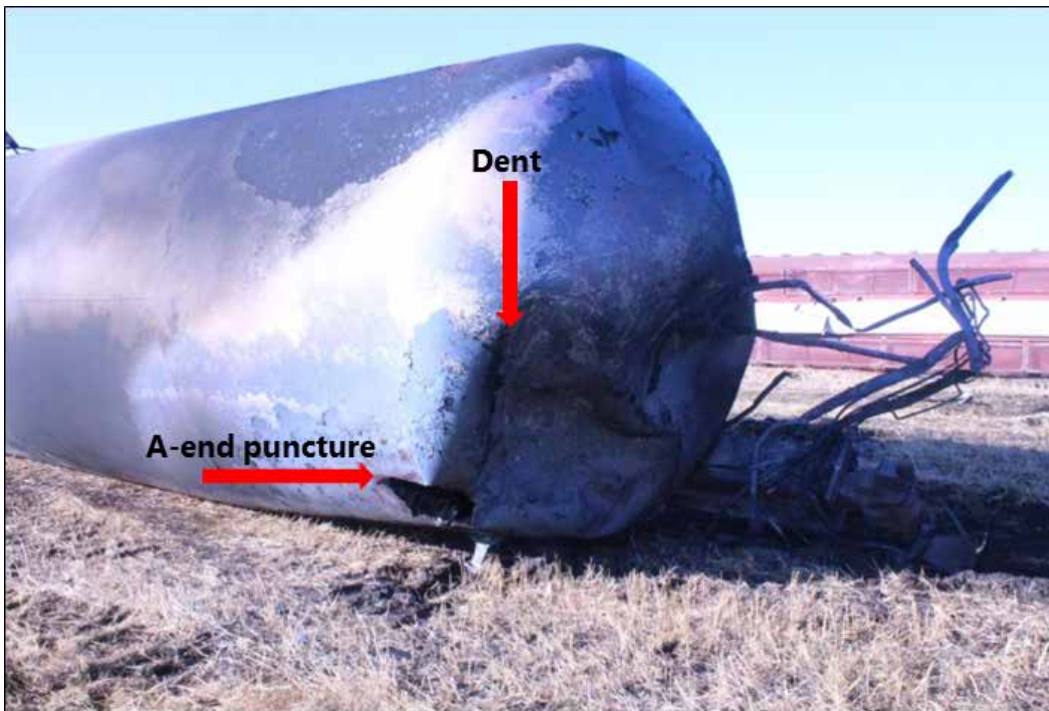
- GATX 82043 (the 51st car) was built in 1998 to the DOT 111A100W1 specification. The tank shell and tank head were constructed with  $\frac{7}{16}$ -inch-thick TC128 Grade B steel. The car was fitted with a BOV, top fittings, a protective housing, a hinged and bolted manway, and PRD. This car sustained a breach from impact damage to its tank shell and A-end tank head, resulting in the release of product that fed the post-derailment fire (Photo 9). The car was not equipped with a jacket, thermal protection, head shields, or top discontinuity protection.

Photo 9. GATX 82043 A-end head and shell dented and punctured

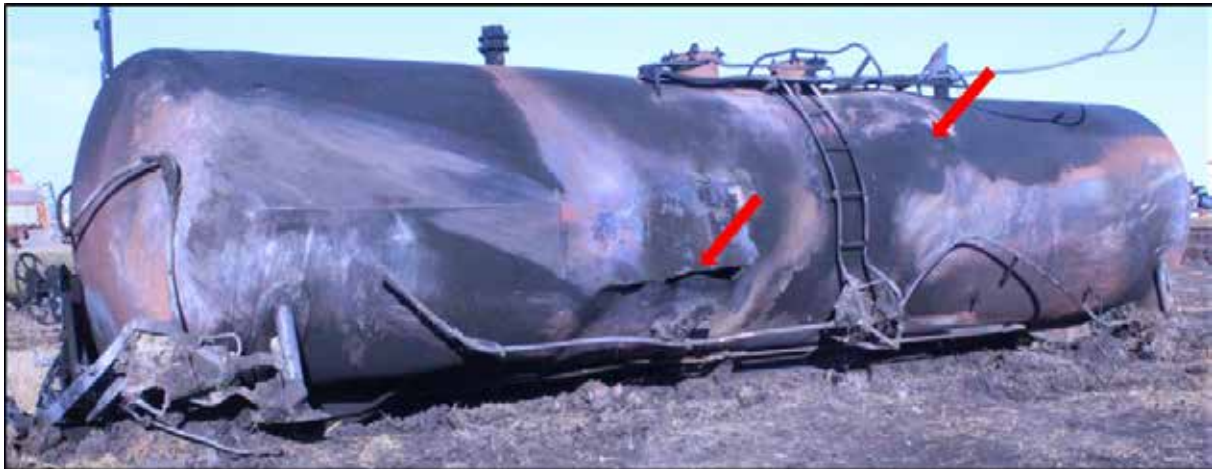
- PROX 126 (the 52nd car) was built in 1974 to the DOT 111A60W1 specification. It was constructed with a load limit of 220 000 pounds. It was built with  $\frac{7}{16}$ -inch ASTM A-285 Grade C non-normalized steel. This car had a dual compartment tilted tank. Each compartment was fitted with a BOV, hinged and bolted manway, and PRD. It was pressure rated for 60 pounds per square inch (psi). Following the derailment, the car sustained 2 thermal tears – 1 in each compartment – as a result of exposure to the post-derailment fire (Photo 10). Nearly all of the contents of the car were consumed in the fire and in the subsequent flaring operation. The car was not equipped with a jacket, thermal protection, head shields, or top discontinuity protection.

Photo 10. PROX 126 with fire damage and thermal tears (red arrows)
