RAILWAY INVESTIGATION REPORT R15H0021

Main-track train derailment

Canadian National Railway Company

Gogama, Ontario

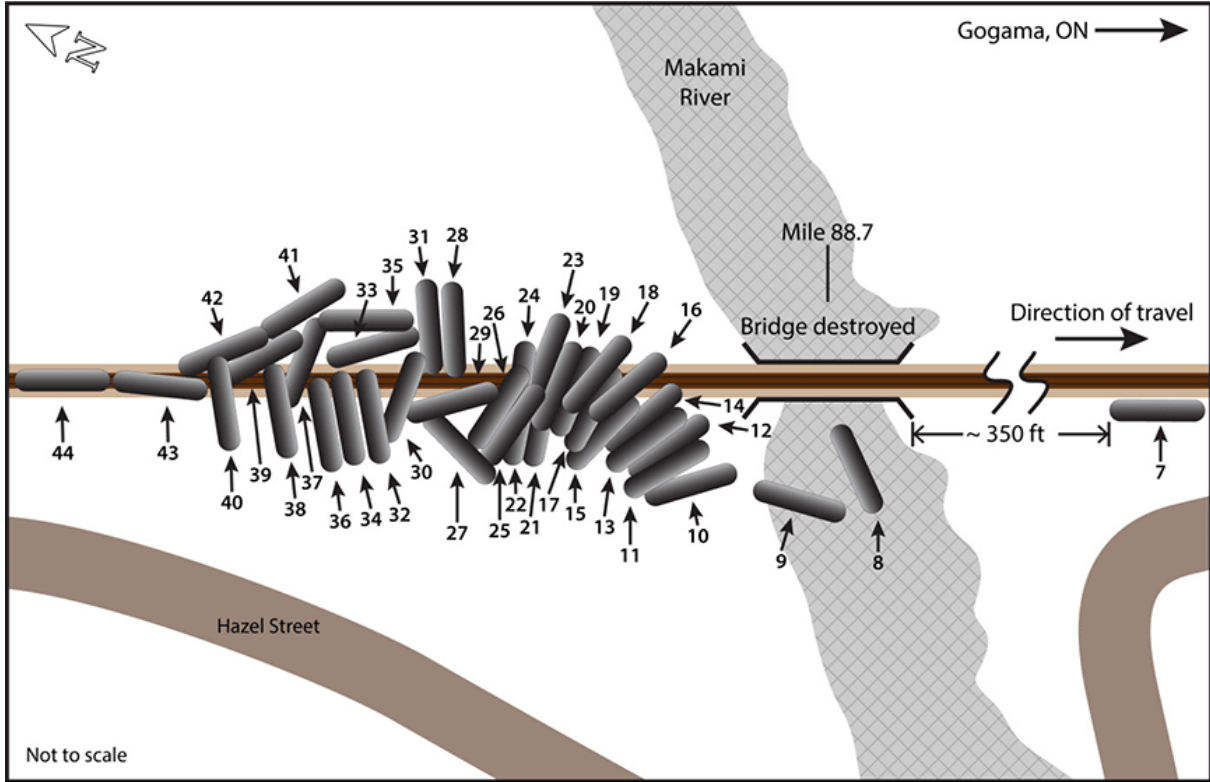
Figure 2. Site diagram

The 6th to the 44th cars from the head end (39 tank cars) had derailed (Figure 2). The 6th car (VMSX 310431) had travelled across the rail bridge over the river and derailed upright to the south of the track. The 6th car was subsequently re-railed and removed from the site. The trailing end of the 7th car (VMSX 310442) had struck the south side of the bridge structure and rolled down the south side embankment about 350 feet east of the bridge. Its bottom outlet valve was damaged and product was released. The 8th car (VMSX 311916) struck the bridge heavily and came to rest in the river south of the bridge, along with parts from 5 other cars. Most of the remaining derailed cars had jackknifed on the west approach to the bridge

and travelled down the south embankment. The last two derailed cars, the 43rd and 44th cars (VMSX 310060 and VMSX 311681), derailed upright and came to rest near Mile 88.75.

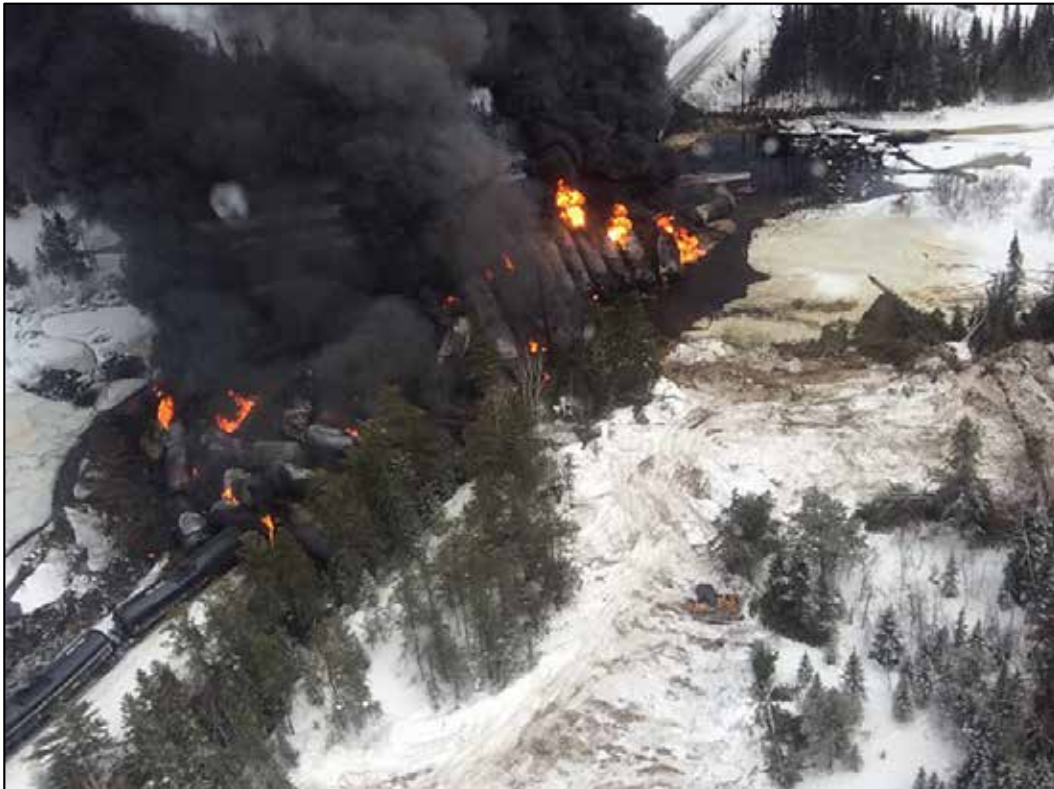
Figure 3. Derailment site

Of the 39 derailed tank cars, 33 had been breached and released product, fuelling the fire, and some product entered the river. The fire occupied an area about 300 yards in diameter and was centred near the west end of the rail bridge (Figure 3). The bridge and about 1000 feet of track were destroyed (Figure 4).

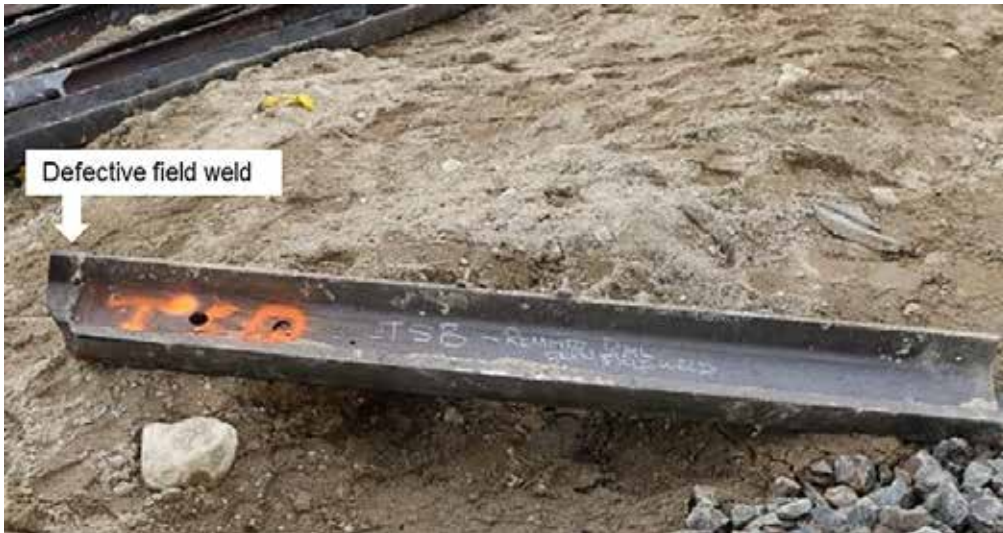
- Sitting beside the track were 2 sections of rail, one measuring 68 inches long and one measuring 78 inches long, which contained a defective field weld (DWF) that had been

removed from the south rail 3 days before the accident, during the repair of a broken rail (Figure 5).

Figure 5. The 68-inch-long section of rail with defective field weld

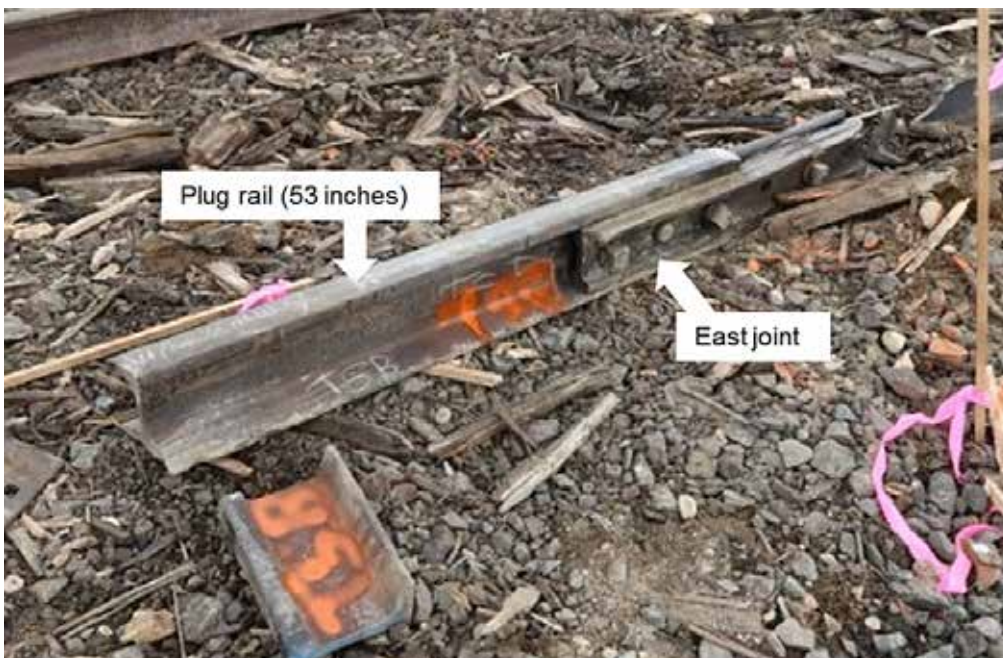
- The east joint of the plug rail, with joint bars still holding together an intact 53-inch-long section of plug rail and a fractured 20-inch-long section of parent south rail, was recovered about 265 feet west of the west bridge abutment (Figure 6).

Figure 6. South rail showing the east joint connecting the plug rail with the parent rail

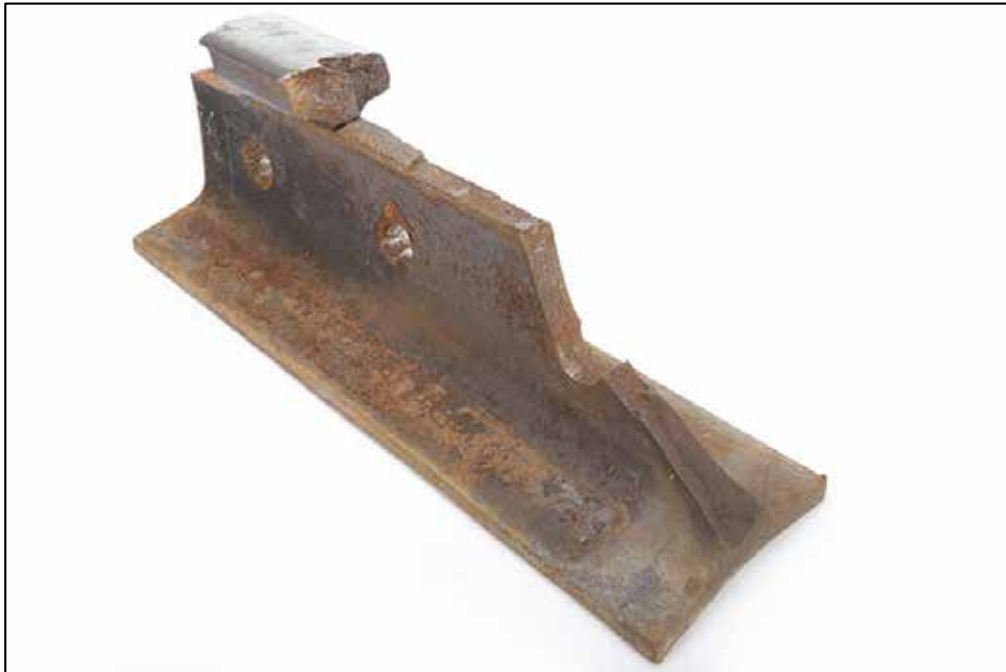
- Most of the rail head of the 20-inch section had broken off (Figure 7). Only a 4-inch-long piece of the rail head was recovered.

Figure 7. Field-side view of parent rail in the east joint with mating 4-inch-long rail-head fragment

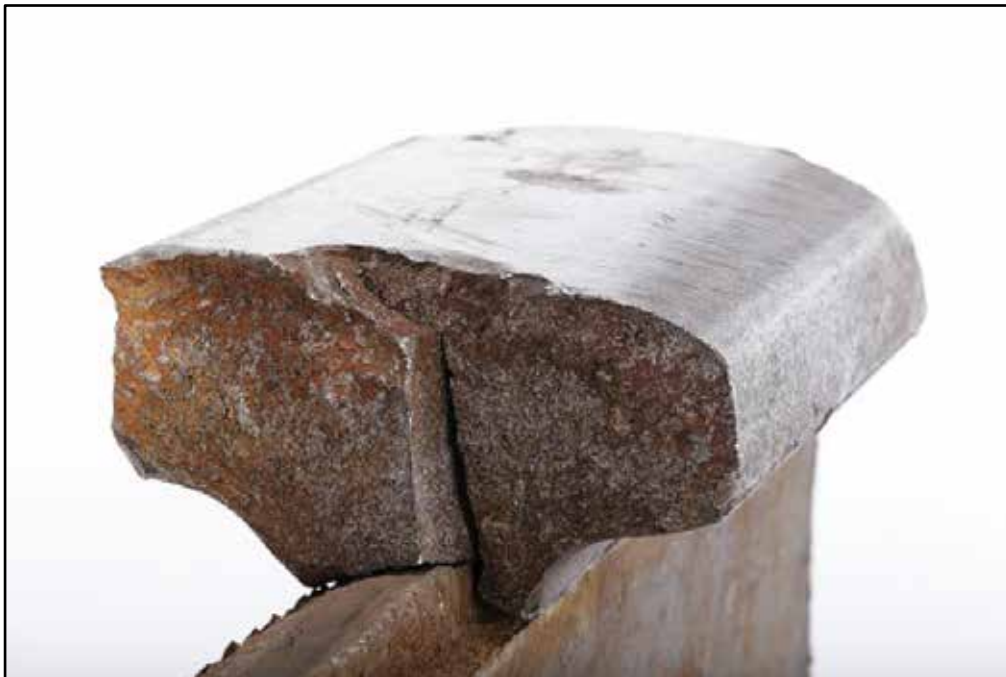
- The 4-inch-long piece of the rail head that was recovered exhibited a vertical split head (VSH) rail defect (Figure 8).

Figure 8. Gauge-side view of vertical split head defect in fragment of recovered parent rail head

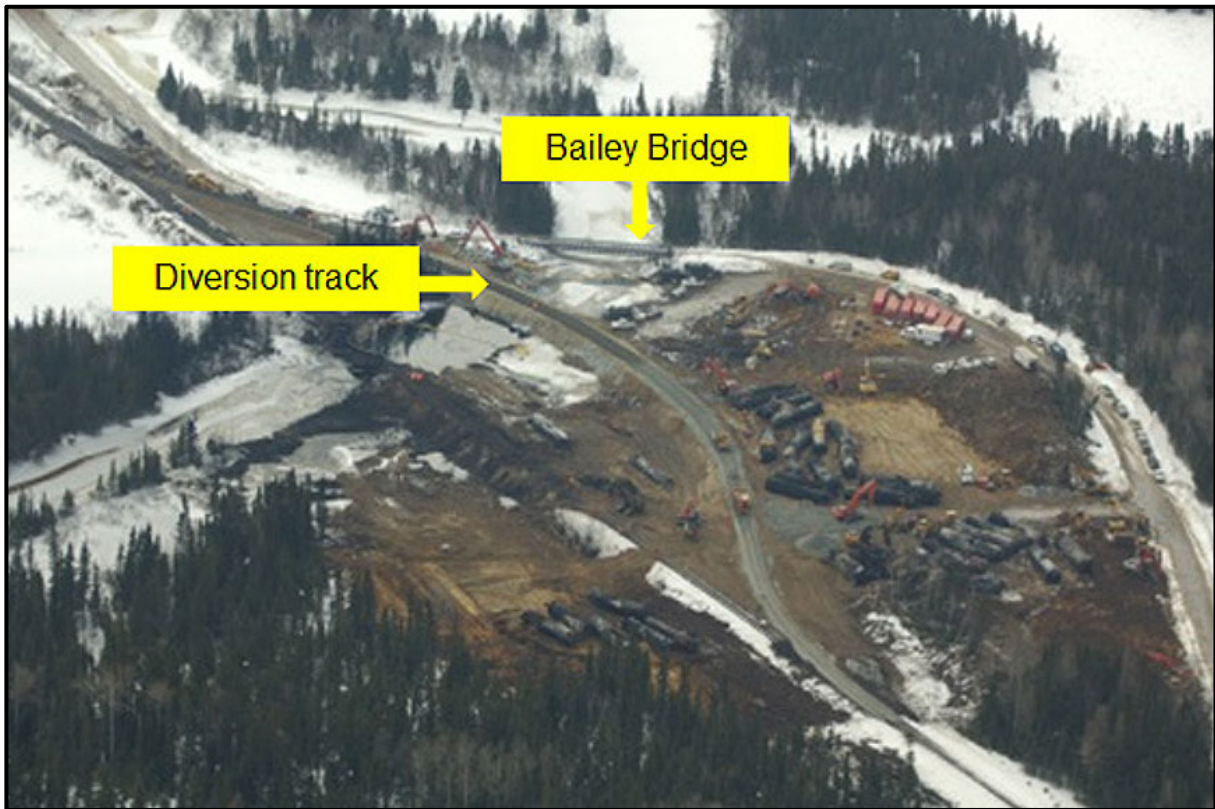
Figure 9. Diversion track south of the main track

Because the accident resulted in a lengthy track outage and impacted rail operations, CN constructed a 1482-foot-long diversion track to the south of the accident site (Figure 9).

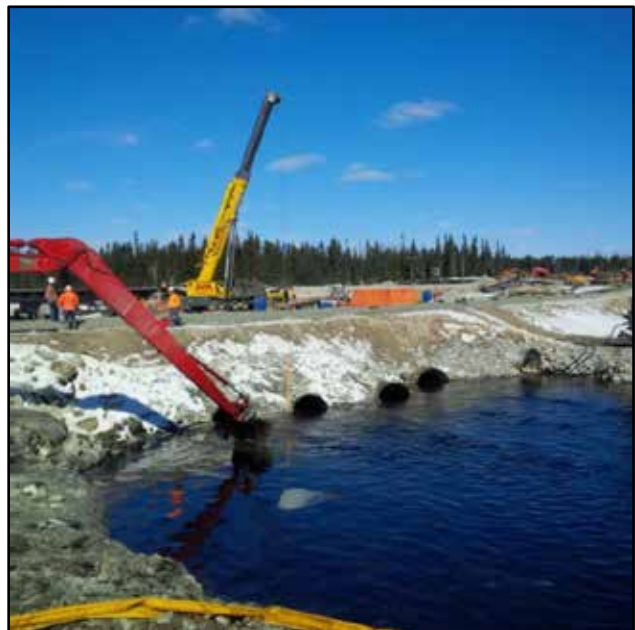
Figure 10. Diversion track over Makami River

The diversion bridged the Makami River with 5 culverts (Figure 10) and was in service from 10 March to 18 March. About 130 trains were routed over the diversion track during that period.

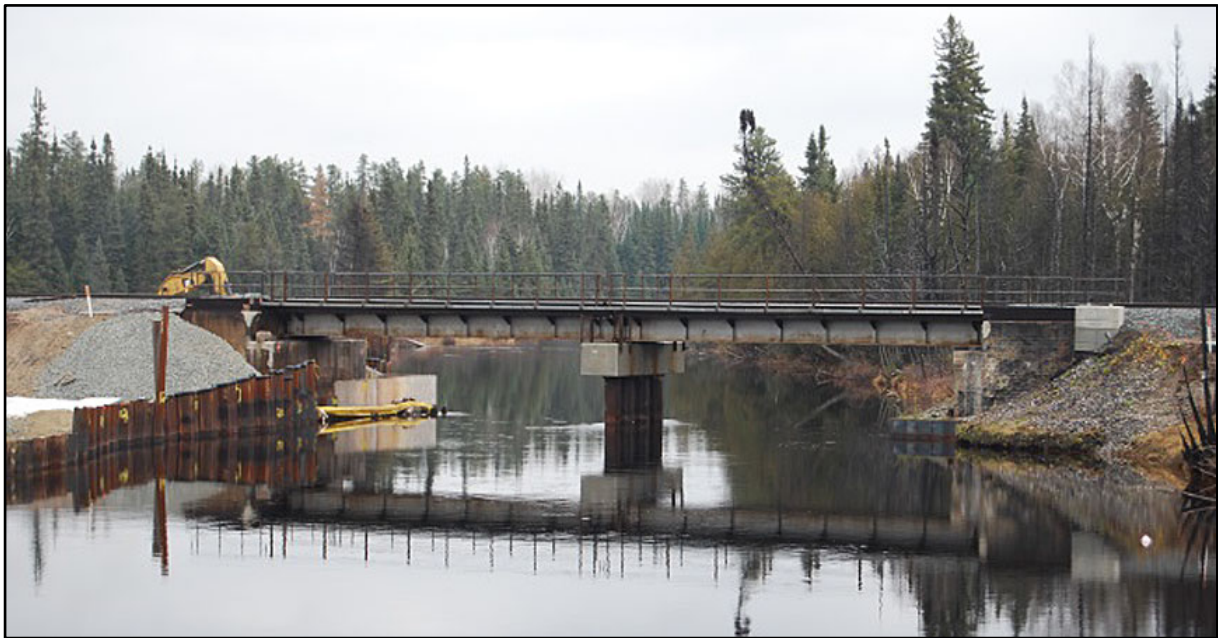
Figure 11. Replacement bridge over Makami River

The destroyed bridge was replaced with 2 previously used beam spans, each measuring 49 feet long, and a steel tray ballast deck. The replacement bridge was supported on the existing bridge abutments. A new centre pier was built out of 4 steel casings filled with concrete and a new precast concrete cap. The first train went over the new bridge on 18 March 2015. Once the new bridge (Figure 11) was operational, the diversion track over the Makami River was removed and the riverbed restored.

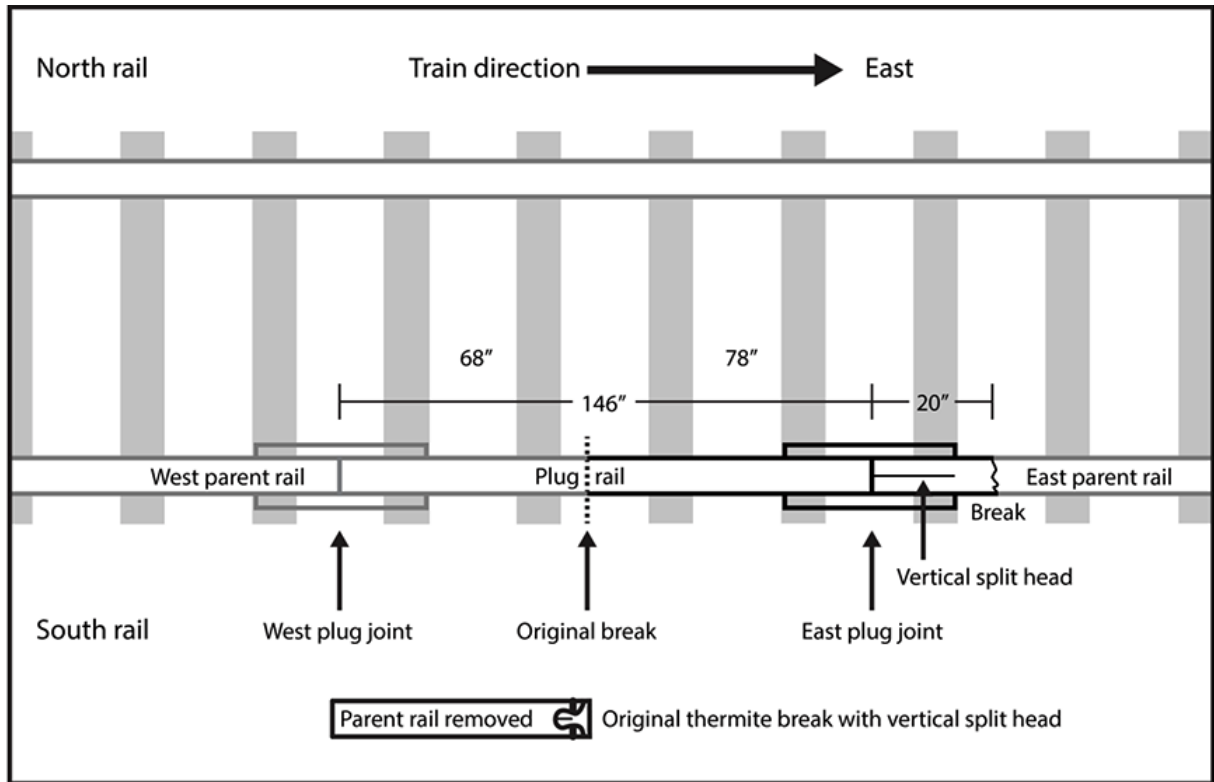
Figure 14. Schematic of the rail pieces in the occurrence track. Recovered sections of rail are shown with bold outlines. Tie location and spacing are for illustration purposes only and not to scale

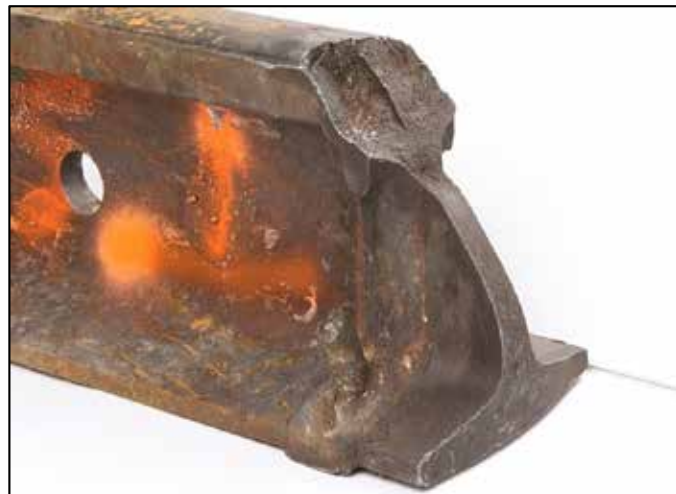
Examination of the original break at the thermite weld on the east end of the removed parent rail revealed a VSH defect in the rail head similar to the VSH defect observed in the east end joint parent rail (Figure 15).

During the plug rail repair, the parent rail was cut, but there was no record of non-destructive dye penetrant testing being performed on the cut rail ends. Had a dye penetrant inspection been performed, VSH indications would likely have been observed in the east cut rail end, and more of the east parent rail may have had to be removed.

Figure 15. Photograph of thermite weld on the east end of the removed parent rail with vertical split head defect in the rail head

With a section of the east parent rail that contained a VSH defect left in service, the defect eventually propagated to failure.

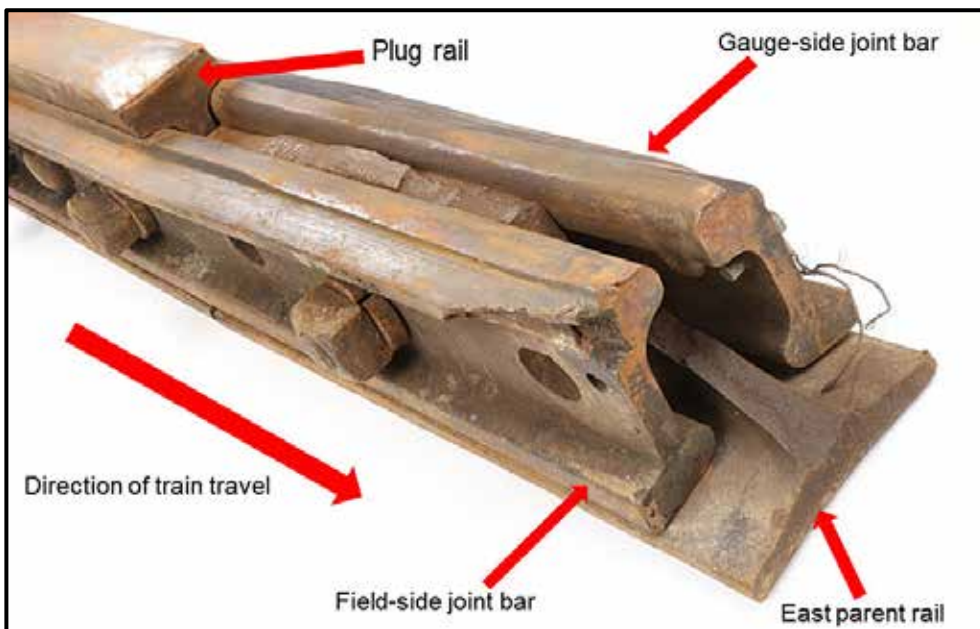
Figure 16. A 20-inch section of east parent rail that had failed inside the joint and a section of the plug rail within the east joint as received

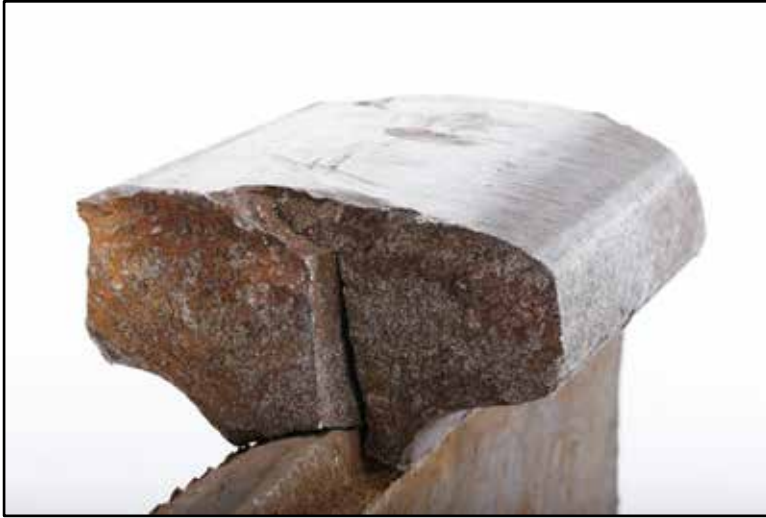
- When the joint bars were removed, there were no indications of movement within the joint that could have contributed to the rail break.
- The 4-inch recovered section of east parent rail head was found to mate with the horizontal web fracture. The rail head contained a VSH defect (Figure 17).

Figure 17. View of vertical split head in fragment of recovered 4-inch-long section of the east parent rail head

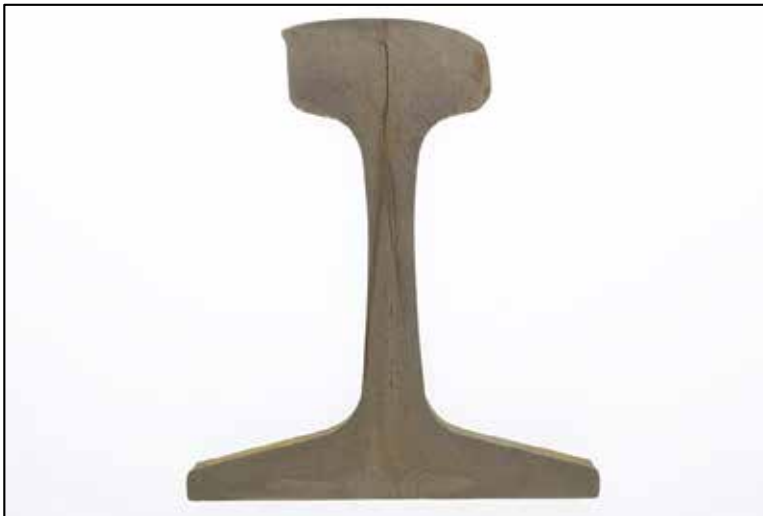
- The east parent rail material contained web streaking and centreline segregation (Figure 18). Although the extent of streaking and segregation did not exceed allowable limits, this type of microstructural defect is known to be conducive to the development of VSH defects.

Figure 18. Rail cross-section taken 3 inches west of the thermite weld, with physical separation in the head and web streaking

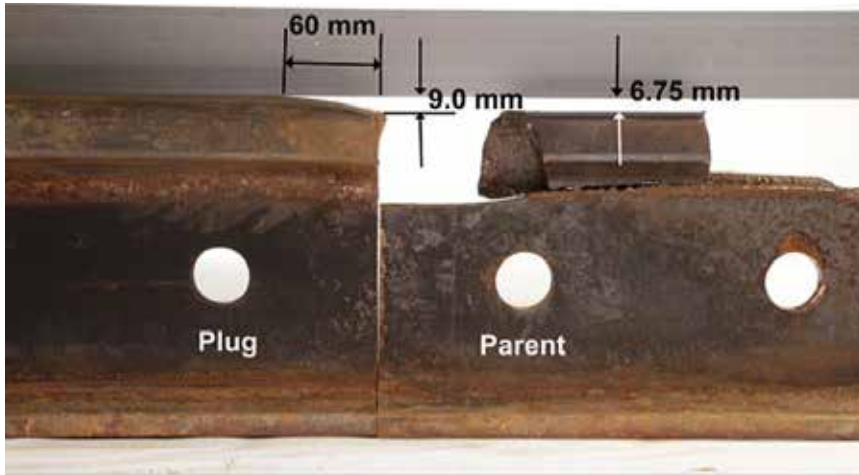
- When the 20-inch section of east parent rail was placed on the same plane as the plug rail, the post-occurrence mismatch in head height measured 0.27 inch (6.75 mm) (Figure 19). For joints in Class 4 track, the allowable mismatch in rail head wear is 0.125 inch (3 mm).

Figure 19. Mismatch in head height between the east plug rail and the east parent rail

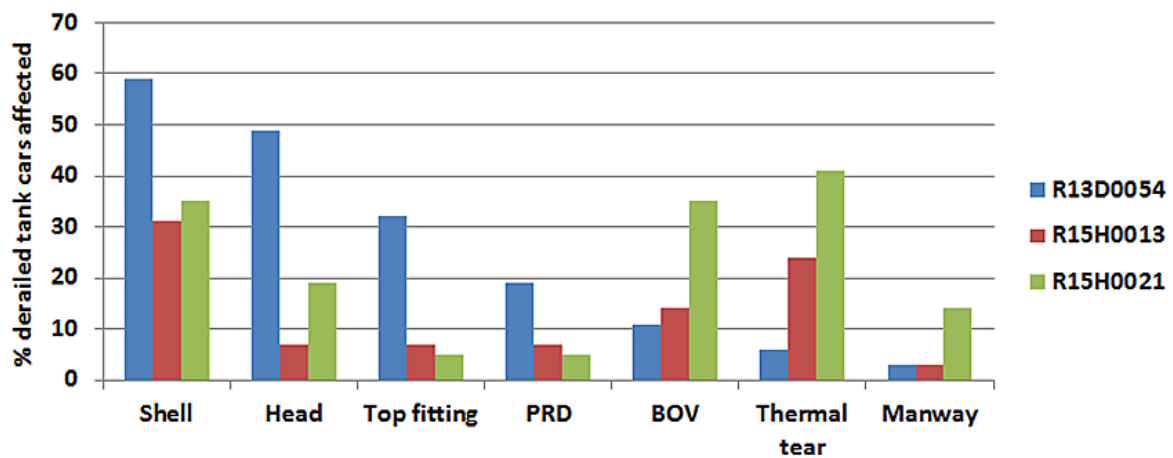
Figure 22. Summary of the various types of breach responsible for product release in occurrences R13D0054, R15H0013, and R15H0021

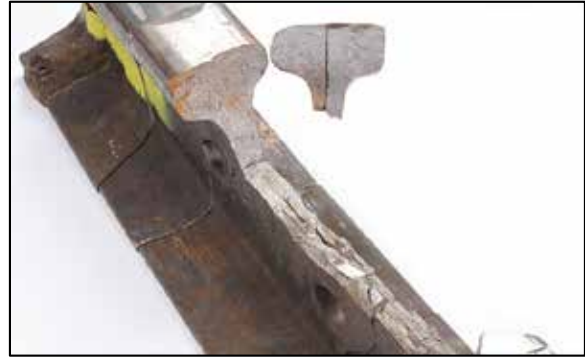
Deterioration of the running surface in the proximity of the thermite weld may have increased dynamic stresses in the area. This increase in stress combined with low ambient temperature and repeated wheel impacts due to the LSC also likely contributed to the rail failure.

Figure A1. Vertical split head defect observed in head and web of rail

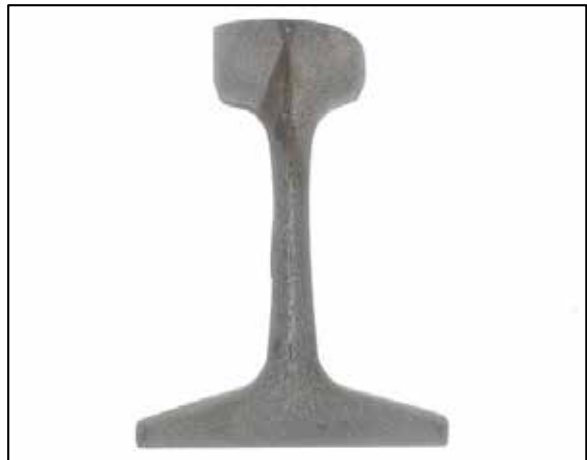
Figure A2. Macro-etched cross-section of the north rail with web streaking and vertical split head defect

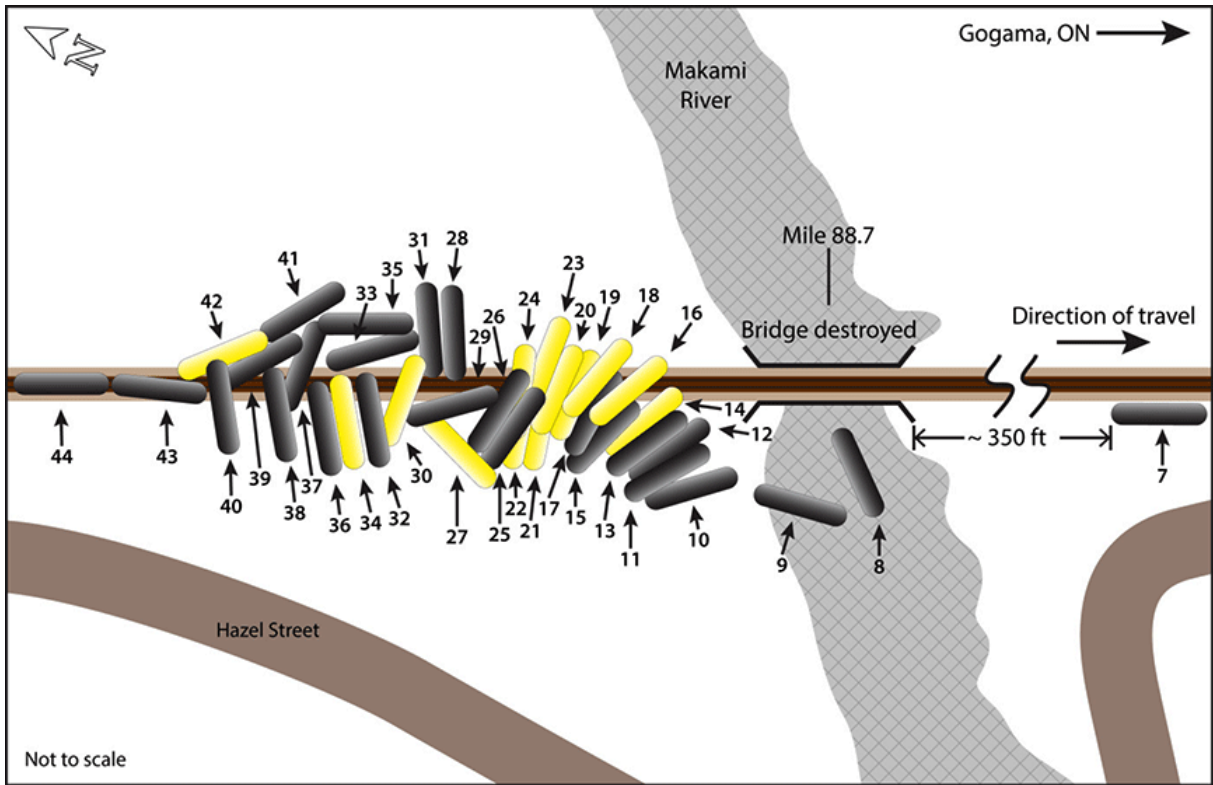
Appendix D – Accident site diagram showing tank cars with shell impact breaches (yellow)

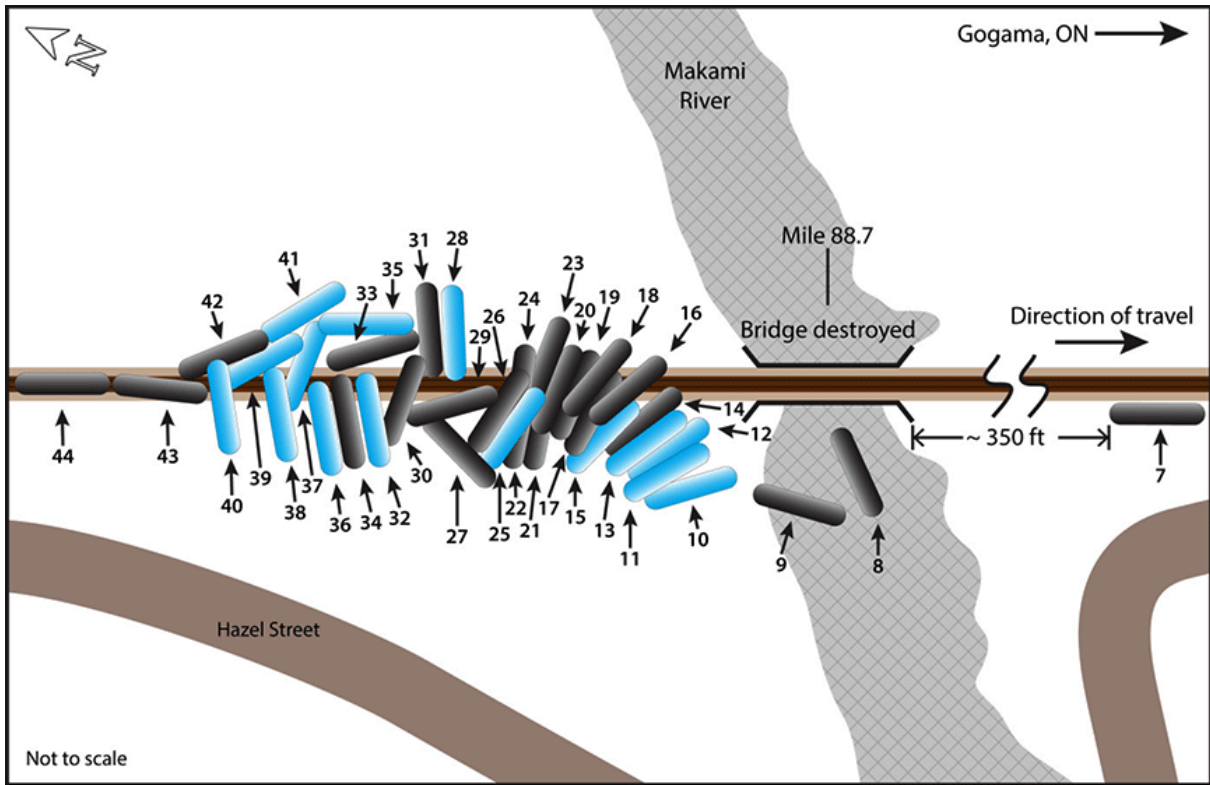
Appendix E – Accident site diagram showing tank cars with thermal tears (blue)

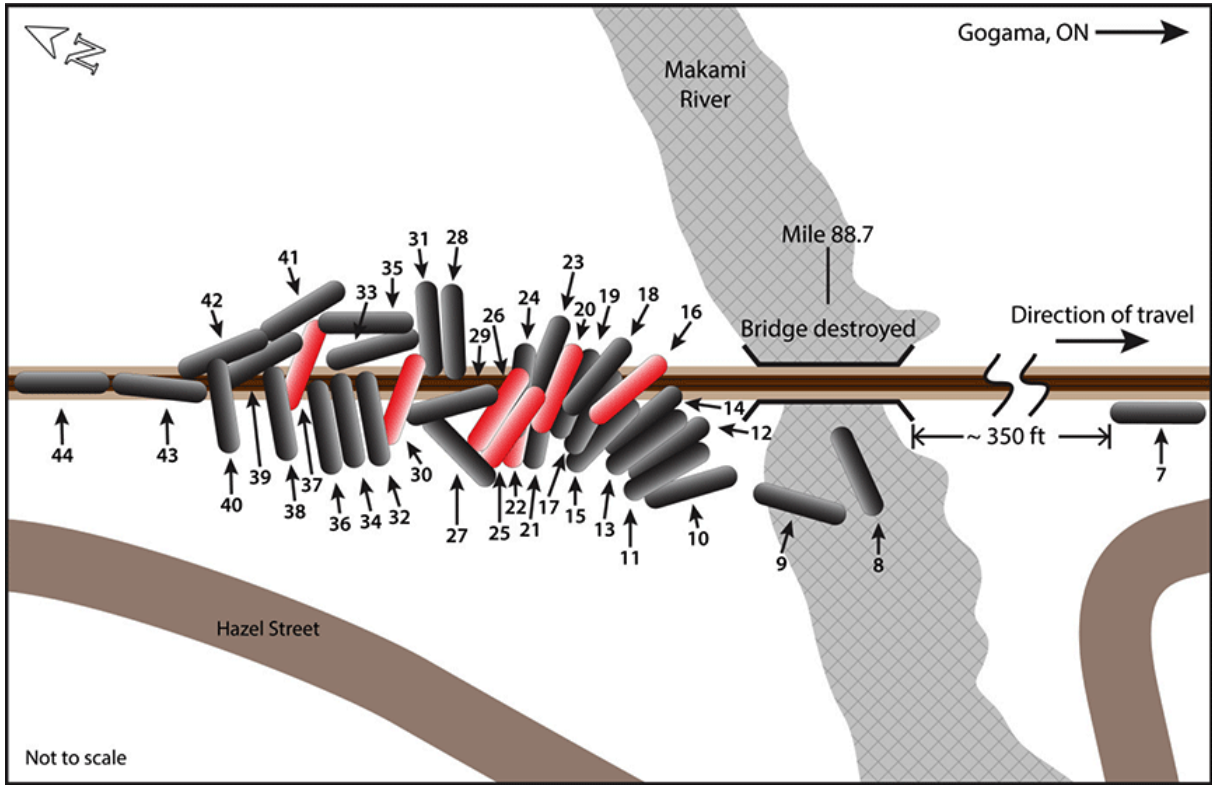
Appendix F – Accident site diagram showing tank cars with head impact breaches (red)

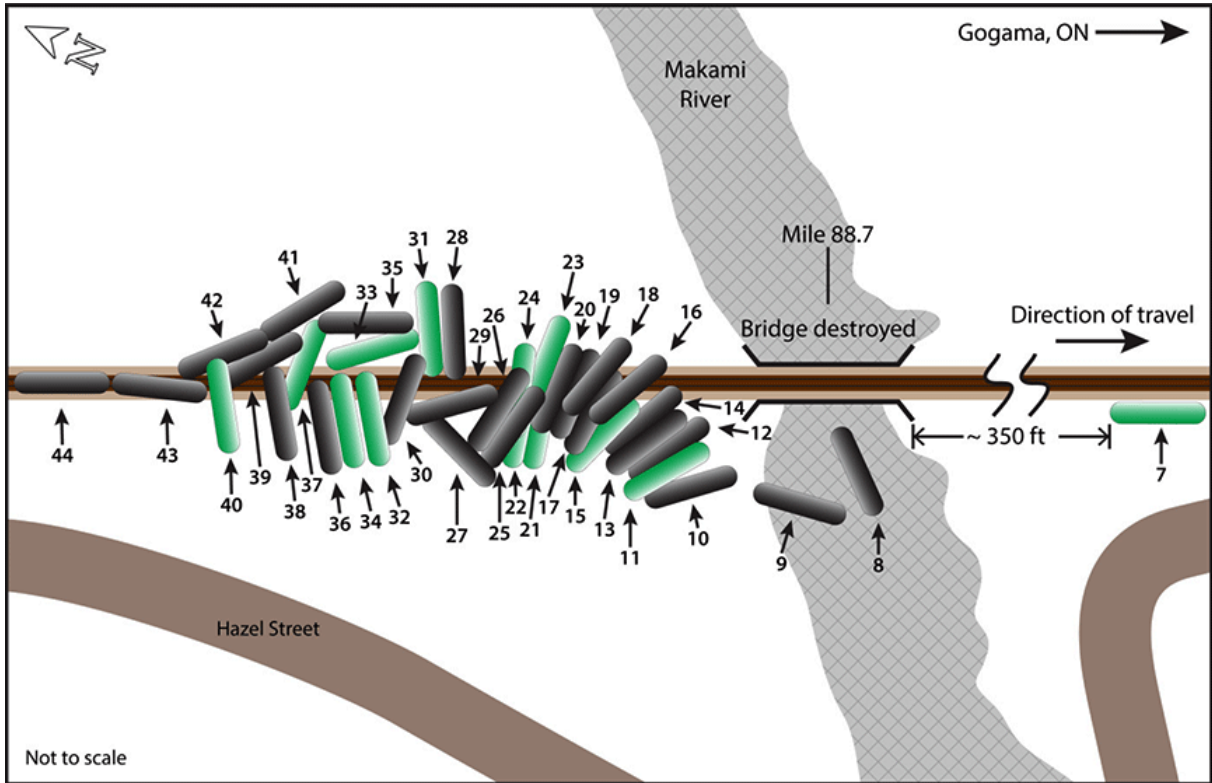
Appendix G – Accident site diagram showing tank cars with breached bottom outlet valves (green)
