RAILWAY INVESTIGATION REPORT

R16M0026

Crossing accident

Canadian National Railway Company

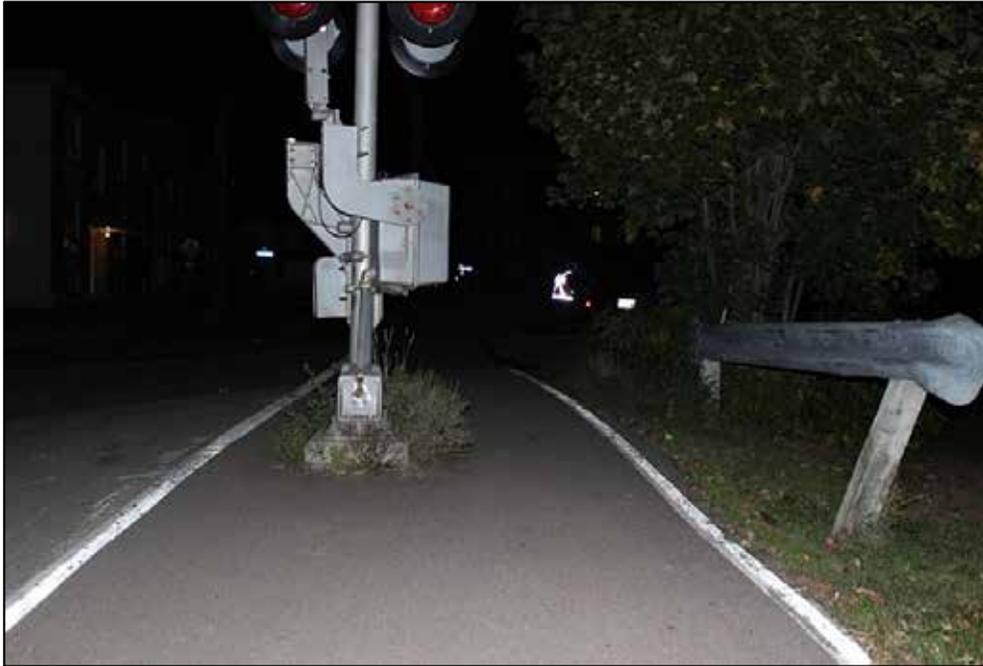
The sidewalks on Robinson Street were made of concrete, except for the portions in the vicinity of the crossing, which were made of asphalt. The width of the concrete sidewalks was 1.5 m, while the width of the asphalt portion varied. The asphalt portion of the east sidewalk south of the crossing was 2.65 m wide to accommodate a post supporting the GCWS, leaving a usable sidewalk width of approximately 1.1 m (Figure 4).

Figure 4. The east sidewalk of Robinson Street, looking north, following the accident. The width of the sidewalk is restricted by the positioning of the grade crossing warning system, directing pedestrians toward the outer edge of the sidewalk.

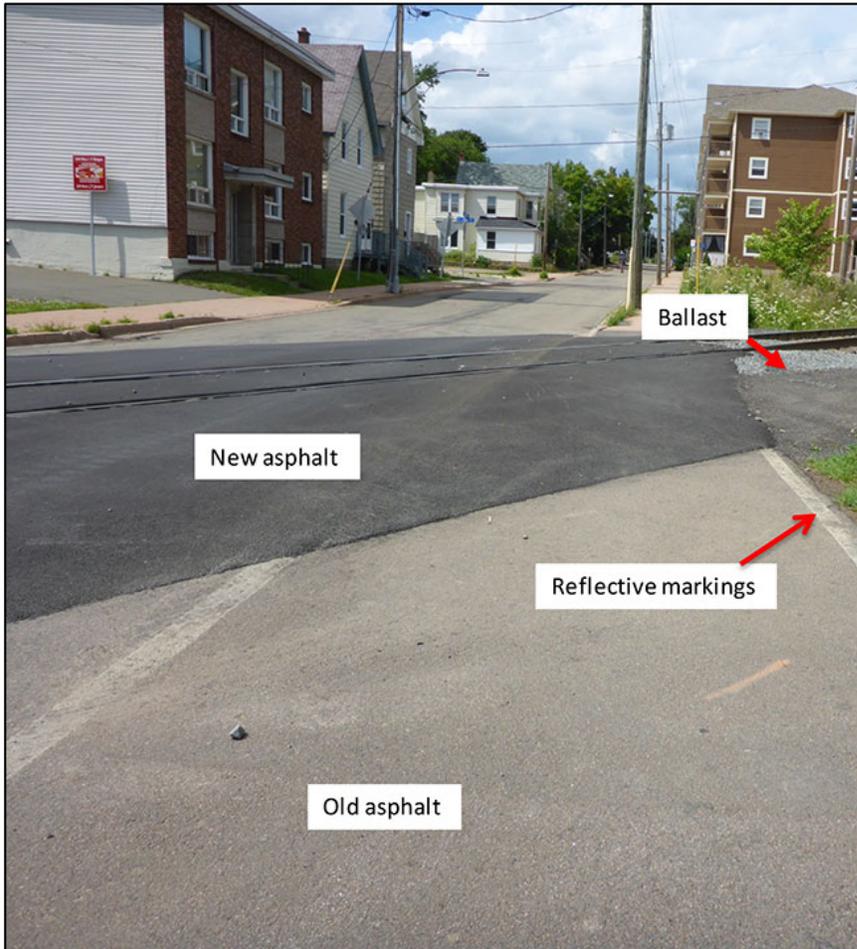
The asphalt portion of the sidewalk immediately south of the crossing was 1.95 m wide. The asphalt sidewalks approaching the crossing had white reflective markings in the form of lines along the inner and outer edges of the sidewalk (Figure 5). These markings were approximately 10 cm wide.

Figure 5. The east sidewalk of Robinson Street, past the grade crossing warning system post, looking north, following the accident. The new asphalt appears darker than the old asphalt.

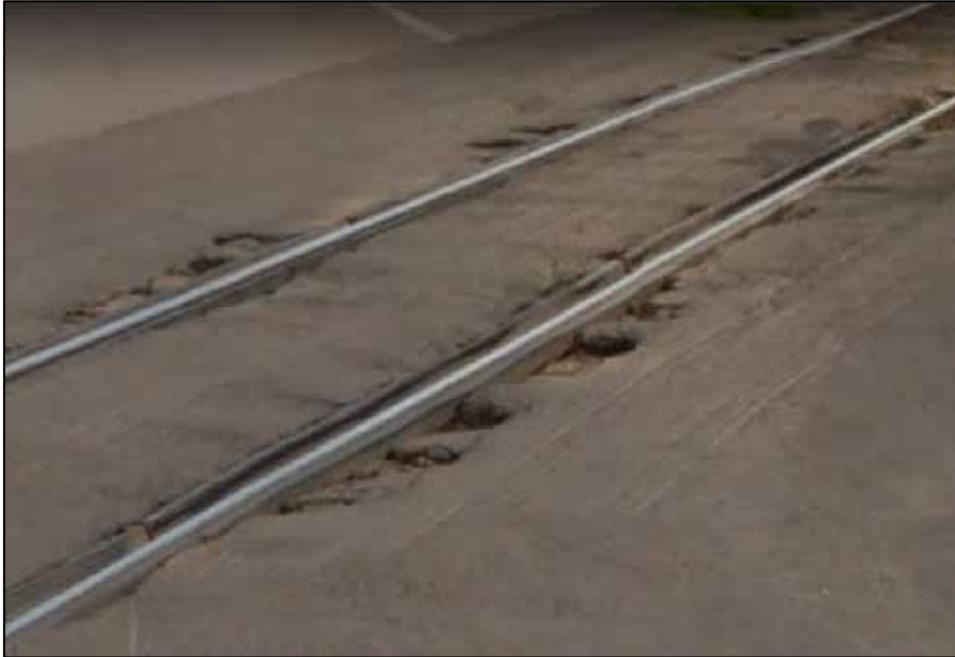
Maintenance records indicate that the Robinson Street crossing was subject to recurrent surface degradation (Figure 6). Consequently, re-asphalting was performed to repair the crossing surface.

Figure 6. Surface degradation at Robinson Street crossing circa 2013 (Source: Google Maps street view)

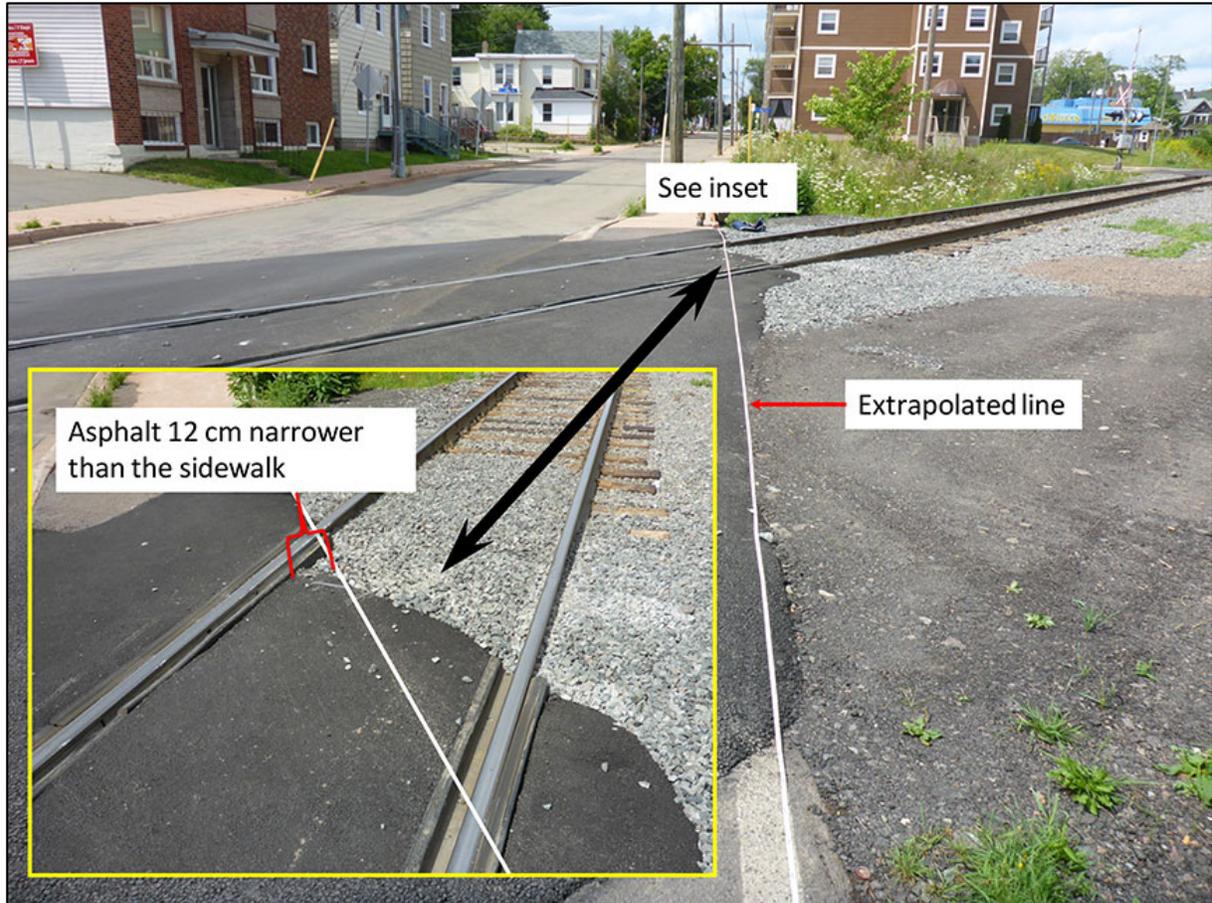
At the south rail, the asphalt covered the rubberized flangeway, which extended 48 cm beyond the edge of the sidewalk (Figure 7).

Figure 7. View of east sidewalk of Robinson Street, looking north. The white extrapolated⁵ line extends from the outside edge of the reflective line to the right-hand edge of the concrete sidewalk north of the crossing. The inset shows a close-up view of the sidewalk at the north rail where the asphalt was narrower than the sidewalk.

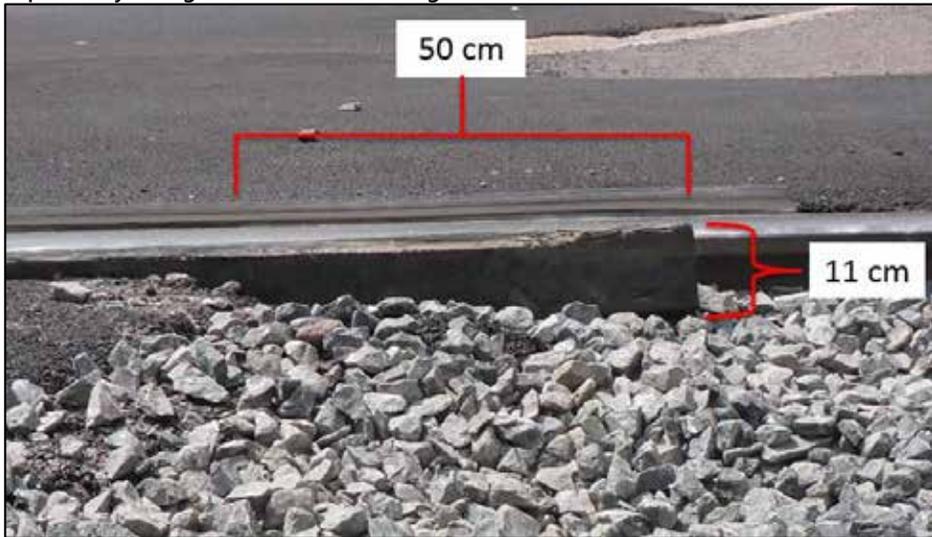
At the north rail, the asphalt stopped about 50 cm short of the end of the rubberized flangeway, creating a void in the sidewalk surface. At its eastern extremity, the rubberized flangeway had a height of about 11 cm above the ballast (Figure 8).

Figure 8. Eastern extremity of rubberized flangeway on the north rail. The flangeway is exposed by a length of 50 cm and a height of 11 cm.

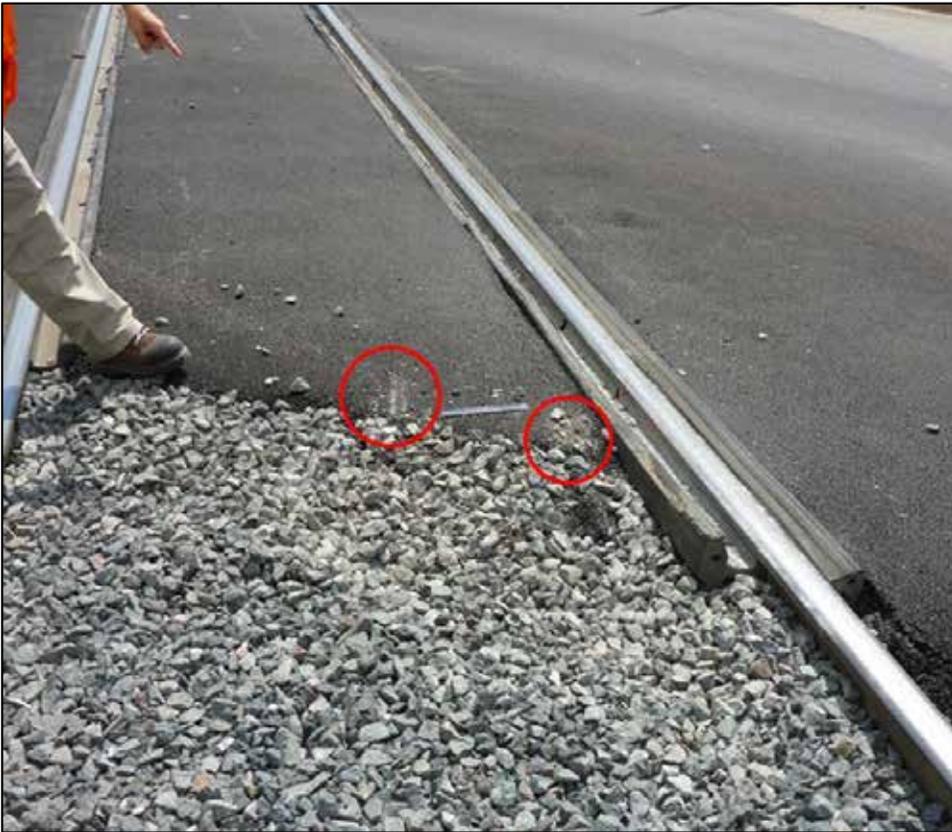
Two gouge marks were present on the asphalt between the rails at the eastern extremity of the crossing (Figure 9). The distance between these marks was about 35 cm (13.8 inches). In front of these marks, the ballast was disturbed. The deformations in the ballast were slightly wider apart (approximately 50 cm) than the gouge marks on the asphalt.

Figure 9. Gouge marks between the rails close to the north rubberized flangeway

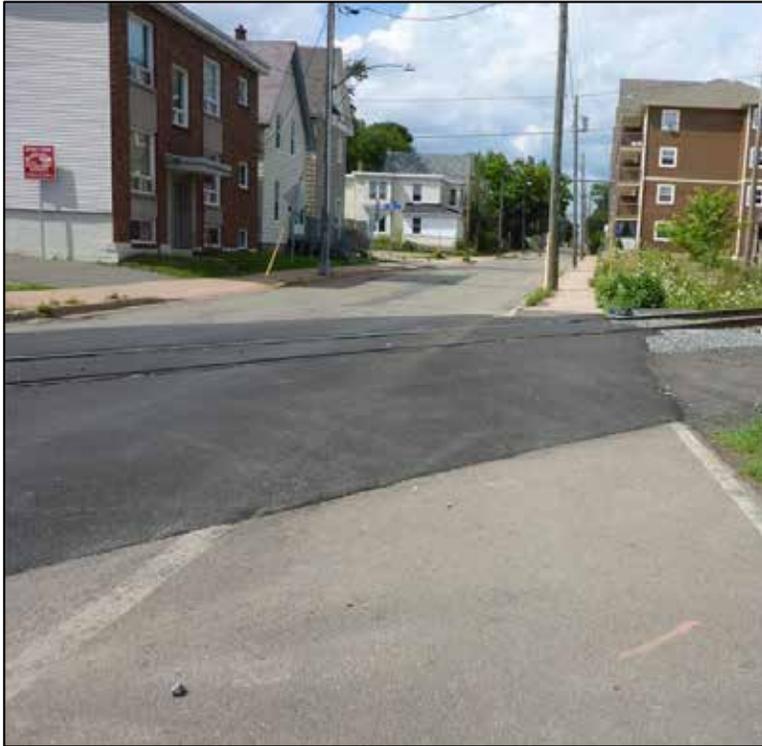
Figure 15. Approach to Robinson Street crossing on the day of the accident. The reflective painted lines on the sidewalk end at the newly paved crossing area.

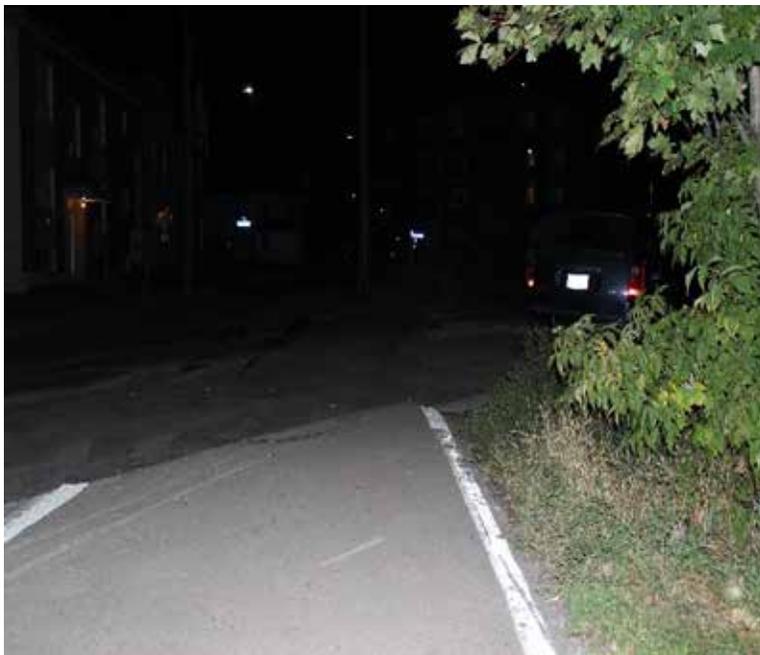
Figure 16. Approach to Robinson Street crossing as it would have appeared on the night of the accident. The reflective painted lines had been extended onto the new asphalt after the accident but were covered for the purpose of the simulation.

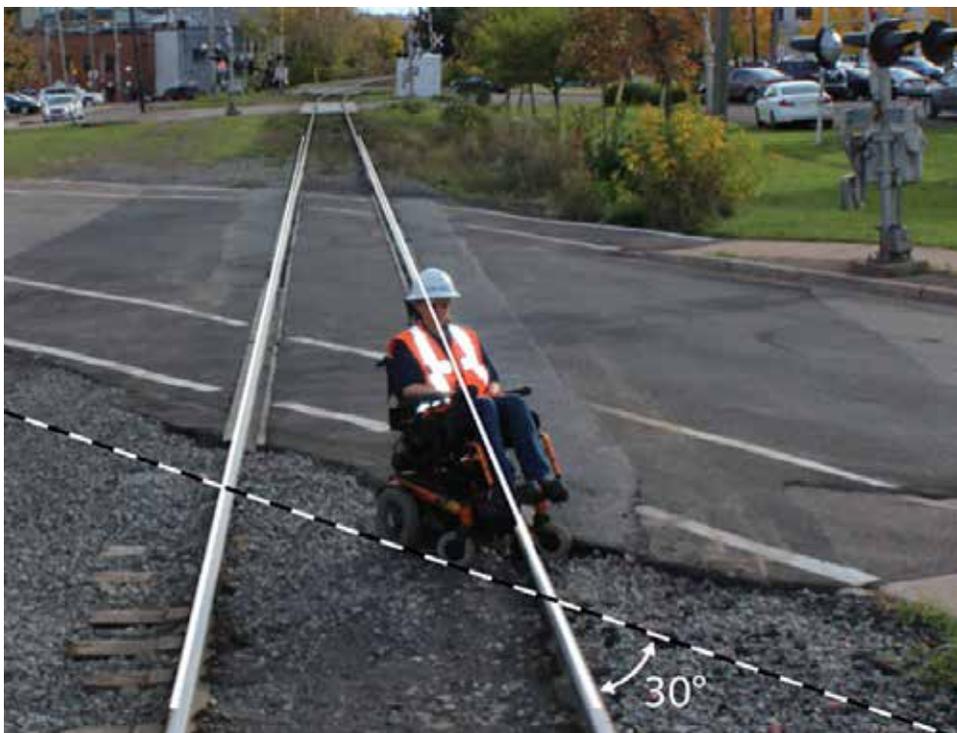
- The wheelchair consistently became immobilized in the ballast along the exposed north rubberized flangeway at an angle of approximately 30 degrees to the rail (Figure 17).

Figure 17. Photo from accident simulation showing the angle at which the wheelchair became immobilized in the ballast (approximately 30 degrees to the rail). The reflective white lines delineating the crossing surface and the additional asphalt that widened the sidewalk area were applied after the accident.
