# Rail Transportation Safety Investigation Report R17T0170

## EMPLOYEE INJURY

Canadian Pacific Railway  
Freight train 141-30  
Mile 113.0, Galt Subdivision  
London, Ontario  
31 July 2017

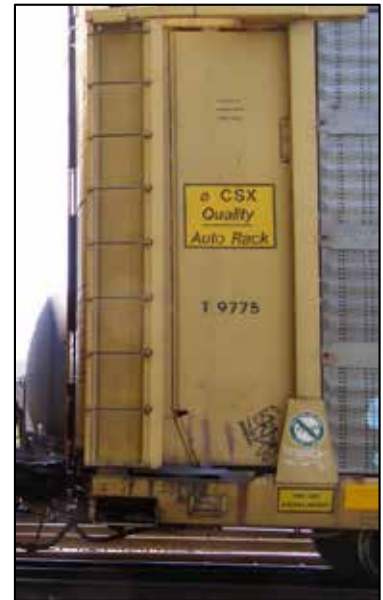
The conductor was correctly positioned on the north side of the lead car and was riding the ladder (Figure 2). The conductor was providing radio instructions to the LE, who was in the controlling locomotive, about 3300 feet away. As an additional safety measure, the conductor advised the LE when the leading car reached a predetermined "1 mile" to the location of the intended coupling, so the LE could set the locomotive distance counter.

Figure 2. Example of a ladder configuration on the side of a car

The movement stopped quickly, producing a rapid run-out of slack that cascaded toward the conductor's location on the lead car. When the run-out reached the lead car, the conductor, who was still being affected by the thick brush, was thrown sideways and lost footing and grip on the ladder. The conductor fell off the lead car to the field side of the track, injuring his left leg. The conductor then radioed for help, indicating that his leg was broken. The radio message was overheard by the rail traffic controller in Calgary, Alberta, who immediately coordinated the emergency response. London-Middlesex Emergency Medical Services transported the conductor to the hospital.

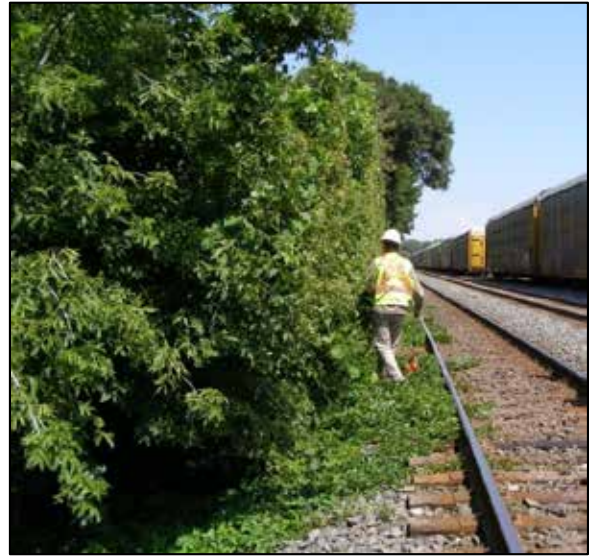
Figure 3. View of brush encountered by the conductor

In the area of the accident, brush suppression work had been scheduled to start on 13 June 2017. However, local engineering forces were engaged in track maintenance at that time and could not provide protection for the brush-cutting contractor. As a result, the work was deferred and the

contractor was reassigned. At the time of the occurrence, brush removal activities had not yet been rescheduled at the occurrence location.

During post-occurrence examination of the site, more than 370 feet of continuous dense brush was present along the north side of the railway right-of-way, encroaching to within about 2 feet of the north rail. When riding the side of a typical rail car, a crew member would be positioned several feet beyond the field side of the rail.

Following this occurrence in London, CP immediately sent out a system bulletin to warn operating crews of the vegetation obstruction. Brush was then cleared in the area of the accident.

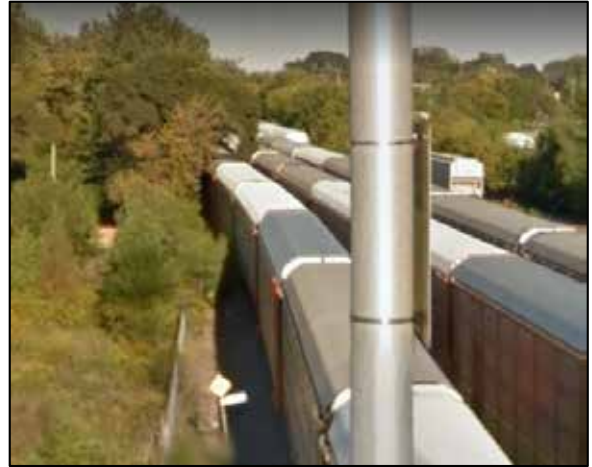
Since March 2017, at least 6 discussions had been held relating to grass, weeds, brush, and tree obstructions within the region, with 1 discussion related to vegetation encroaching in a manner that could have an impact on employees riding on the side of a car. The accident location was not specifically mentioned during the health and safety committee meetings. However, Google Street View captures from September 2015 (Figure 4) and July 2016 indicated that there had previously been heavy vegetation in the vicinity of the occurrence.

**Figure 4. View of brush in September 2015**  
(Source: Google Street View)
