## **RAIL TRANSPORTATION SAFETY INVESTIGATION REPORT R18H0039**

### **UNCONTROLLED MOVEMENT OF ROLLING STOCK**

Canadian Pacific Railway  
Remote control locomotive system  
Yard assignment T16-13  
Mile 195.5, Belleville Subdivision  
Toronto Yard  
Toronto, Ontario  
14 April 2018

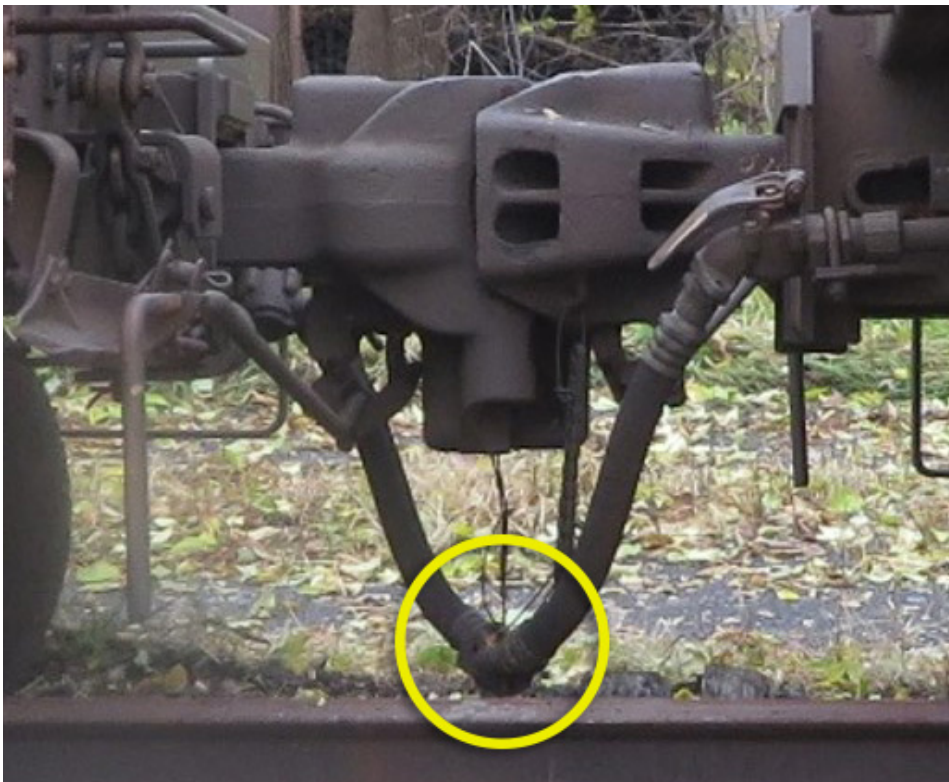
Figure 5. Typical glad hands connecting air hoses (Source: TSB)

When air hoses are mounted to a rail car, care must be taken to ensure that the glad hand is properly positioned so it is in line with the glad hand on the connecting car. Otherwise, the glad hands may be difficult to connect.

Following the occurrence, a CP manager attempted to connect the air hoses between locomotive CP 4434 and the lead car of the assignment to determine why they could not be connected. After one unsuccessful attempt, the manager was able to connect the air hoses. It was noted that the freight car hose did not line up with the connecting air hose on the locomotive. The air hose on the freight car was later adjusted.
