RAIL TRANSPORTATION SAFETY INVESTIGATION REPORT R19H0021

ROLLING STOCK COLLISION WITH OBJECT AND EMPLOYEE INJURY

VIA Rail Canada Inc.
Train No. 62/52
Mile 240.44, Kingston Subdivision
Brighton, Ontario
02 February 2019

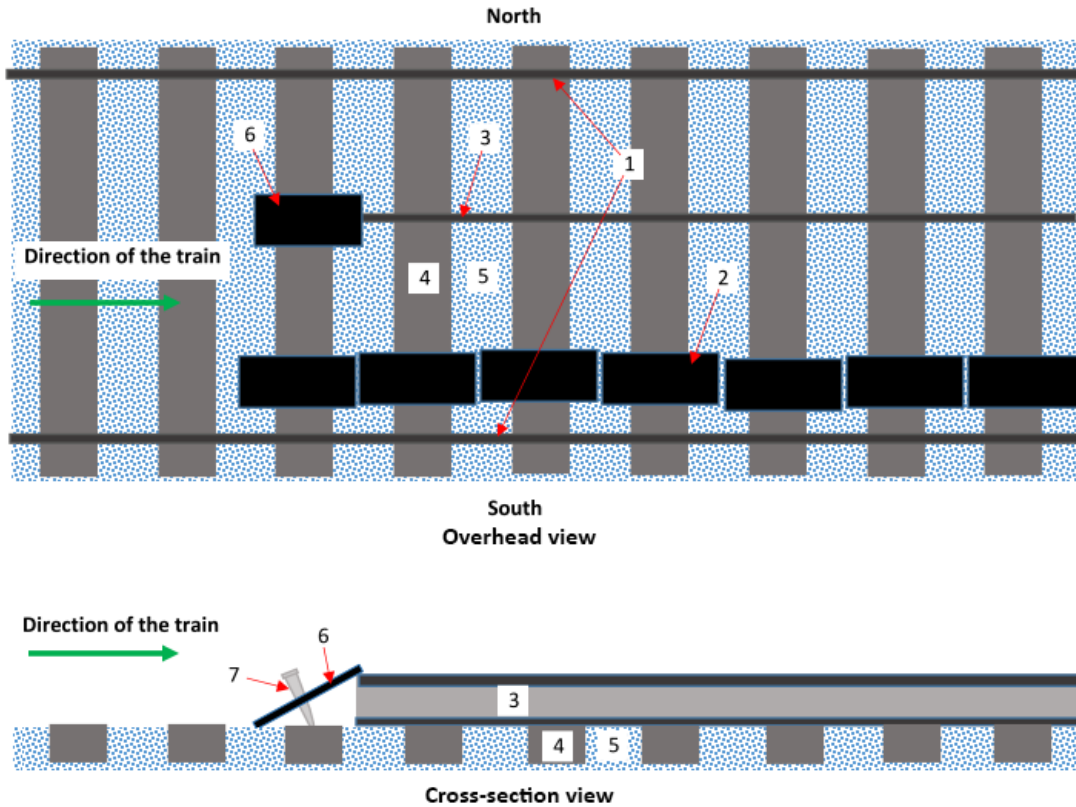
Figure 2. Sketches of track configuration (Source: TSB)

- One angled deflector tie plate (number 6 in Figure 2) was leaned against each butt end of the replacement rail positioned between the rails and secured to a tie with a single track spike (number 7 in Figure 2). The plate was not to sit higher than 1 inch above the running rail of the north track.

- Replacement tie plates (number 2 in Figure 2) were pre-placed on each tie on the gauge side³ of the rail for the length of the replacement rail. The tie plates had generally been placed with the shoulders down and the bases facing up (i.e., upside-down).

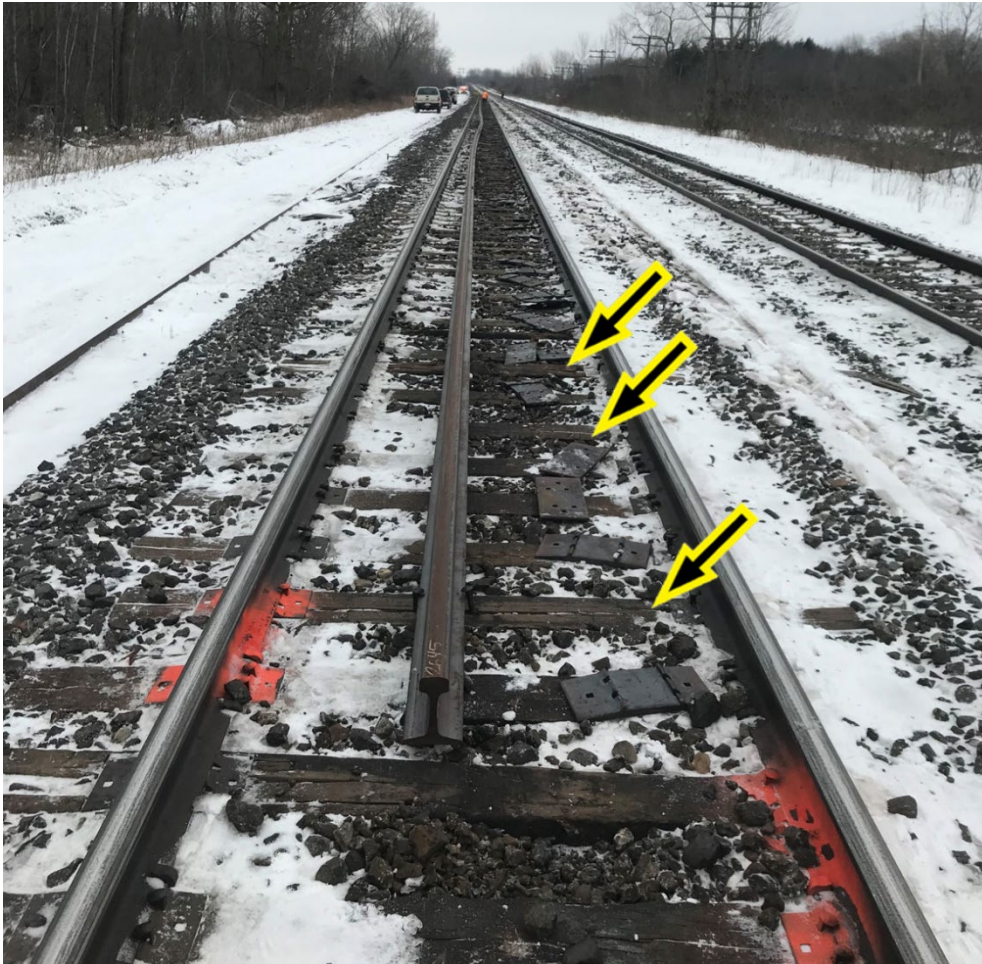
Tie plates and ballast had been displaced. The tie plates were no longer positioned in an orderly manner on the ties. Some tie plates remained between the rails and some were displaced to either side of the north track. Some tie plates and ballast had been propelled more than 100 feet away. Among the first 10 ties, 3 did not have tie plates on them (Figure 3). In addition, debris from various damaged components of the train was strewn about the site. About 100 feet west of the replacement rail, there was disturbed ballast between the rails of the north track.

Figure 3. West end of replacement rail, facing east, showing some ties without tie plates on them (Source: CN, with TSB annotations)

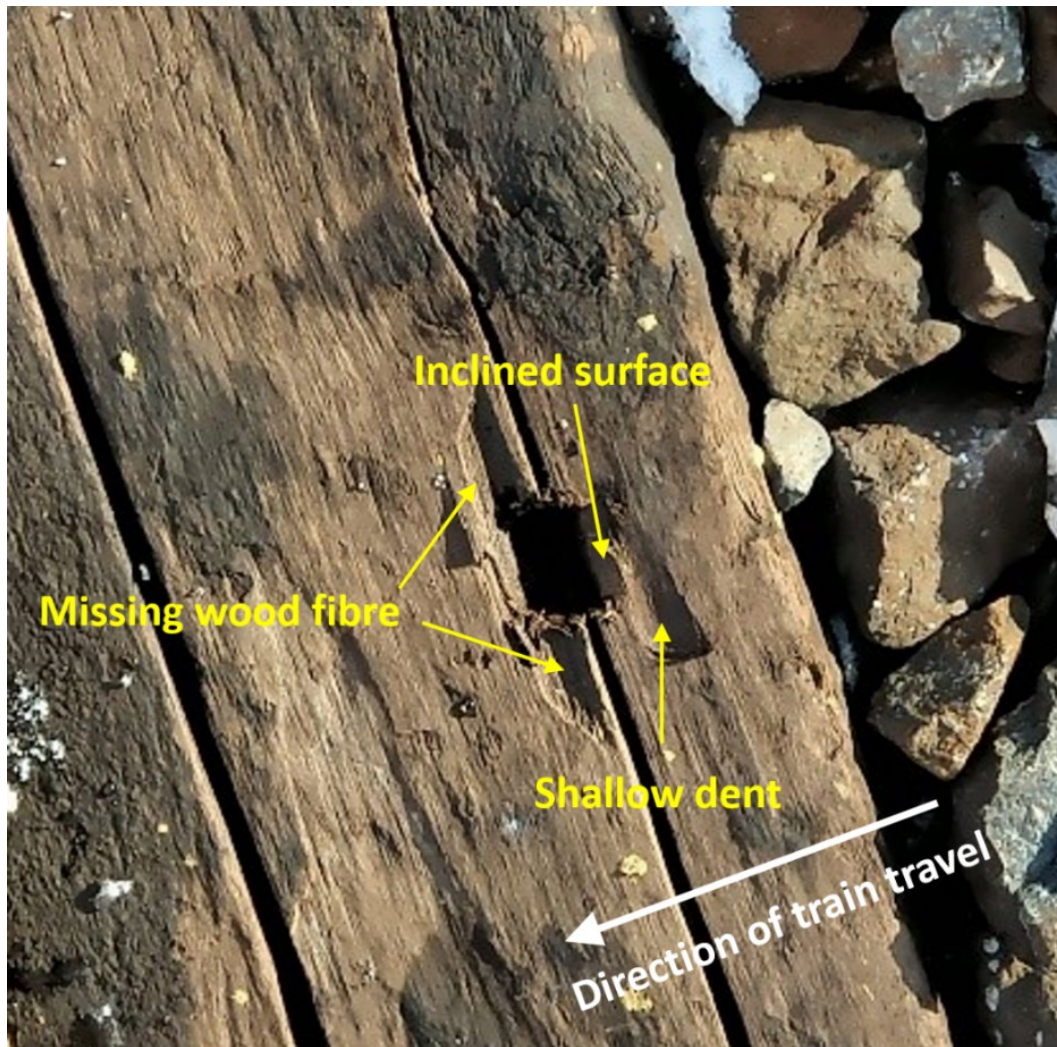
- A square hole, that matched the profile of a spike, was observed within a crack in the tie, just in front of the west end of the replacement rail between the north track rails.
- The hole was consistent with the location of a spike that had been hammered into the tie to anchor the tie plate covering the west butt end of the rail.
- A shallow piece of wood fibre forward of the spike hole was missing.
- There was an inclined surface on the top edge of the spike hole.
- A shallow dent was present behind and to the left of the inclined surface.

Figure 4. Tie at the west end of the replacement rail showing the spike hole and the crack in the tie (Source: TSB)

- The angled deflector tie plate, which was used to cover the west butt end of the replacement rail laid between the rails of the north track, was secured using a spike that had been hammered into a large crack in the tie.

- A shallow piece of wood fibre that was forward of the spike hole was missing, and there was an inclined surface on the top edge of the spike hole. Both of these features were consistent with damage that could have been sustained by a spike that had loosened and rotated backwards.

- The shallow dent located immediately behind and to the left of the inclined surface was consistent with damage sustained from impact by a shoulder of the displaced angled deflector tie plate.

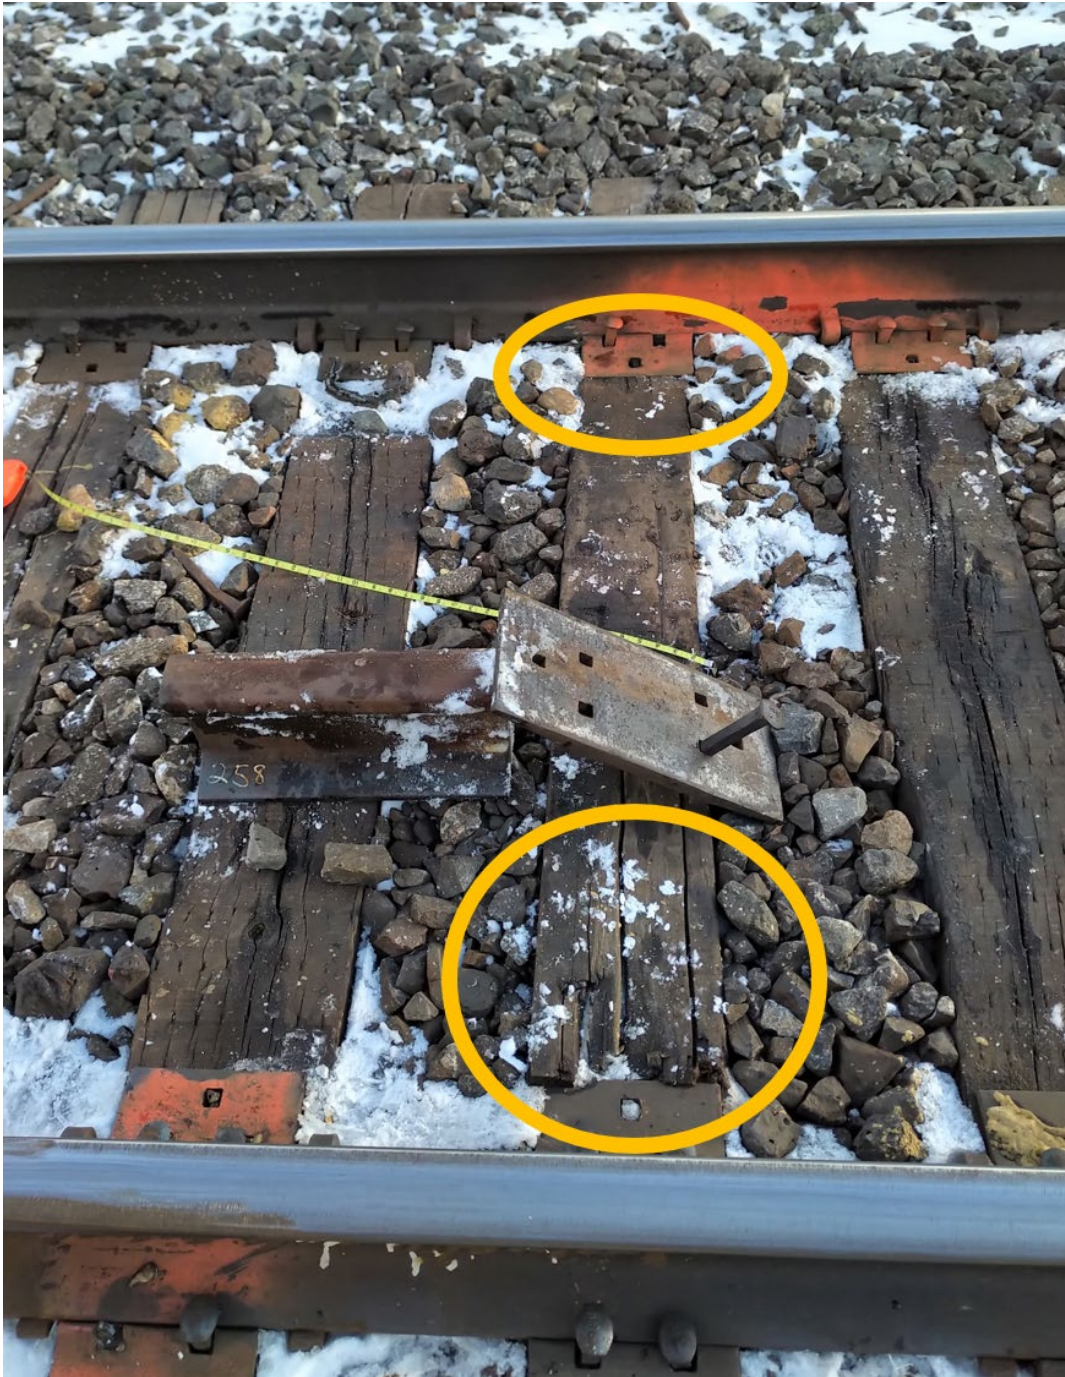
- The crack extended from the edge of the tie plate to the center of the tie (Figure 5).
- The top surface of the tie plate had sunk below the surface of the tie indicating that the wood was in a state of decay.

Figure 5. Tie at the west end of the replacement rail showing cracking along the length of the tie and wood decay under the tie plate (Source: TSB)

deflector tie plate against the west end of the replacement rail had been driven into a crack in the tie exhibiting signs of decay, which reduced the holding capacity of the spike. The spike became loose likely due to repeated deflections generated by the 4 trains that traversed the north track prior to the arrival of VIA passenger train 62/52.

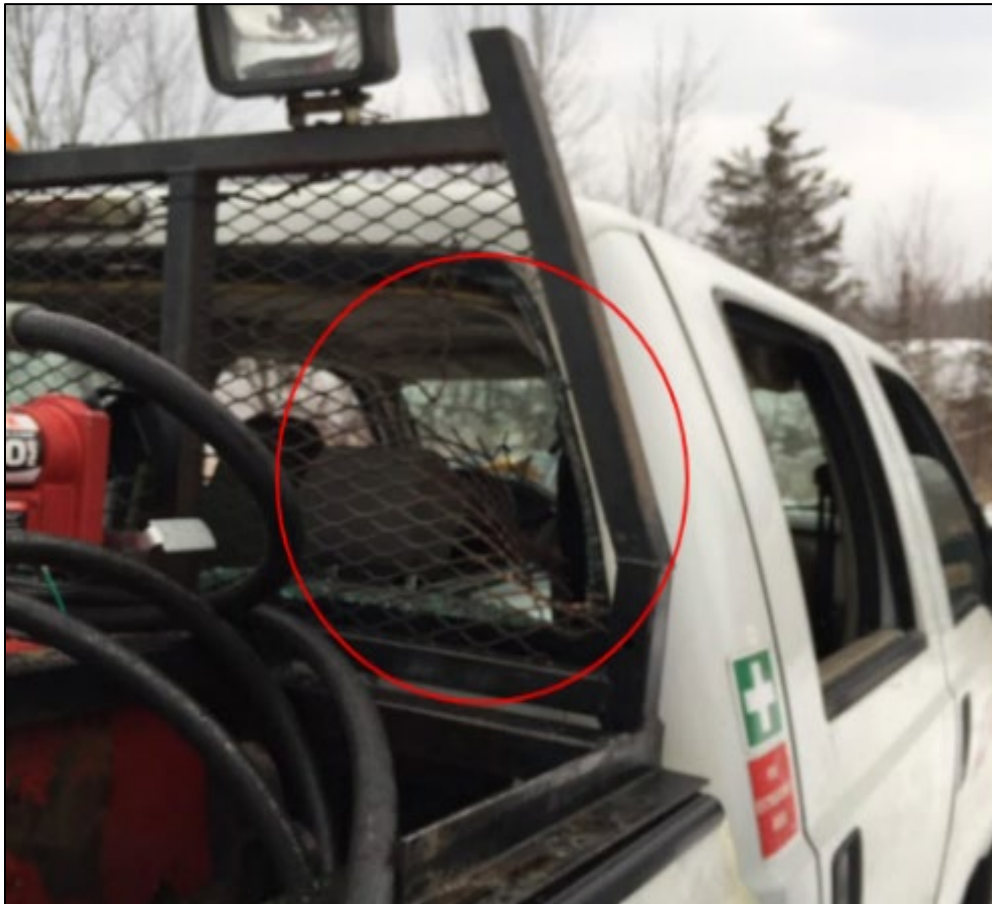
The CN engineering hi-rail vehicle sustained damage in the form of dents and broken glass. Impact damage from tie plates and ballast was evident on both the front and rear passenger-side doors. The rear window and the window of the rear passenger-side door were shattered. The protective metal screening on the rear window was punctured on the passenger side (Figure 6). The rear passenger-side seatbelt was damaged, as was the headliner above the driver's seat. As a result of the damage, the hi-rail vehicle had to be towed to a shop facility for repairs.

Figure 6. Damage to the protective screening on the rear window of the hi-rail vehicle (Source : CN, with TSB annotations)

Tie plates and ballast were expelled from under the train. The CN engineering hi-rail vehicle that was positioned adjacent to the north track sustained impact damage and became immobilized due to airborne tie plates and ballast. An airborne tie plate struck the hi-rail vehicle from behind, broke through the rear protective screen and window, entered the vehicle, and seriously injured one of the 4 CN engineering employees inside.
