Rail Transportation Safety Investigation Report R19W0329

MAIN-TRACK TRAIN DERAILMENT

VIA Rail Canada Inc.
Passenger train 692
Mile 22, Canadian National Railway Company Gladstone Subdivision
Beaver, Manitoba
31 December 2019

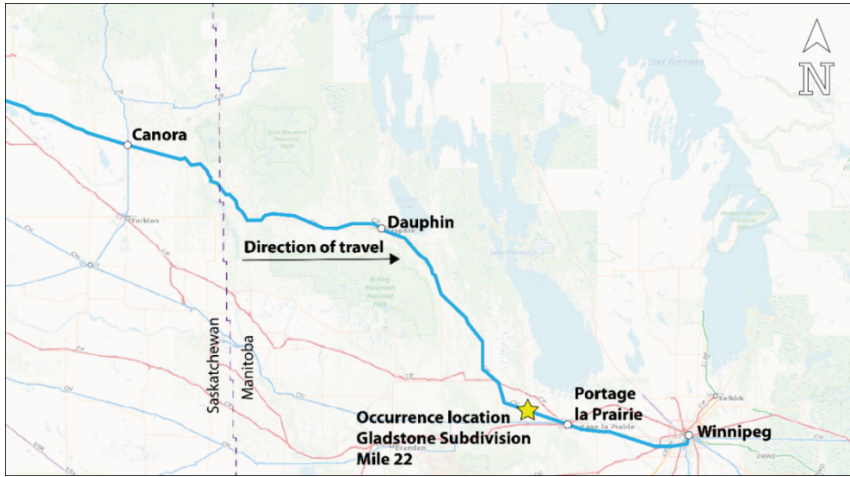
At 0645, while proceeding eastward at about 60 mph near Mile 22 of the CN Gladstone Subdivision, VIA 692 experienced a train-initiated emergency brake application, and derailed just west of a short bridge, as it traversed the Provincial Road 350 passive public crossing (Figure 1).

Figure 1. Derailment location (Source: Railway Association of Canada, Canadian Rail Atlas, with TSB annotations)

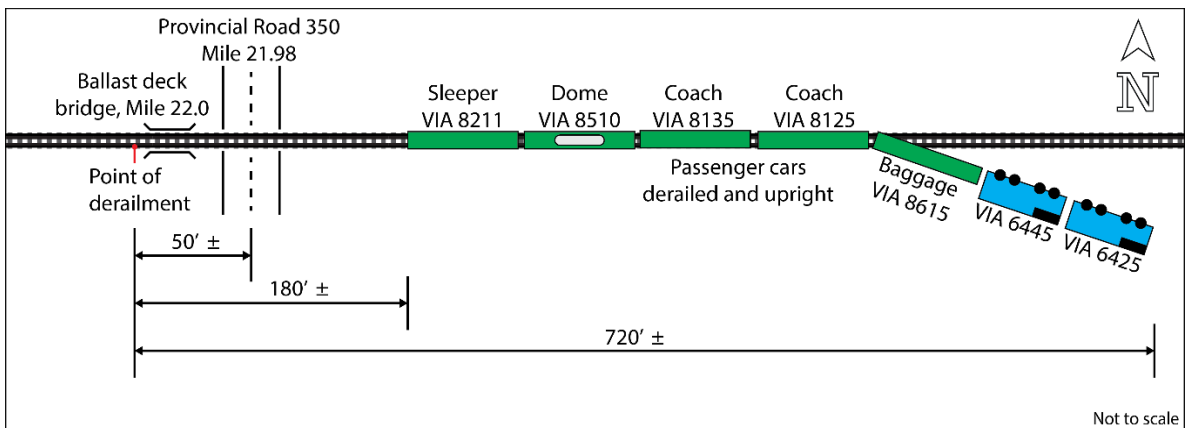
Marks observed on the ground indicated that all cars and locomotives on VIA 692 abruptly derailed to the south side of the track and stopped on the east side of the crossing. The 2 locomotives came to rest on their side while the 5 other cars remained upright (Figure 2).

Figure 2. Diagram of the derailment site (Source: TSB)

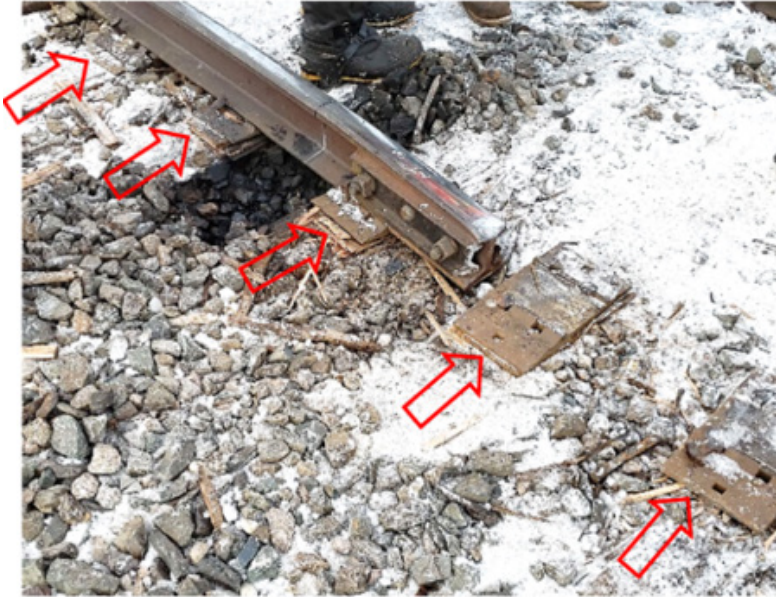
The broken joint was located at the east end of a 22-foot-long plug rail that had been installed in the south rail on 10 March 2019. Several tie plates under the joint had plywood shims² that appeared to have been recently installed (Figure 3).

Figure 3. West end of failed joint and plywood shims under tie plates
(Source: TSB)

- On 16 December 2019, a vehicle track interaction (V/TI)⁸ cross-level exception⁹ of ¼ inch was identified in the south rail, in an area between the joint and the crossing. A track maintenance crew added plywood shims¹⁰ under the tie plates to correct the condition.
- On 30 December 2019, a V/TI cross-level exception was identified in the area of the joint in the south rail. A track maintenance crew responded and found the joint suspended ½ inch above the tie plates. Plywood shims were added to correct the condition.

As a result of the cross-level conditions in the area of the derailment, the east joint of the plug rail would have been subjected to vertical displacement and cyclic impact loading with the passage of each train. Such loading is known to accelerate the growth of any cracks that may be present in the rail or the joint bars.

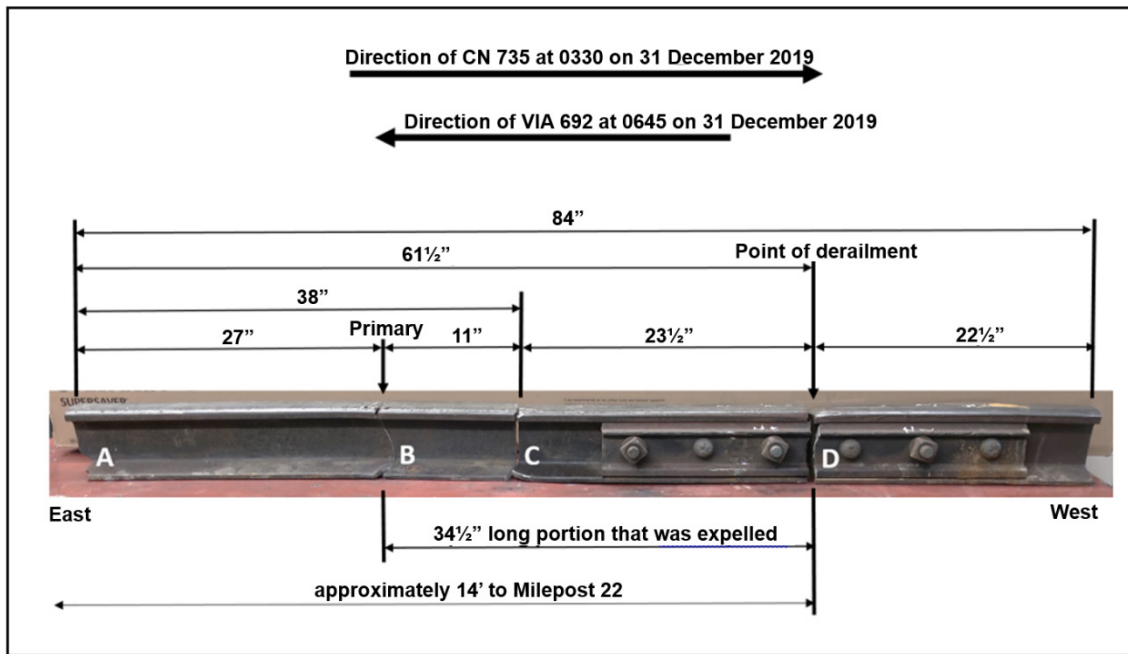
The head of the 71-year-old rail was worn, but within allowable limits. The 84 inches of the south rail that were recovered, which included the failed joint, consisted of 4 mating pieces measuring 27 inches, 11 inches, 23½ inches and 22½ inches long respectively from east to west. The pieces were labelled A through D (Figure 4).

Figure 4. Gauge-side view of the recovered portion of the south rail, containing 4 breaks labelled A to D, with break B being the primary (first) break. Note the 34½-inch-long portion that was expelled before the arrival of VIA 692. (Source: TSB)

Rail break A was catastrophic and occurred as a result of the derailment. The fracture surfaces of rail breaks B and C, located 27 inches and 38 inches from the east end of the rail section respectively, displayed gauge-side rail head detail fractures (DFs).

The observed pattern of the rail head impact damage indicated that the rail and joint bar failures likely occurred under westbound CN 735. The failures (breaks B, C, and D) occurred progressively and led to the expulsion of a section of the south rail, creating a gap of 34½ inches as CN 735 traversed and exited the area. The next train, eastbound VIA 692, could not bridge the gap and immediately derailed to the south side of the track at the west end of the failed joint.

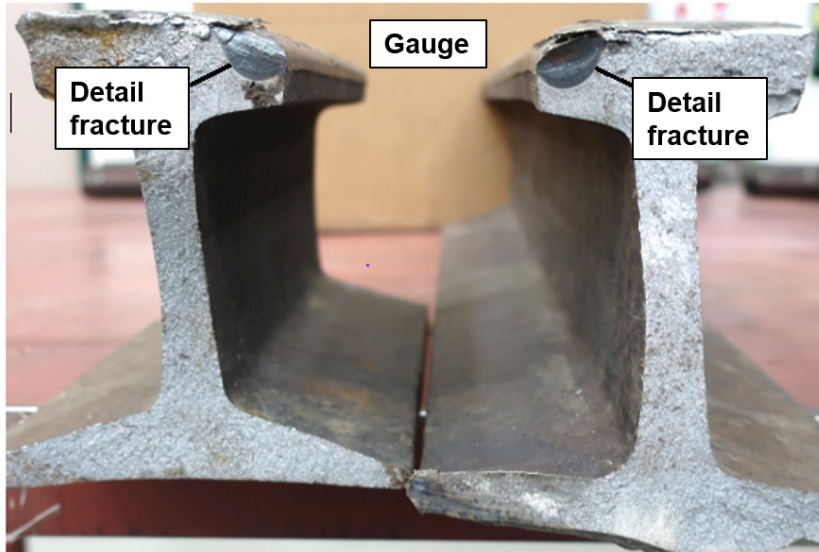
The DFs observed on rail breaks B (Figure 5) and C were dark with well-defined fatigue fracture characteristics, indicating that they had both been present for some time. The rail break B DF measured about $\frac{5}{8}$ inch deep by $\frac{3}{4}$ inch wide, which accounted for 15% of rail head cross-section. The rail break C DF measured about $\frac{1}{4}$ inch deep by $\frac{3}{4}$ inch wide, which accounted for 5% of rail head cross-section. Impact marks on the running surface of the west end of rail break C were consistent with a westward movement (i.e. CN 735).

Figure 5. Rail break B exposed fracture surfaces with gauge-corner detail fracture (dark surface) measuring about $\frac{5}{8}$ inch deep by $\frac{3}{4}$ inch wide (Source: TSB)

In each of the 3 failures (rail breaks B and C, as well as broken joint D), brittle fractures had developed from the extremities of the pre-existing fractures and propagated through the remainder of the cross-sections. The pre-existing rail head DFs and joint bar fatigue cracks acted as stress risers and facilitated the initiation of brittle through fractures in the south rail and joint bars, respectively.

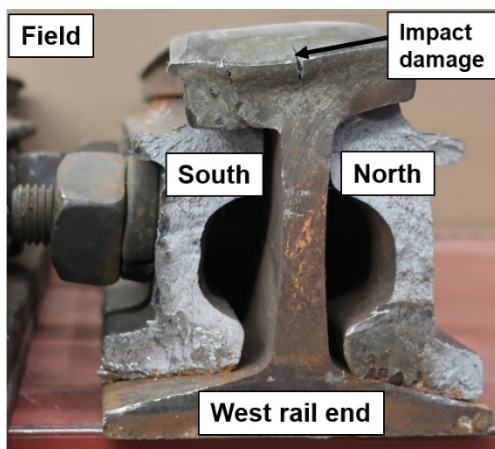
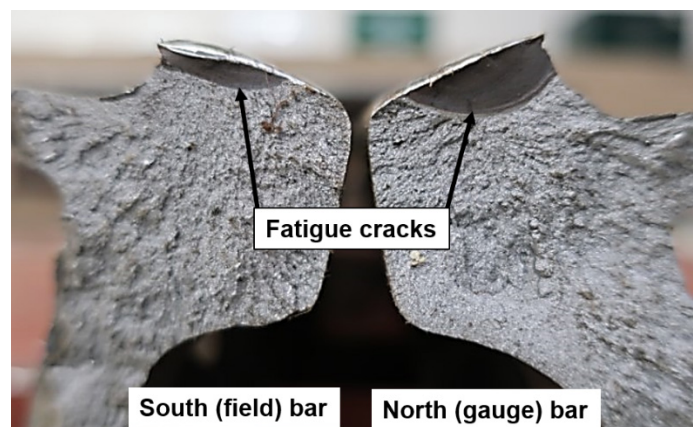
Broken joint D was located 61½ inches from the east end of the rail section. The joint bars were properly applied and the joint was tight. Both joint bars had broken in two near their mid-point.

The exposed fracture surfaces of joint D displayed pre-existing fatigue cracks in the top surface of the joint bars that fit the radius between the rail head and web. Although joint bar cracks typically occur in these locations, they are very difficult to detect by visual examination. The west-end rail exhibited heavy impact damage that was also consistent with a westbound movement (CN 735) (Figures 6 and 7).

Figure 6. Broken joint D, showing impact damage on the west end rail end surface (Source: TSB)

Figure 7. Close-up view of broken joint D, showing the joint bar fatigue cracks (Source: TSB)

On 06 January 2020, CN expanded section 1.2 (Joints) of its ETS whereby additional inspections and preventative maintenance measures are now required whenever work is being conducted in the vicinity of a joint. The additional measures are:

- Whenever work is being performed at or near a joint, the joint bars must be inspected for cracks, the bolts must be tightened and the low joints must be tamped or shimmed.
- Any joint bar found to be cracked or broken, outside of the middle bolt holes in Class 3 track and above, must be replaced.
- When replacing a cracked bar, closely inspect the matching bar for cracks and replace if needed.
