RAILWAY OCCURRENCE REPORT

R97H0008

STRIKING OF A PUBLIC HIGHWAY OVERPASS

IRON HIGHWAY

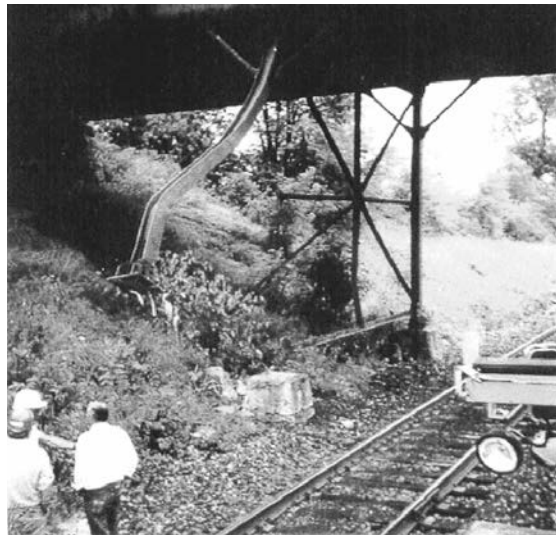
CPR freight train No. 121-13 (train 121) departed Côte St. Luc Yard in Montreal, Quebec, at 1030¹, and was proceeding westward on double main track near Bedell, Ontario, Mile 102.9 of the Winchester Subdivision. The crew of a rail grinding train, operating eastward on the adjacent south track, noticed that the last trailer on train 121 had shifted and, as they observed the train pass under an overpass for County Road No. 44, believed the shifted trailer may have struck part of the bridge support structure on the north side of the track. The crew of train 121 was immediately notified by radio of the possible problem and stopped the train. The conductor of train 121 confirmed that the last trailer was extensively damaged, and had shifted approximately 10 feet to the east end and 5 feet to the north side of the trailing platform. One of the four main support columns of the public highway overpass was ripped away from its pedestal, and several smaller diagonal steel braces were bent and twisted (see Figure 1).

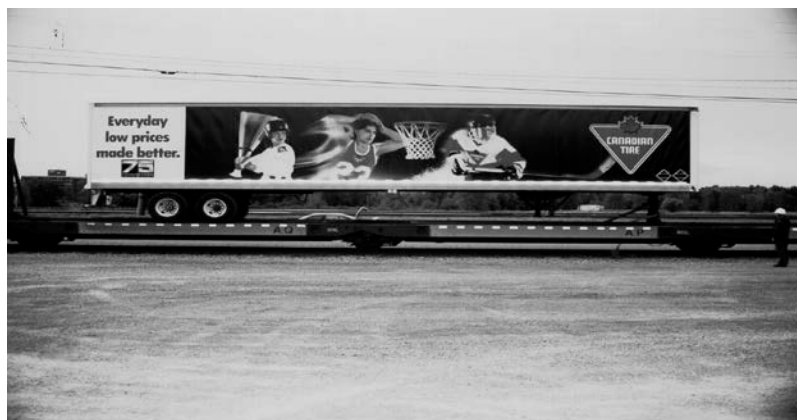
The trailer was connected to the hitch on the platform identified by the alpha designation 'AP'. The AP platform was the next-to-last (trailing) platform of the Element. As the train was proceeding westward, the hitch end of the trailer was leading. The trailer spanned two platforms, with the tandem wheels located on the last platform of the Element (see Figure 3). In transit, there is no air supply to the trailer resulting in full application of the spring-activated trailer parking brakes.

The trailer superstructure was extensively damaged in the accident. A small blunt impact mark was observed on the king pin⁴, and the surrounding support plate had scrapes consistent with the direction of movement. The king pin on the trailer was gauged with a Holland King Pin Gauge for four different wear contours and all measurements were within acceptable wear limits. The trailer brakes were tested and found to be operative and properly adjusted. The trailer had no indication of being damaged before the accident.

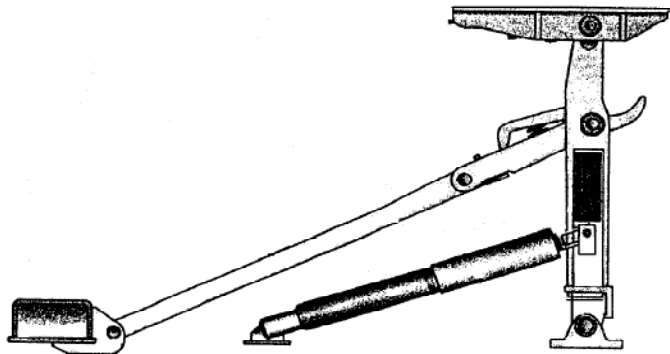
The 16 trailers loaded on train 121 were secured by Trinity LP-9 hitches (see Figure 4). This type of hitch is known as a pull-up retractable, with automatic locking of both the trailer king pin rotor lock within the head assembly and the folding diagonal strut. The hitches are manufactured by Trinity Industries of Dallas, Texas, and are designed for a maximum king pin load of 30,000 pounds. Although they are not AAR-approved, they are similar to the AAR-approved LP-3 hitches (manufactured from 1968 to 1973) and the LP-8 hitches which have been used in marine service since 1971, with over 6,000 units in use today⁵. The LP-9 hitch was specifically adapted for use on the Iron Highway project. There are no other known railway applications. When raised to the vertical position, the head of the hitch approaches the king pin of a trailer from the rear. This is the opposite direction than that of a fifth wheel on a normal highway tractor.

The hitch involved in this accident did not appear to have sustained any damage during the accident. When inspected, the hitch was upright with the diagonal strut in the locked position and the rotor in the hitch head in the unlocked position. The only abnormalities noted were a leaking hydraulic damper and a bent lock indicator pin on the hitch head.

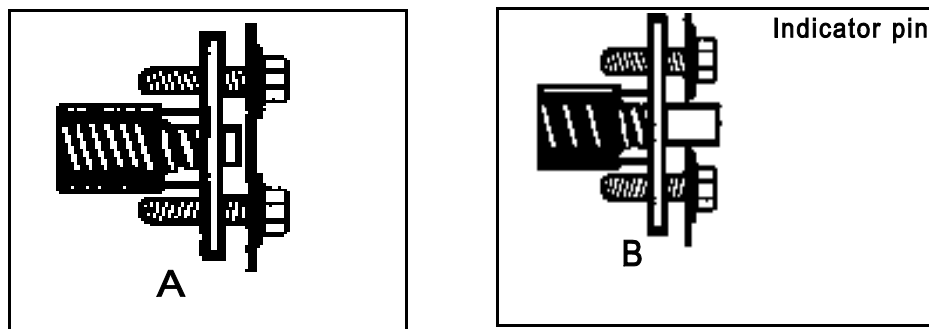
Figure 5 - Indicator Pin in A) Locked Position and B) Unlocked Position

The normal engagement depth of the lock plunger is 7/8 inch when fully locked. The lock indicator pin is designed to protrude at least 3/4 inch to indicate an unlocked position.

The position of the indicator pins on locked hitches varied. Some pins considered to be in the ‘locked’ position were reported by employees to be inside the flat plate; others were flush, or even slightly protruding.

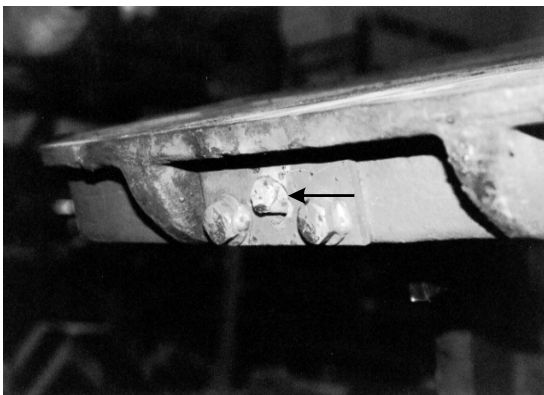
Figure 6 - Bent Lock Indicator Pin

When placed in the 'locked' position, the lock indicator pin protruded 10 mm (3/8 inch) from the normal flush position. Tear down revealed that the indicator pin was bent upwards 11 mm at an angle of approximately 15 degrees over a length of 48 mm (see Figure 6).

- The rotor lock indicator pin was bent due to contact with the trailer floor ribs as a result of hyper-extension during the knock-down sequence.
- There is no secondary locking mechanism on the hitch to retain the trailer king pin in the event the primary lock fails or is not fully engaged.

Post-accident tear down analysis showed that the rotor lock indicator pin was bent. The trailer involved in the accident is not considered to have bent the lock indicator pin for the following reasons: 1) there were no unusual marks on the trailer floor underframe; 2) there were no bent floor cross members; and 3) testing has shown that the hyper-extension of the lock indicator pin occurs during the off-loading process, during the hitch knock-down sequence, rather than when the trailers are being loaded. Therefore, the lock indicator pin was damaged before the last loading sequence.

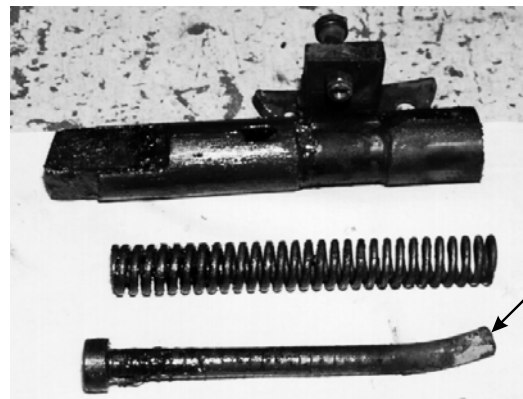
The examination also showed that, if the forward acceleration of the hitch head is sufficient, the resultant inertia in the indicator pin causes over-compression of the spring, allowing the indicator pin to extend past the

protective area of the hitch, where it is vulnerable to damage (see Figure 7).

The cause of the bend in the indicator pin, as identified in TSB Engineering Branch report LP 150/97, was as follows: the rotor lock indicator pin hyper-extended during knock-down of the hitch, and then bent due to contact with the floor ribs of a trailer. Employees’ past experience with pins getting caught on floor underframes, and the number of bent pins examined by TSB investigators or referenced in inspection and repair records, suggest that this type of problem is not infrequent. During the off-loading sequence, a spotter may not be aware that an indicator pin has contacted a floor underframe, unless the hitch head actually remains jammed under the trailer. Because subsequent safety inspections of the Element are performed
