RAILWAY OCCURRENCE REPORT

R97V0063

DERAILMENT

CANADIAN NATIONAL

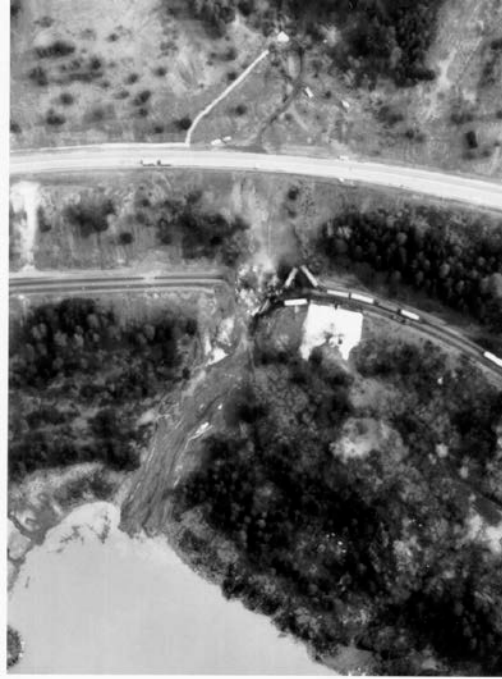
In the area of the derailment, the single main track and siding (west of the main track) run between the Trans-Canada Highway, approximately 60 m (197 feet) to the east and 34 m (112 feet) above, and the Fraser River, approximately 150 m (492 feet) to the west, and 50 m (164 feet) below. The railway embankment and toe of the highway fills had slipped away, leaving a void approximately 60 m (197 feet) long and 12 m (40 feet) deep, stretching up into the highway fills. The mud-like fill had flowed west, trailing into the Fraser River. The locomotive consist and first three cars of train 711 were standing upright and railed on the siding south of the depression. The fourth car was derailed and leaning, the fifth and sixth cars had rolled onto their sides and spilled their lading, while the seventh car was lying partially down the embankment. The eighth, ninth and tenth cars were near the bottom of the embankment on the westerly edge of the pile-up of equipment at the bottom of the depression, while the eleventh car was derailed and upright north of the slide area. The tenth car had come to rest approximately 46 m (150 feet) west of the siding track. The pile of equipment included the locomotive consist and the first six cars from train 102. The seventh and eighth cars were upright, but derailed, on the south edge of the depression (See Figure 1).

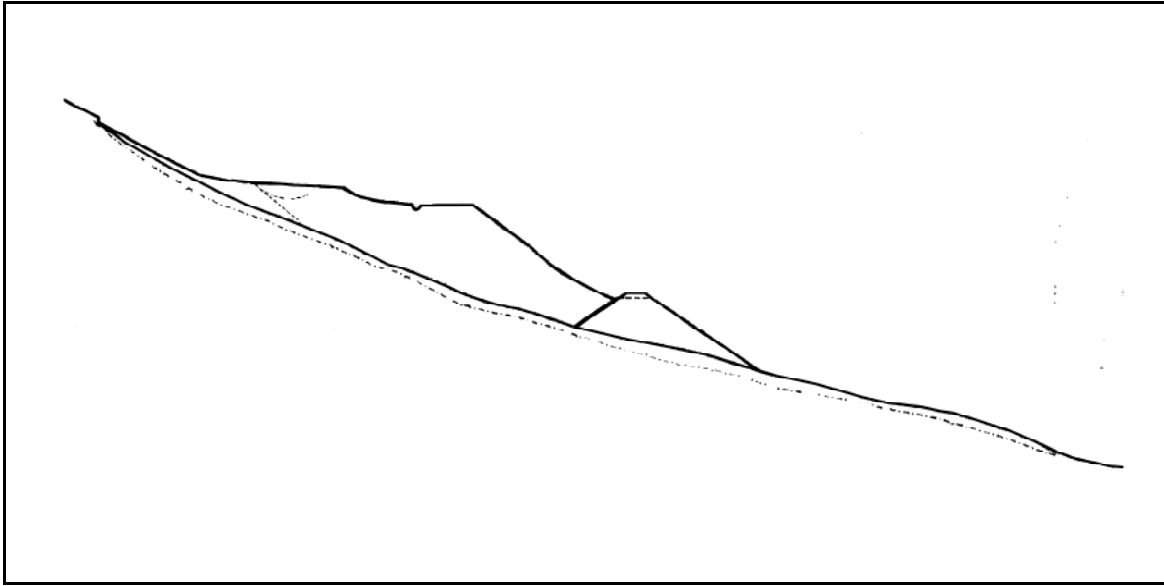
The terrain is mountainous and heavily forested. The highway, originally built in 1948, had been realigned in 1952 and 1960. Each realignment resulted in the highway being moved closer to the railway right-of-way (See Figure 2). The highway subgrade and embankment consist of local fill materials laid over original ground. The highway embankment is at an approximate 1 to 1.5 slope. A service road, 3 m (10 feet) wide, runs between the railway subgrade and the toe of the highway fill.
