RAILWAY INVESTIGATION REPORT

R98C0022

REAR-END TRAIN COLLISION

FREIGHT TRAINS A-447-51-01 AND C-771-51-28

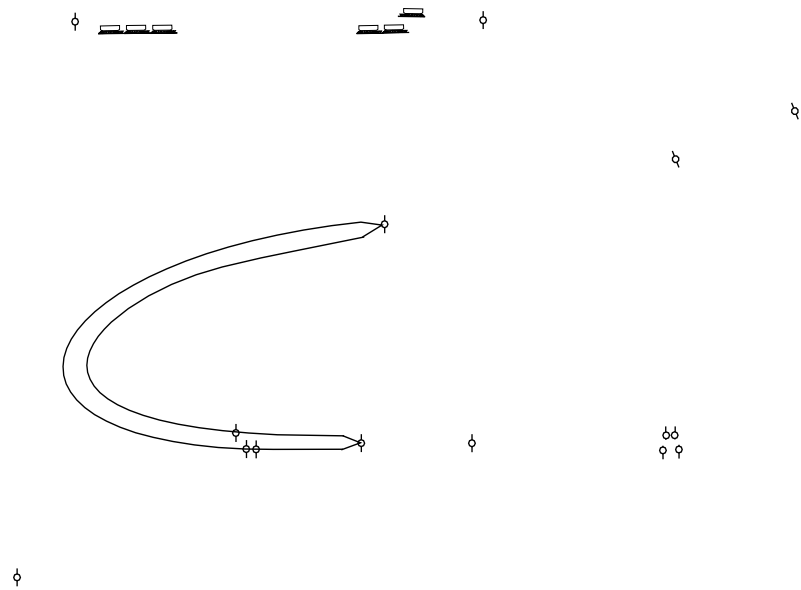
The locomotive engineer and conductor of train 447 assumed, based on the information broadcasted from the WIS, that the rear end of train 771 was clear of Mile 166.5. The locomotive engineer decided to have a light snack and the conductor was checking the train manifest while negotiating a two-degree right-hand curve at Mile 165.0. The sight-line from the locomotive of train 447 was obstructed by a grove of trees. The distance from where the last car (CN 197930) of train 771 could be seen by the approaching train 447 was determined to be approximately 1,050 feet. The locomotive engineer of train 447 stated that he saw the last car just before he initiated an emergency brake application. Approximately nine seconds then elapsed before the collision with the rear car. The train proceeded for approximately 190 feet between the time the emergency brake application was made and impact. The estimated distance required to stop train 447 under normal conditions would be approximately 270 feet. The impact occurred at a speed of approximately 8 mph. There was no fuel spillage or fire.

Both the locomotive and empty hopper car derailed and remained upright obstructing the south track. The knuckle of the rear car on train 771, CN 197930, climbed over the knuckle of the lead locomotive of train 447 and severely damaged the nose of the cab. The empty open-top hopper car was also severely damaged.
