MARINE TRANSPORTATION SAFETY INVESTIGATION REPORT M21P0297

LOSS OF CONTAINERS OVERBOARD AND SUBSEQUENT FIRE

Container vessel *ZIM Kingston*
La Perouse Bank, British Columbia
21 October 2021

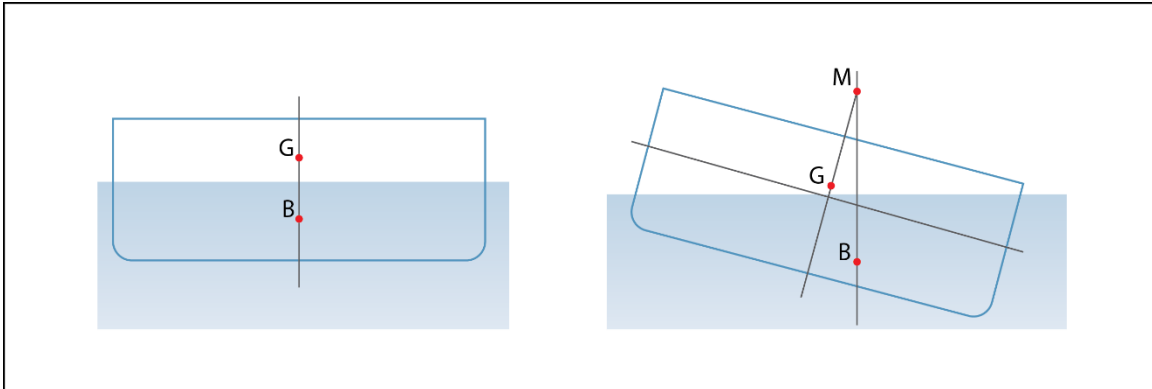
Figure 13. Diagram depicting a vessel's centre of gravity (G), centre of buoyancy (B), and metacentre (M); metacentric height is the distance between G and M (Source: TSB)

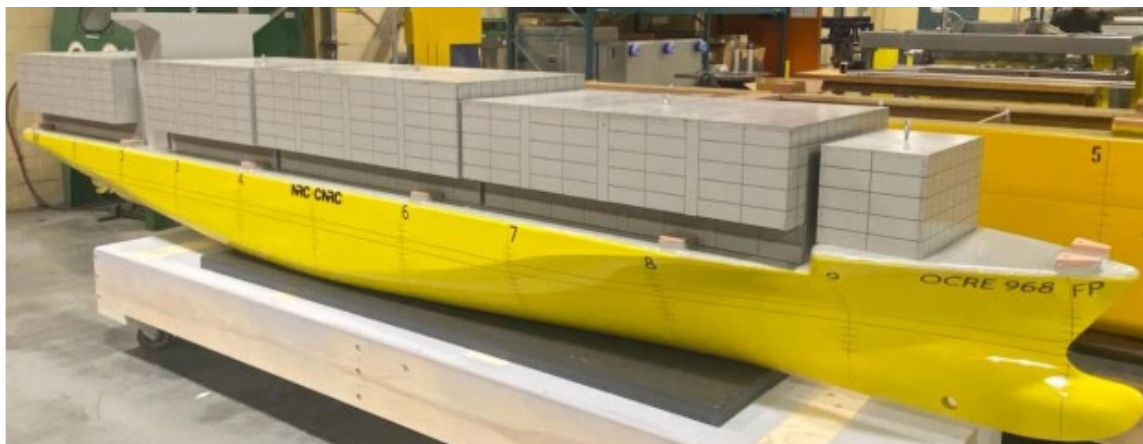
Figure 15. Scale model of the *ZIM Kingston* (Source: National Research Council Canada)

The model was built with steering capability and was self-propelled so that testing could be done in drifting, transiting, and manoeuvring operational modes. The model was also fitted with accelerometers. The testing took place in the Ocean Engineering Basin, which is 75 m long, 32 m wide, and 3.2 m deep, and had segmented wave generators along 2 of its sides to create waves (Figure 16). Wind was modelled using a fan bank stationed on one side of the basin.

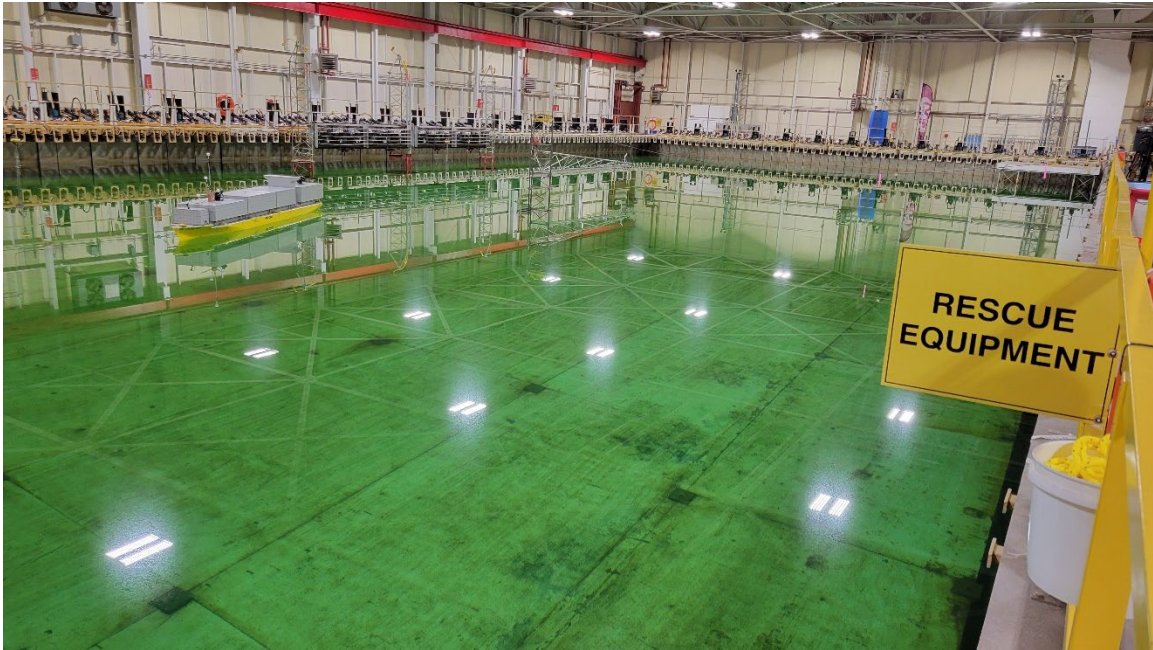
Figure 16. Ocean Engineering Basin (Source: NRC)

The basin and model used an optical motion tracking system to record the model's motions. The data recorded in the model testing were then scaled up to understand the motions experienced by the *ZIM Kingston* and the wave phenomena that can create these motions.
